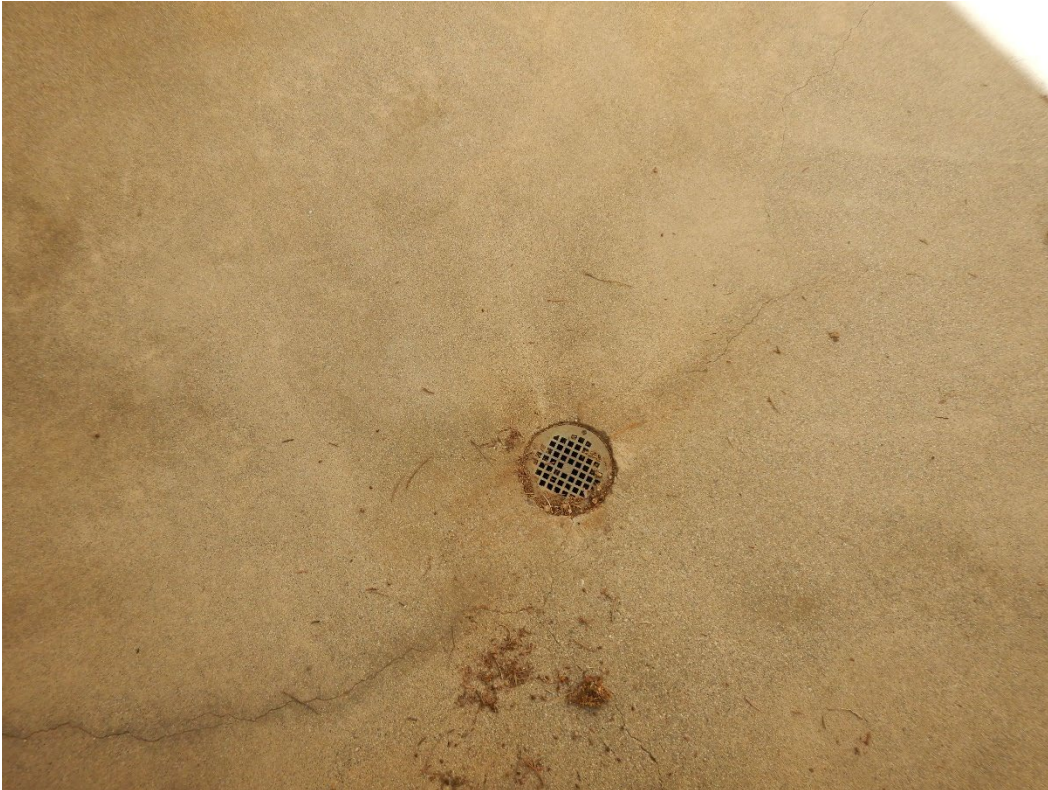
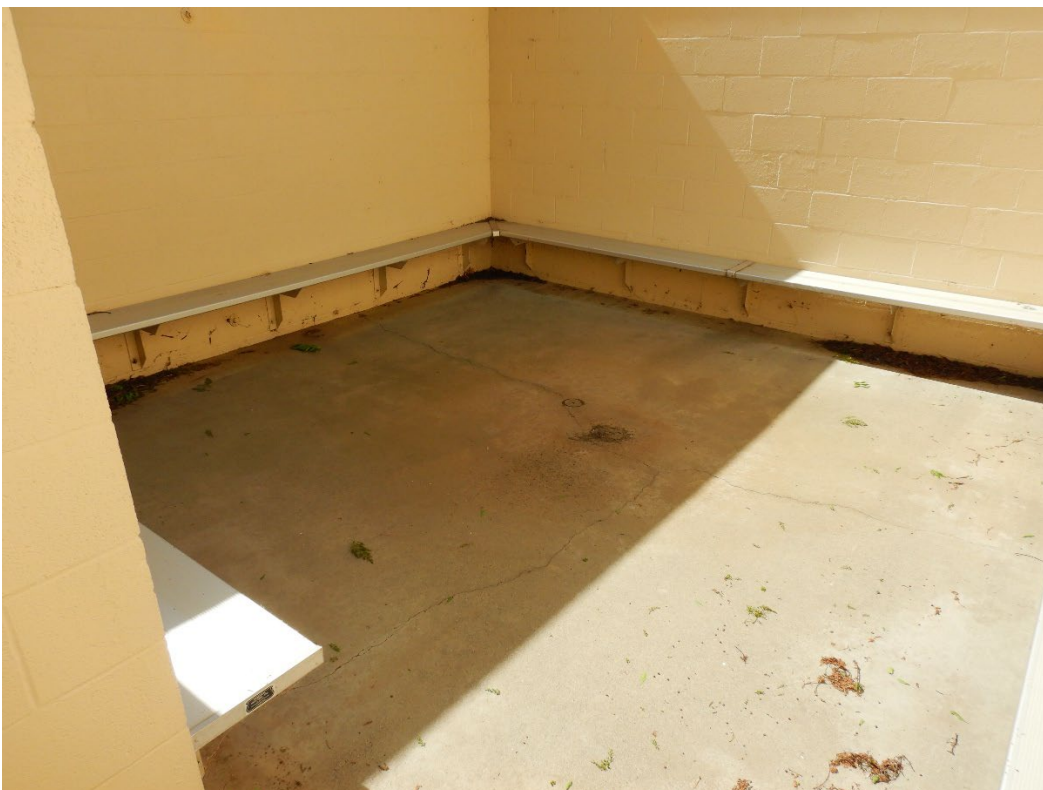
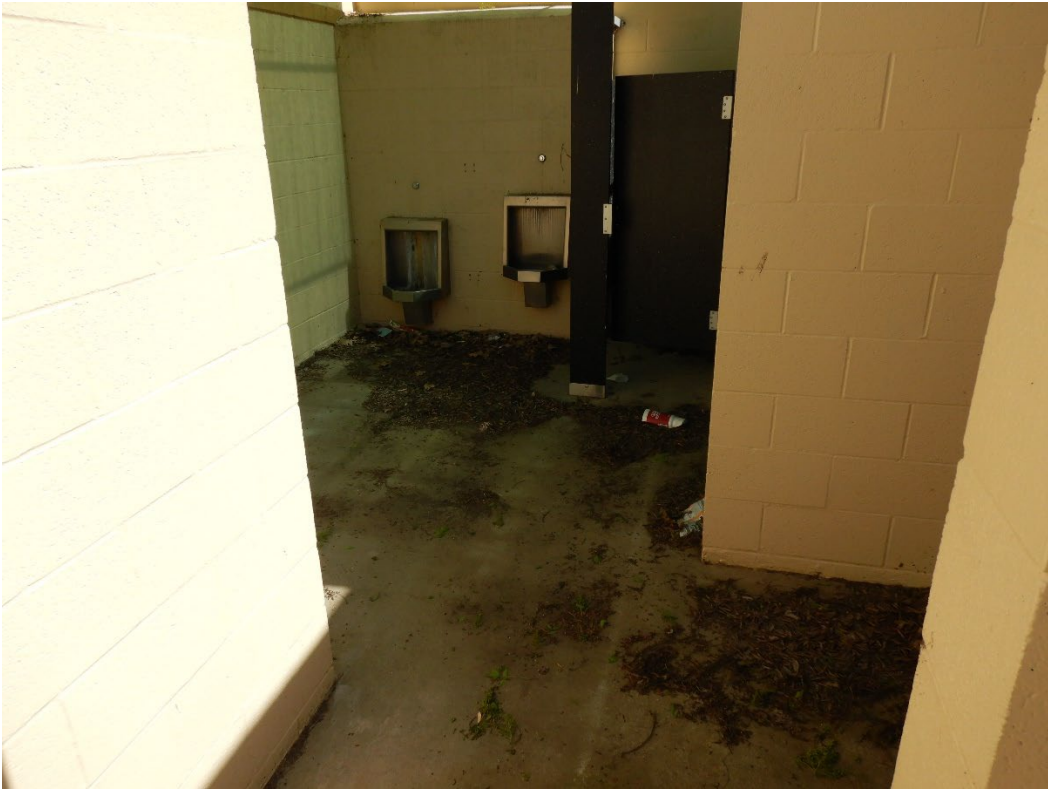
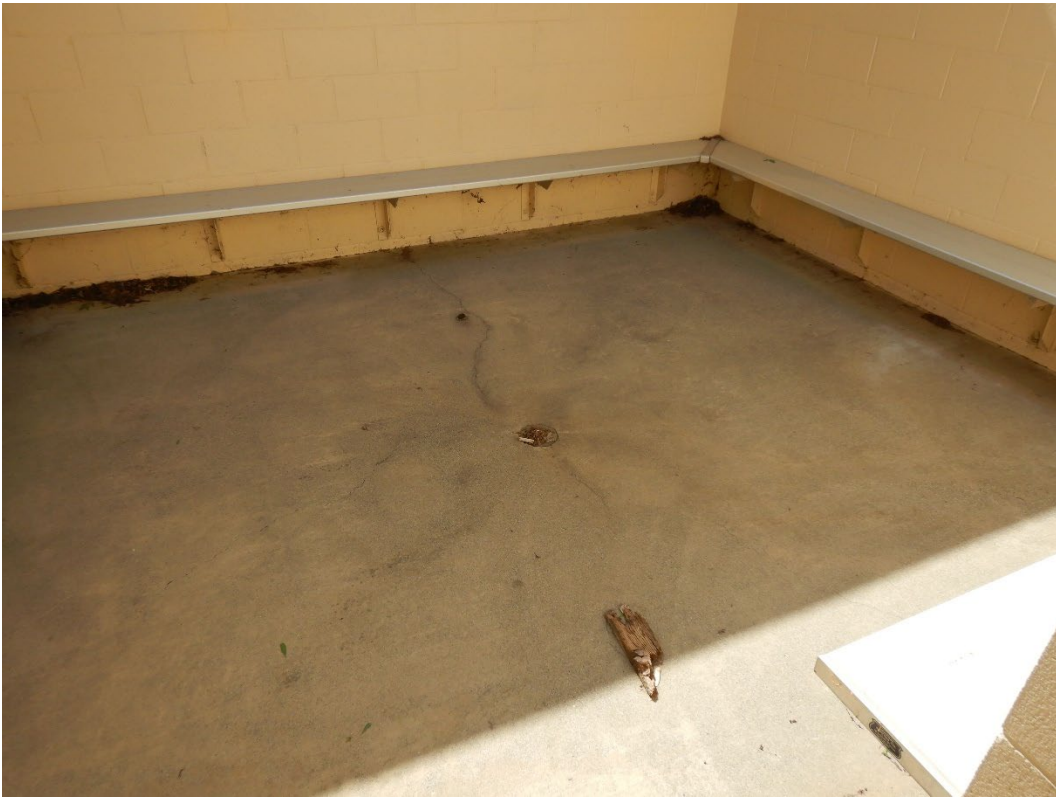
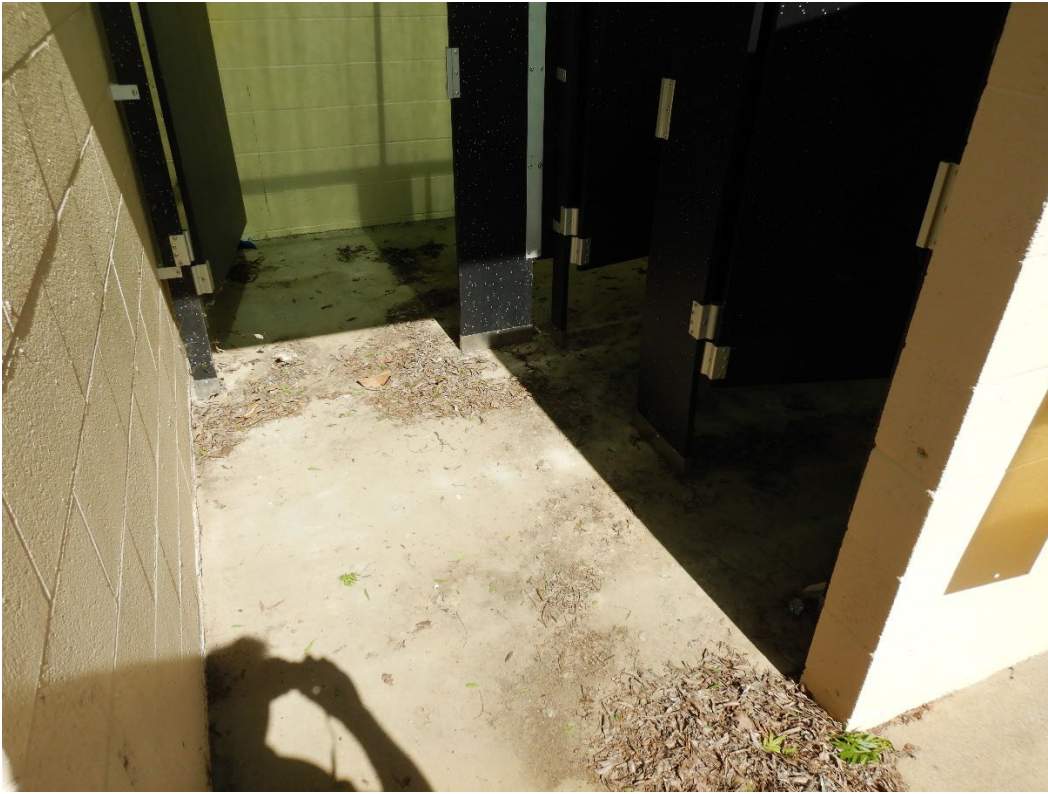
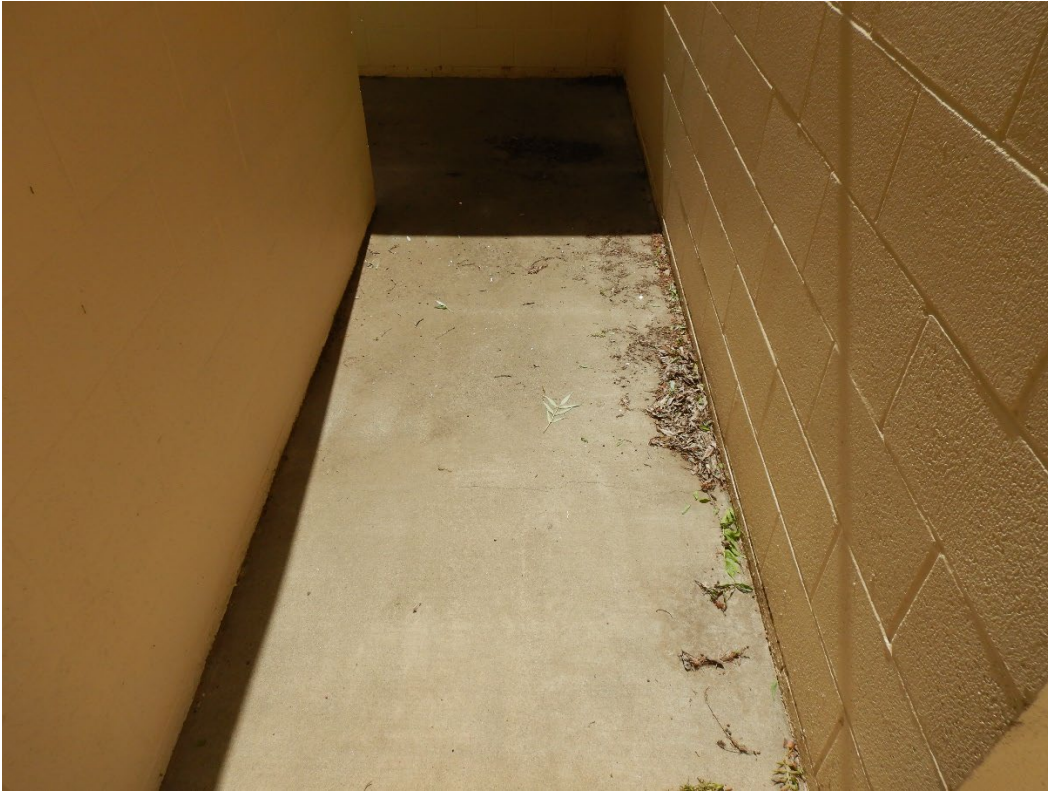
Evaluation Categories	Comments	Fiscal Impact
Floors and walkways are clean, walking surfaces are appropriate.	The concrete floors have a good surface, minimal cracks and the drain covers look to be in good working order. The floors might get a little slippery when wet, but this is normal for finished concrete floors. These would need to be cleaned very well, pressure washed and scrubbed with street broom prior to opening.	\$0

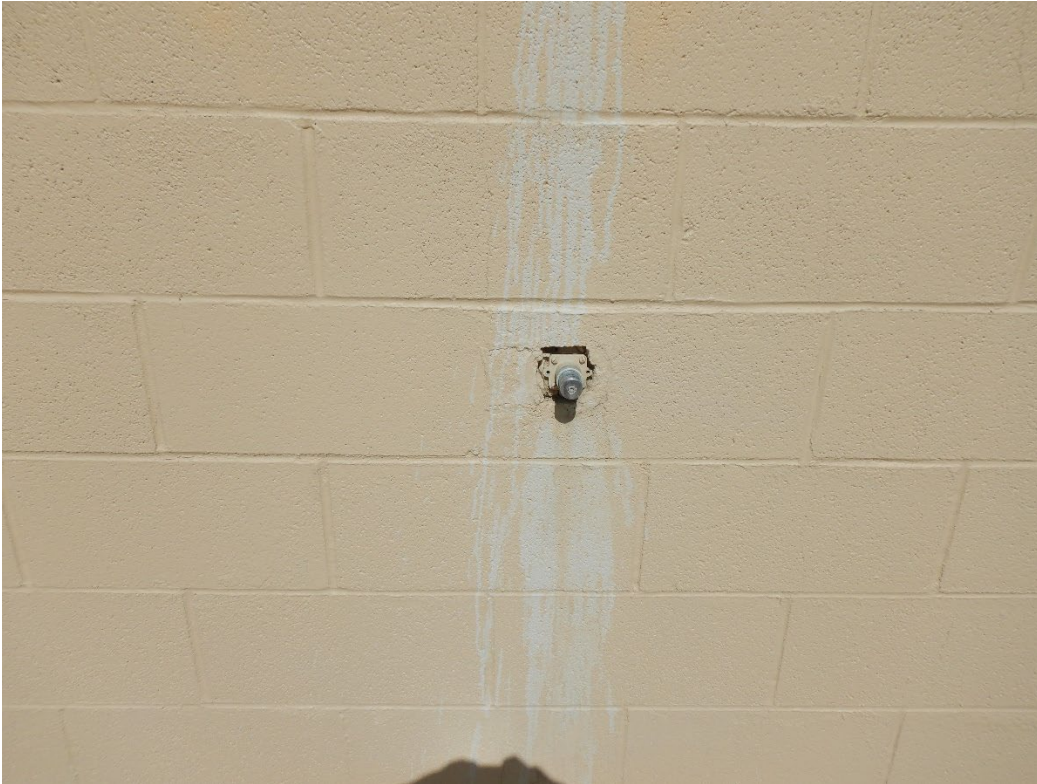
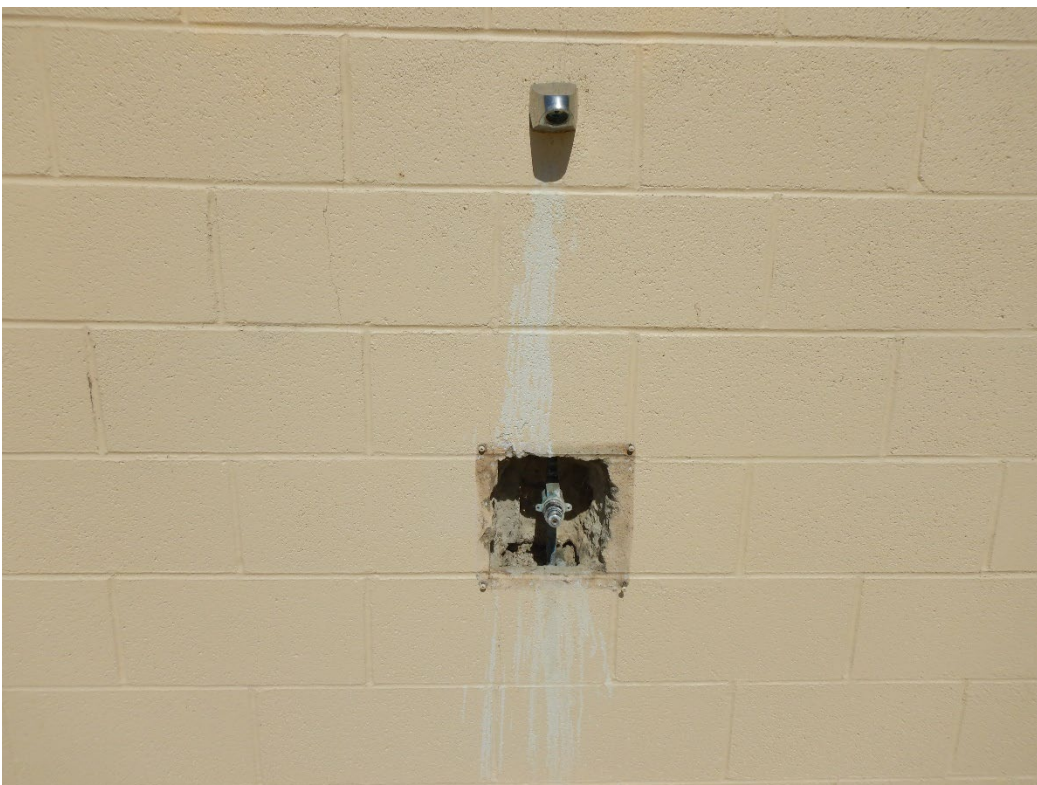
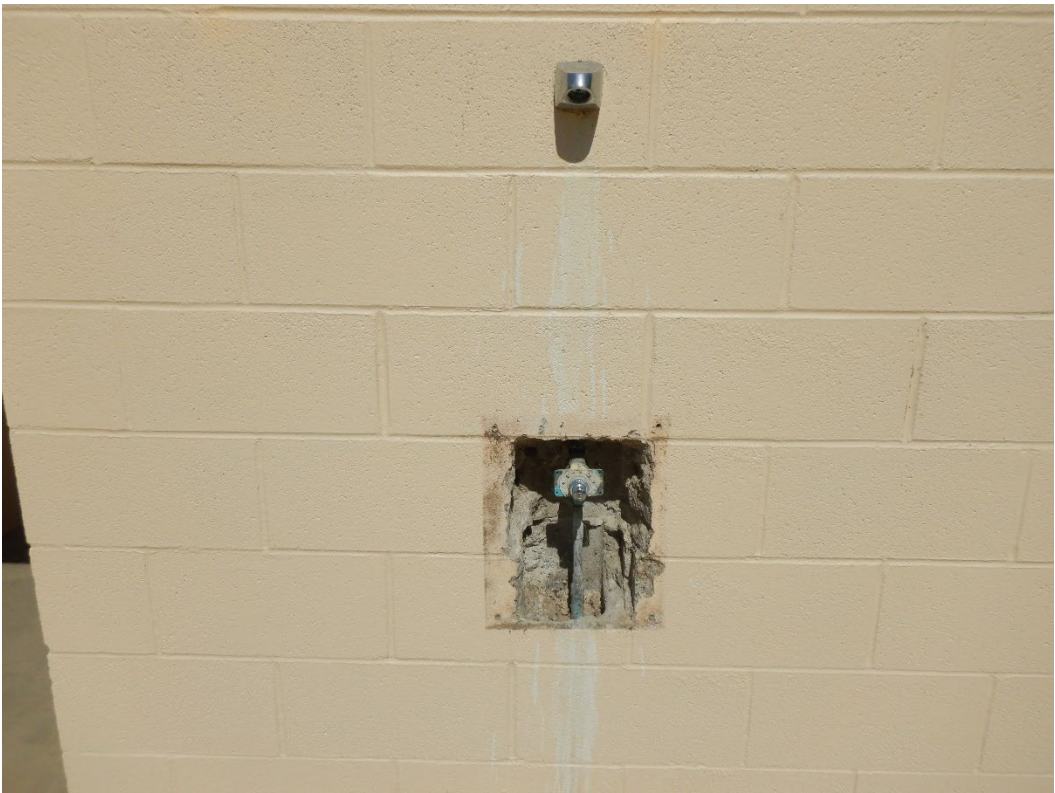
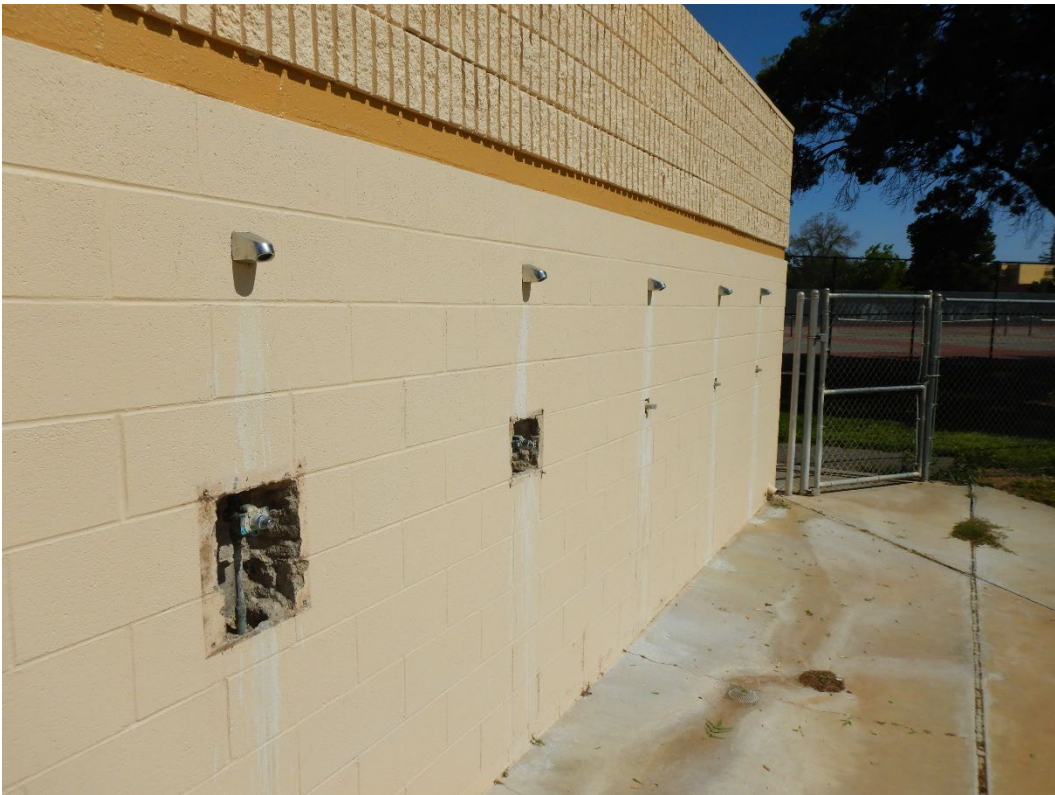
Evaluation Categories	Comments	Fiscal Impact
Shower area is clean, showers are functional and have soap dispensers, ADA shower(s) is/are working	There are five deck showers, this a good number for the facility and considering changing areas are uncovered, and it is a seasonal pool, outdoor showers are appropriate. They all will need spray nozzles reinstalled, covers and/or face rings around push buttons replaced and put back on before opening	\$0-\$30

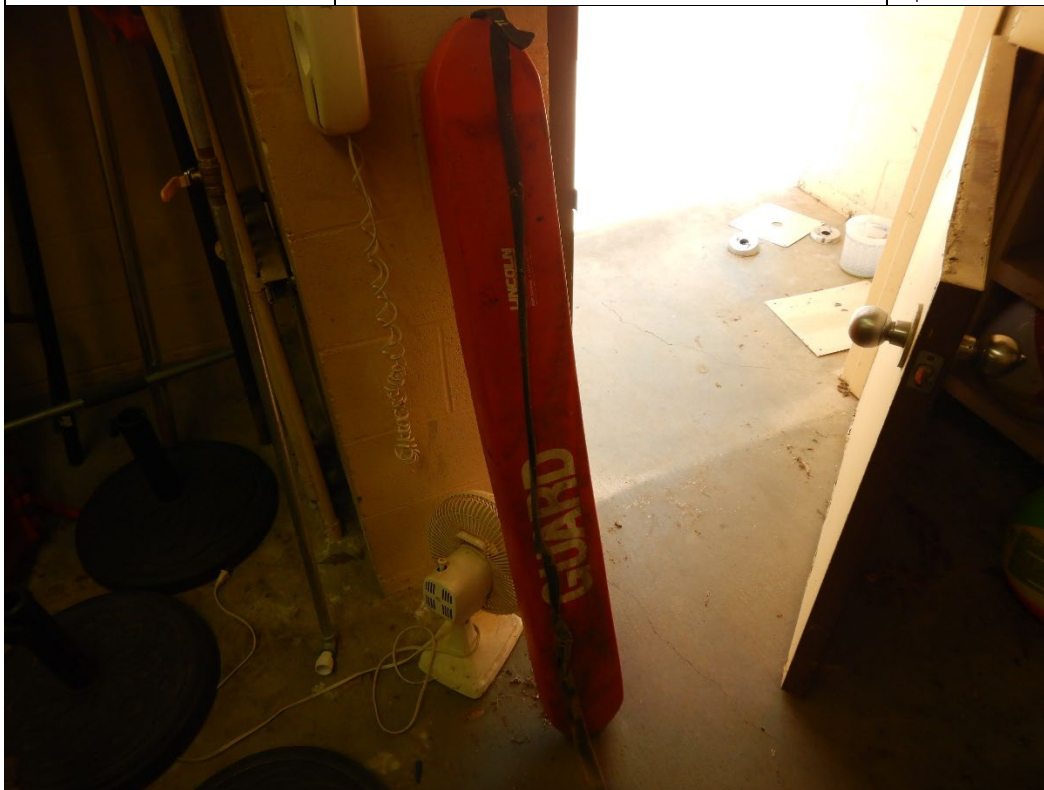
Evaluation Categories	Comments	Fiscal Impact
Rescue tubes are in good condition and those not in use are stored well	One rescue tube was observed, tube strap is faded and worn, will need to be replaced. The facility should have at least four, or even more for staff training.	\$70/each, \$280 total

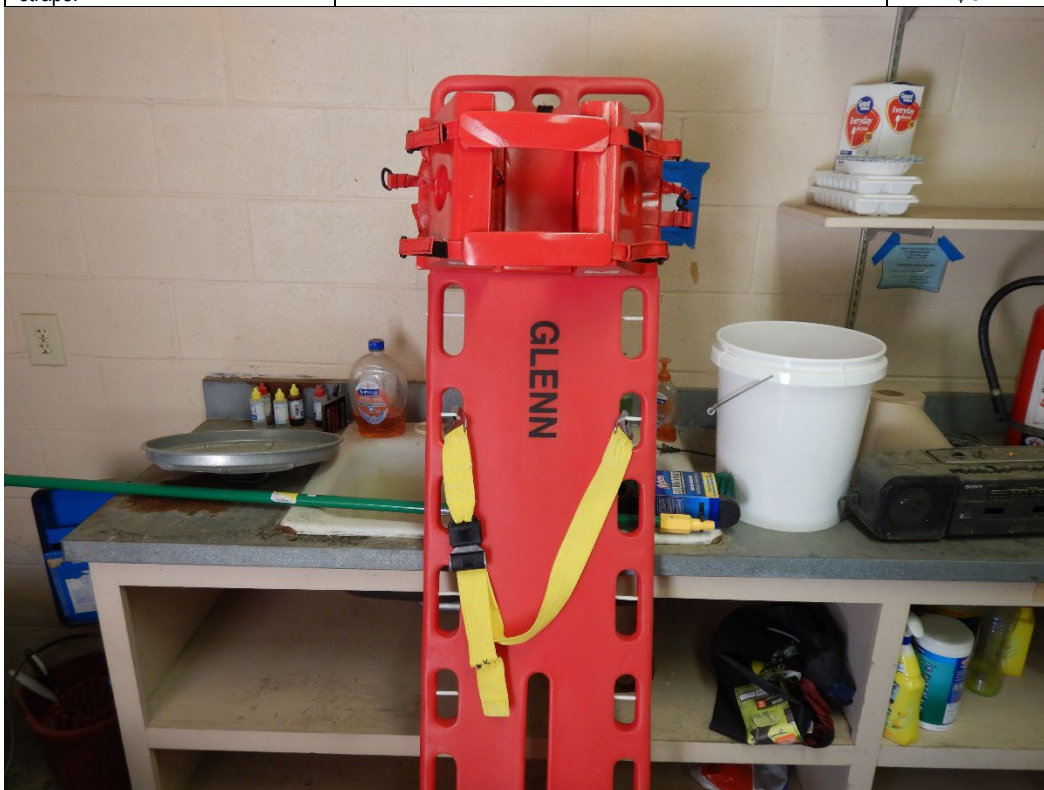
Evaluation Categories	Comments	Fiscal Impact
Back board is on deck, stored appropriately and has functional head stabilizers and proper straps.	The backboard was inspected and is in excellent condition and ready for use.	\$0

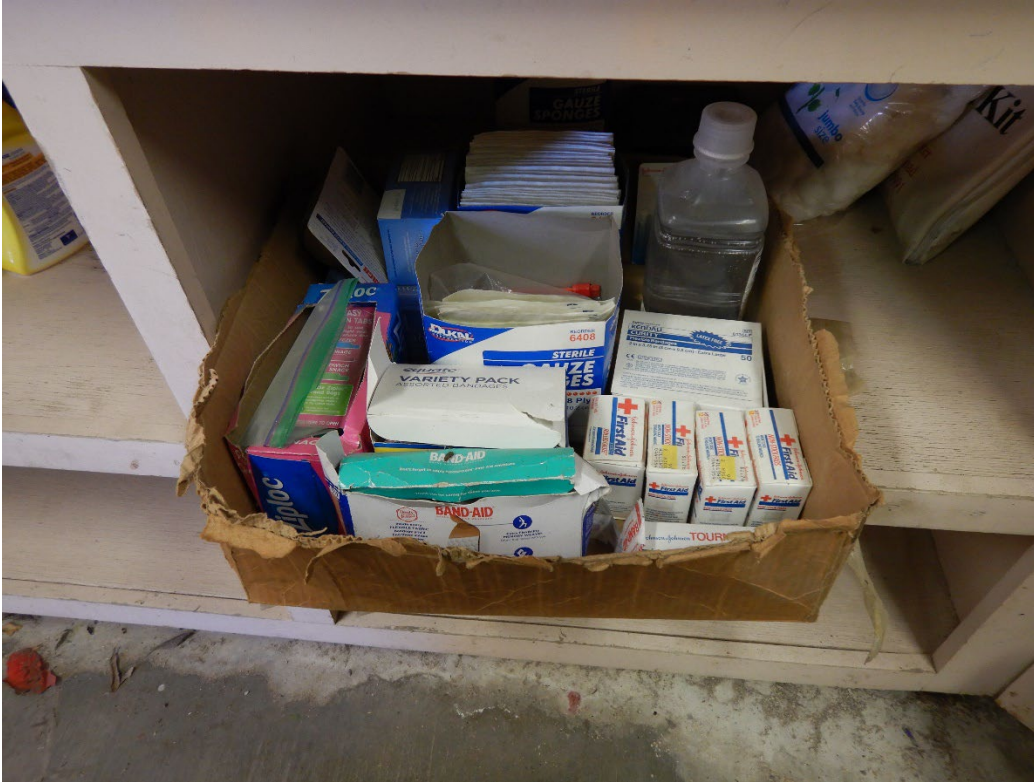
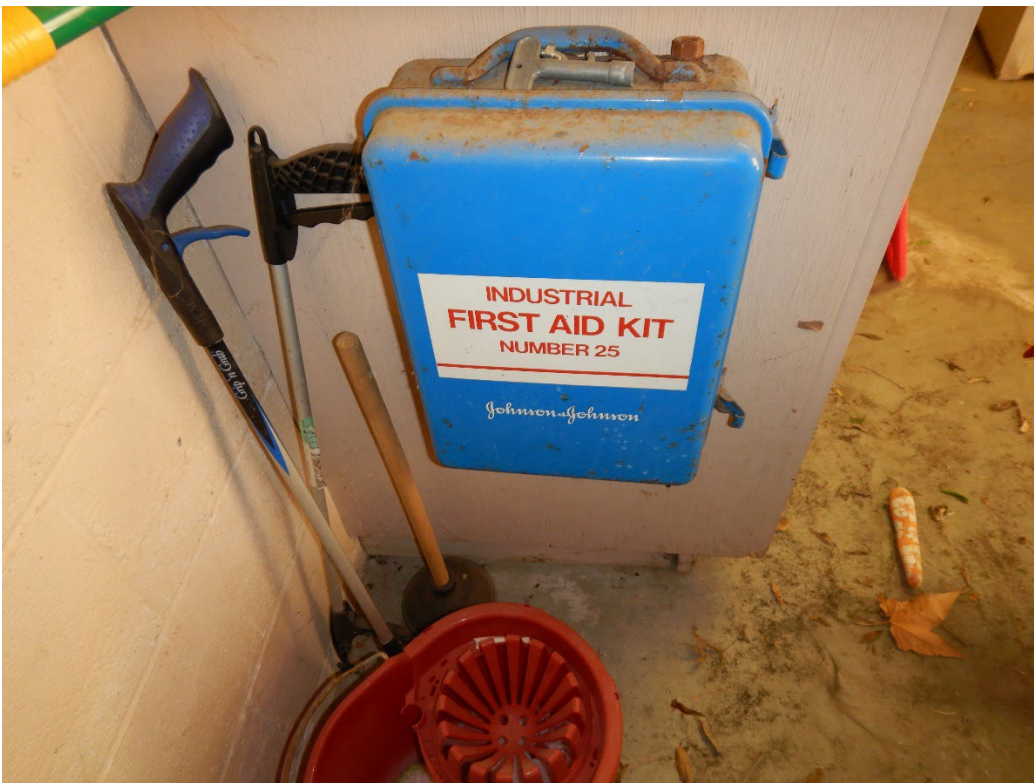
Evaluation Categories	Comments	Fiscal Impact
Crash bag or other portable medical kit is located in a good location and has equipment "bundled" in it.	Did not see a "Crash" or "Go Bag", these generally have BVM, AED, gauze and blood control supplies, pulse oximeter, emergency blanket and are used to take to the patient in any area of the facility in an emergency.	\$400 without AED
OSHA 10-person first aid kit	The first aid supplies on site exceed the OSHA ten-person kit standard, consider cleaning or buying a new first aid box or cabinet. Location is good in the office	\$0 to \$75

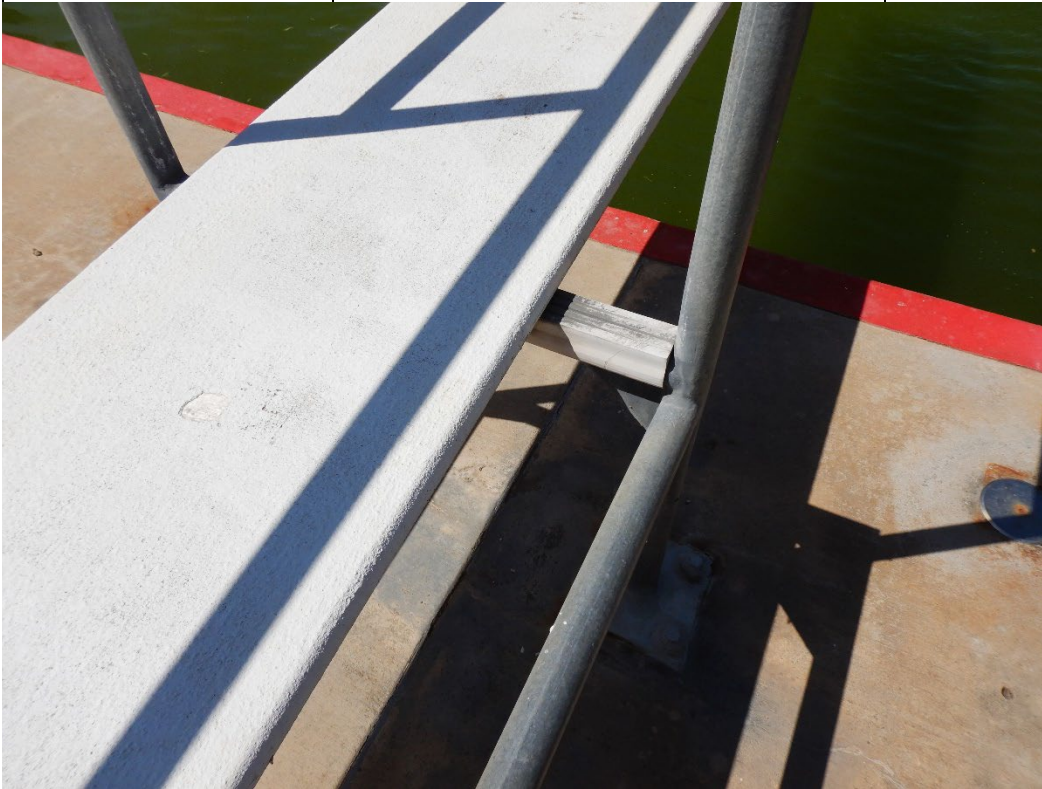
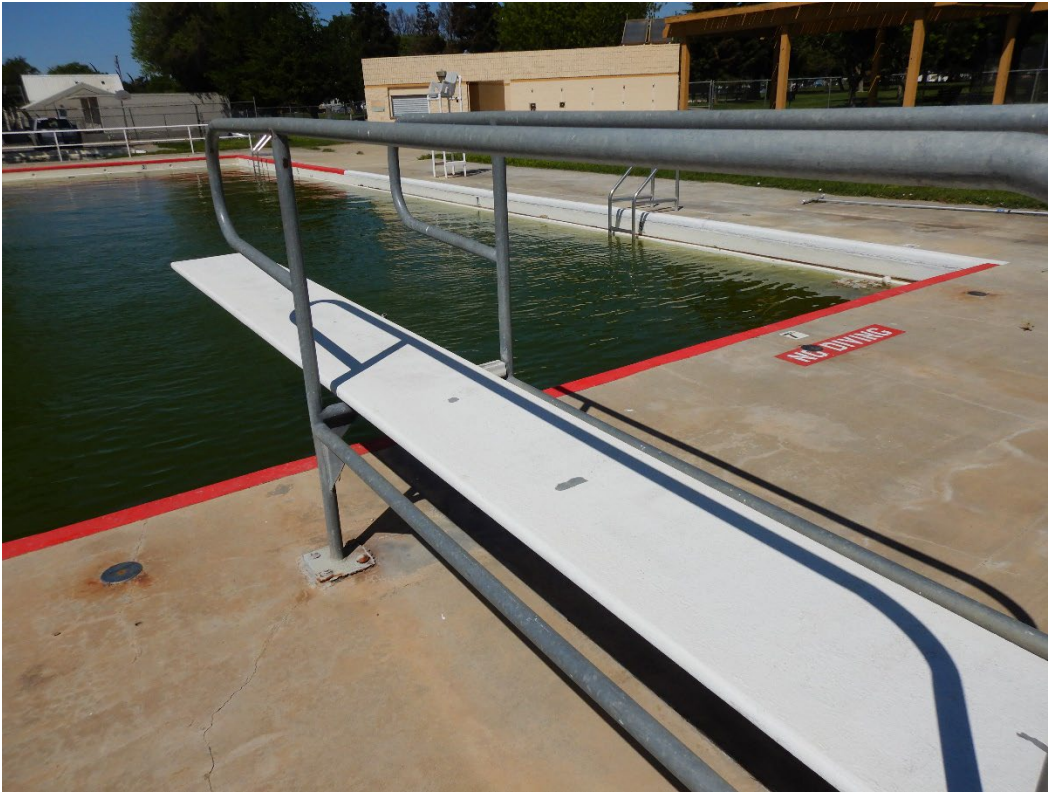
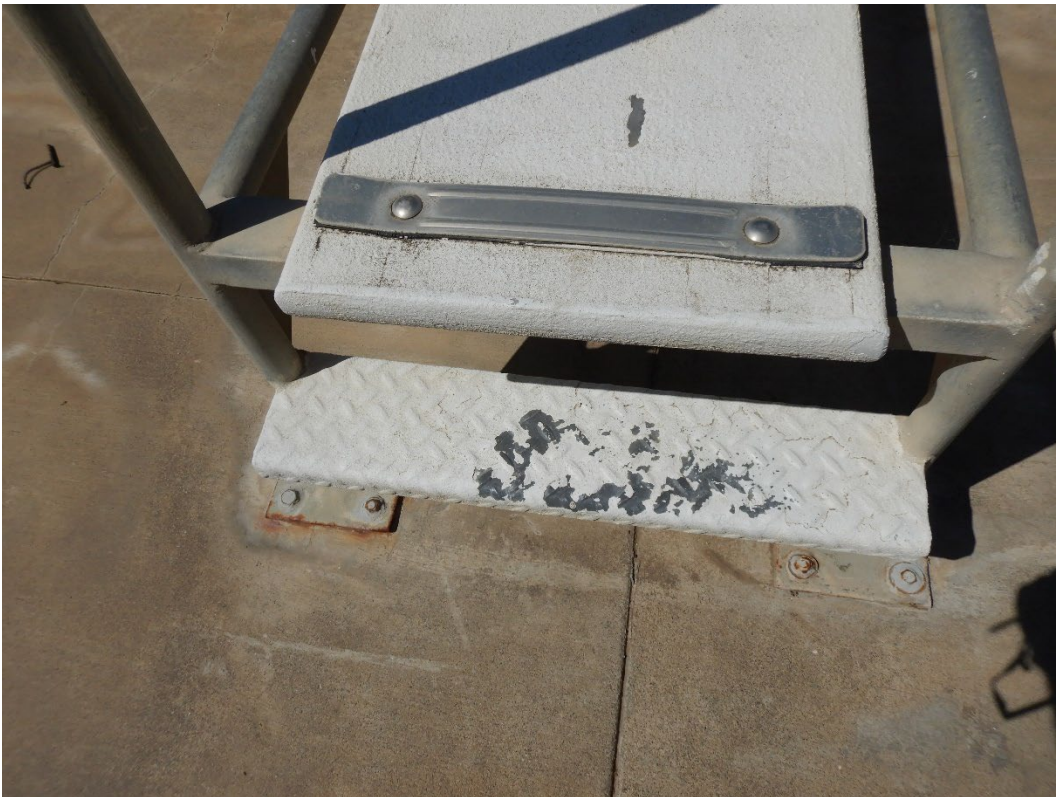
Evaluation Categories	Comments	Fiscal Impact
Facility has a working AED per State code	Each aquatic facility in California now is required to have an AED	\$1,500
Correct number of reaching hooks are available and ready for use.	Code requires a pool of this size to have two reaching hooks. They could be in storage	\$200 ea. \$400
Correct number of ring buoys are available and ready for use.	Code requires the pool to have two ring buoys with line that can span th pool width. They could be in storage	\$102 ea. \$204
Inspection of Lifeguard Fanny Packs for proper PPE	Every Lifeguard should have a fanny pack and it should contain gloves and a pocket mask at a minimum	6 @ \$10 \$60
Diving boards are well maintained, stands/bases, fulcrums, steps, mounting bolts, handrails and board surface are in good condition	The diving board is 16 feet long made of aluminum and has been "self-resurfaced" this is not good practice, especially if there is an accident. It should have the manufacturers surface. It is a "one meter" (39" off the pool surface of the pool) board. Further research should be done to evaluate if it is still allowed in 9 feet of water. If it ok to stay it should be replaced. The deepest portion of the pool is 9 feet however the bottom should be "profiled" to ensure the depth from the end of the board that is over to water is an adequate depth. The handrails are solid, pipe diameter should be checked against current code for handrails. There should be another bar installed if you continue to use this. It should be a continuation of the bottom rail that comes back from the water and connect to the entry end, parallel to the top bar. The rubber fulcrum pad needs to be centered under whatever board may be installed. It could be determined the water depth and potential for injury using this board outweighs having a diving board at the facility.	Cost is based on type of board and stand. It would have to be determined the pool is safe for a one-meter diving board by performing a bottom profile. Up to \$20,000

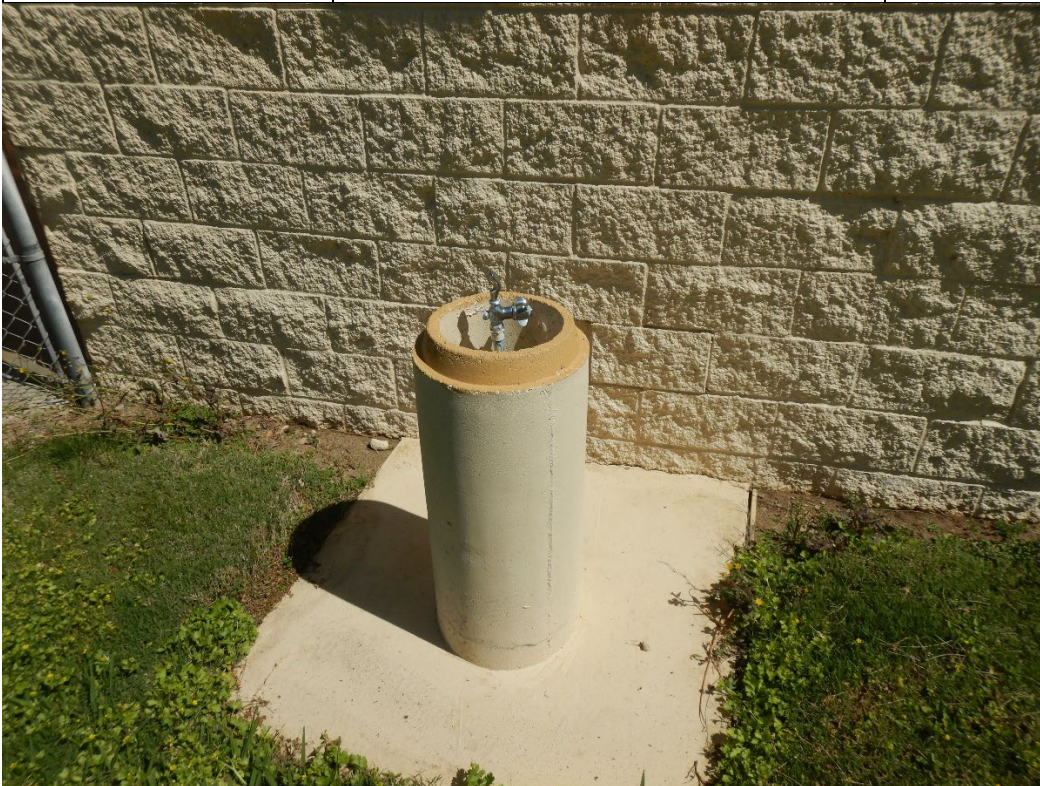
Evaluation Categories	Comments	Fiscal Impact
Drinking Fountains are clean and functional	Drinking fountain is not ADA accessible both from lack of a pathway that meets accessibility standards and from a design point of view, this should be relocated to the pool deck area, and replaced with a modern model	\$2,000

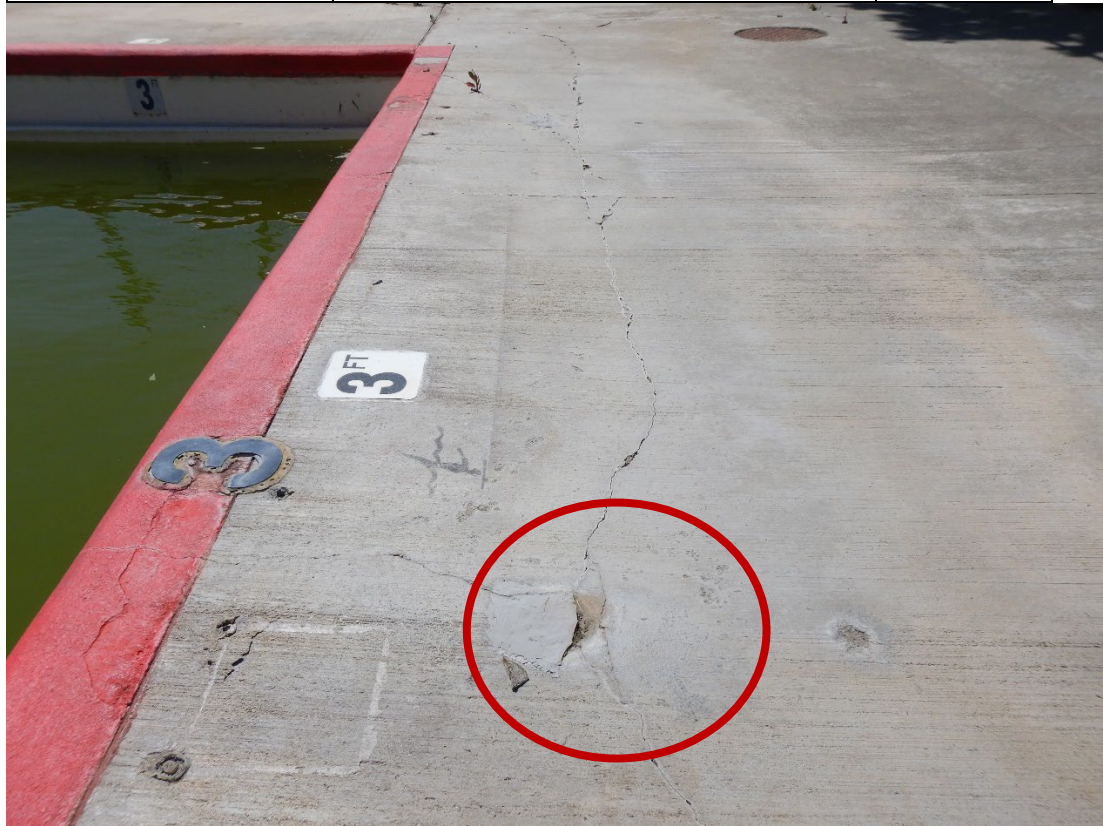
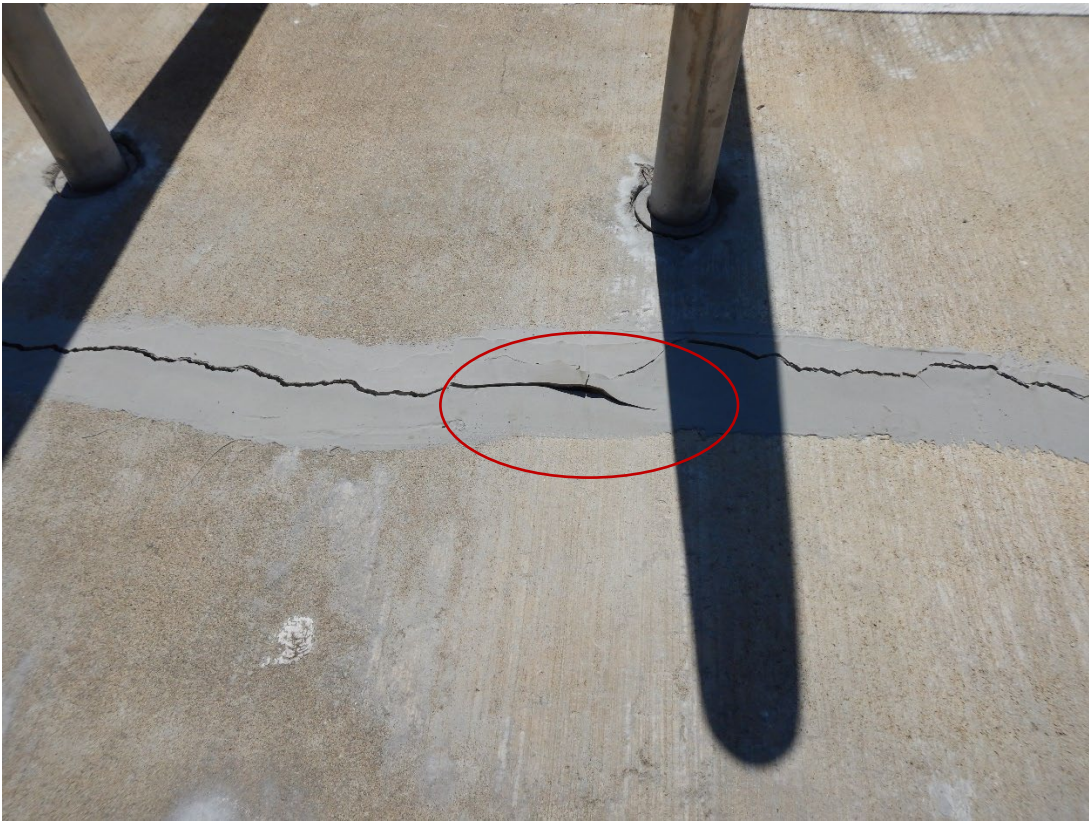
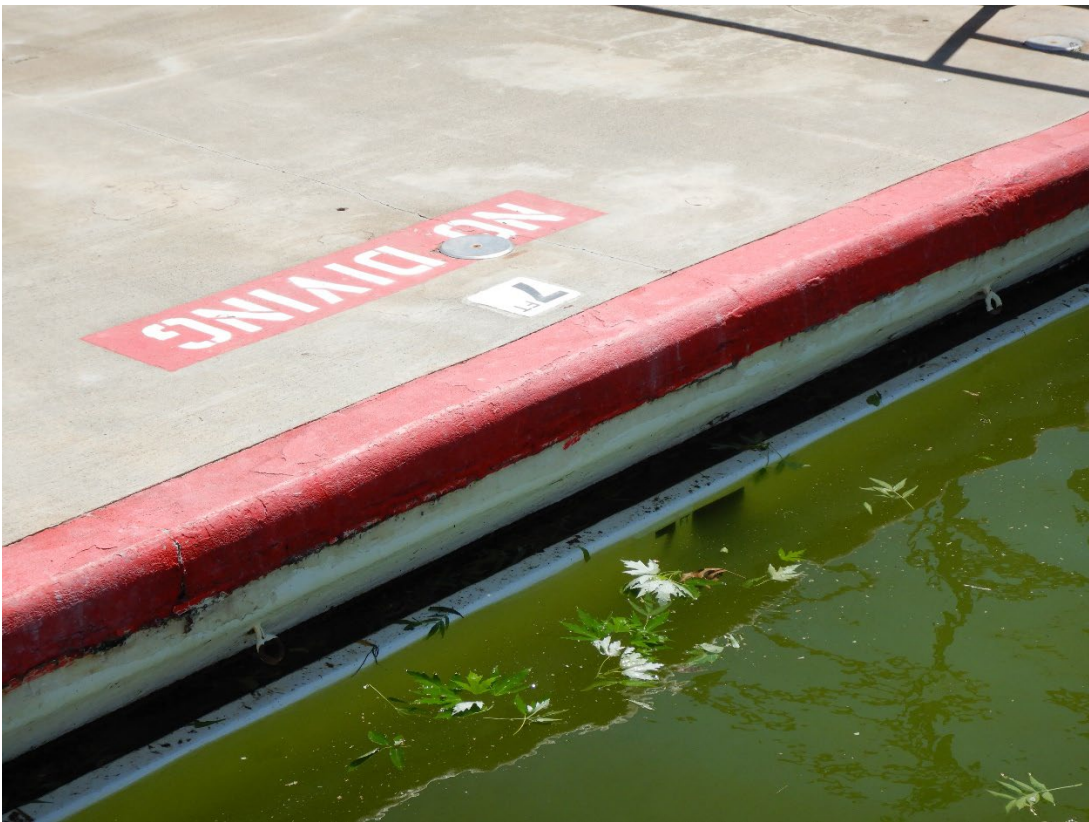
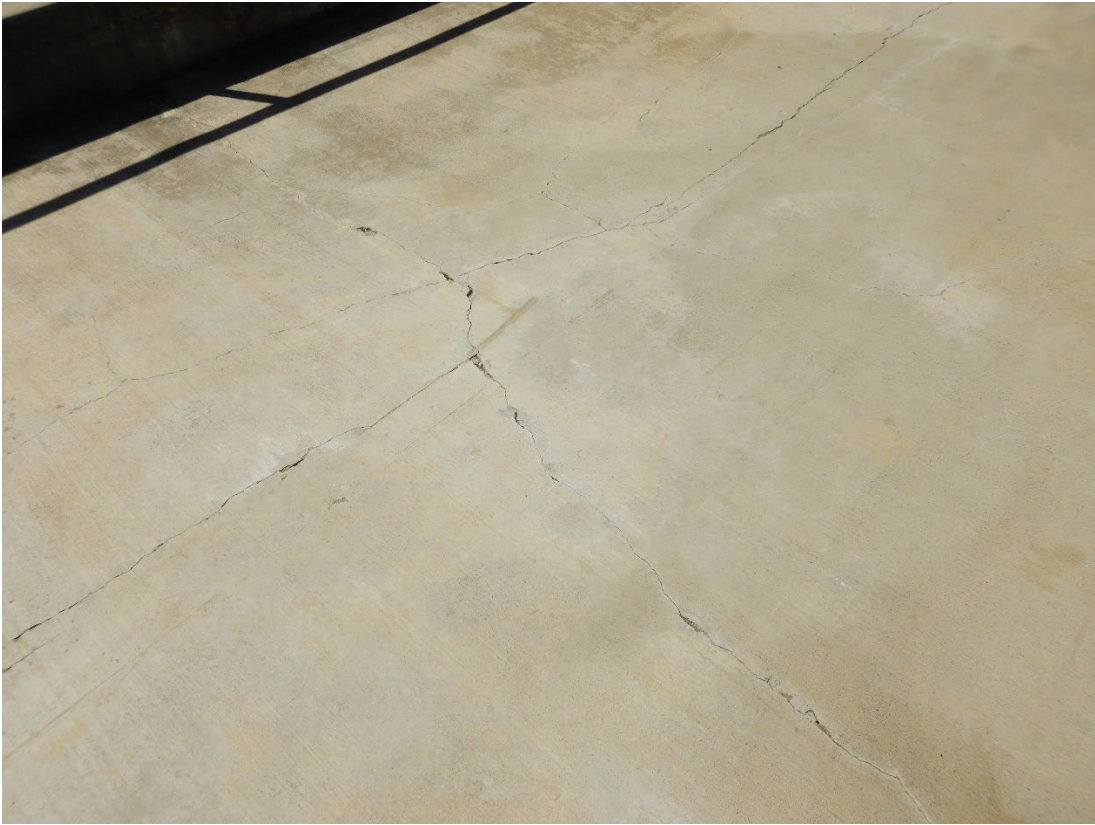
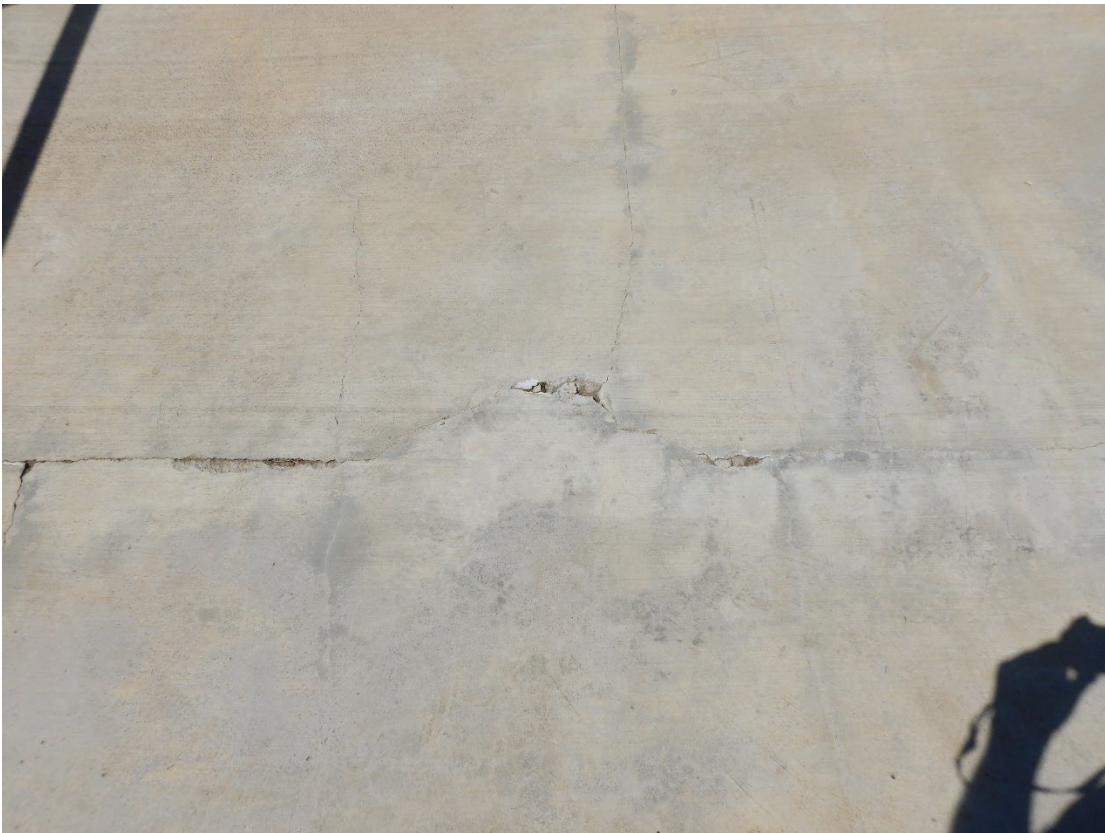
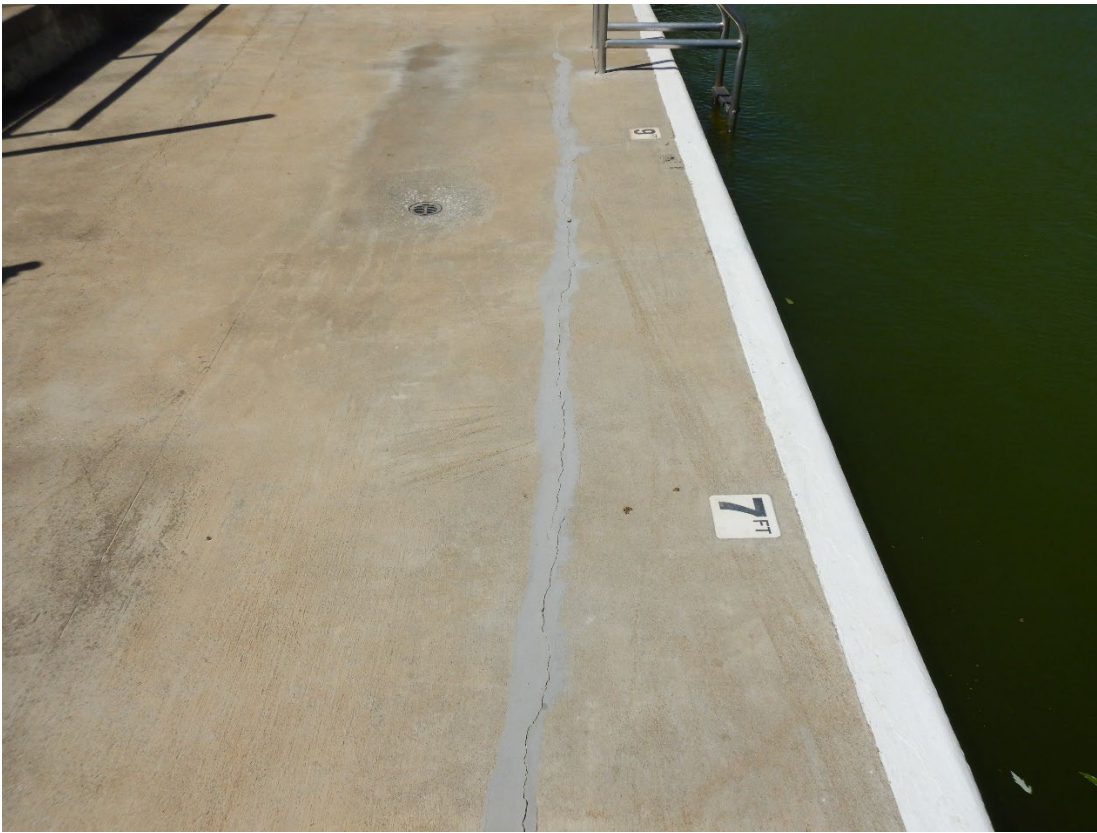
Evaluation Categories	Comments	Fiscal Impact
Decks are clean and free of cracks, chips and standing water.	<p>Decks are in pretty good condition, although they have some long cracks. Some portions have been ground to level ledges between slabs. These are very typical issues. Filling cracks and chips or pits needs careful attention to not trying to fill a crack or pit that does not have enough depth to hold the patch material (sample picture shows a patch that is failing at edges), Sometimes sealant (Deck-O-Seal, Quick Crete or grout) can be put in long cracks and will hold. Otherwise, grinding them out before patching is recommended. Consideration could be given to replacing the entire deck, but good patching could be sufficient.</p> <p>There is one area where it looks like some sort of plastic filler was used, it sticks up and has sharp edges where it has broken and cracked.</p> <p>A total deck replacement with demolition and replacement could be considered. It appears the deck is contiguous to the pool edge it does not appear that there are typical coping stones (picture below). There are concerns in multiple health department reports that the seal between the coping and pool shell has cracks and could be leaking. The fact that fiberglass was used as the pool surface makes this hard to determine as the joining of the fiberglass to the coping is messy. If the pool were returned to plaster the joint could be evaluated and potentially sealed when that project was done.</p>	<p>\$800 plus man hours to \$250,000 replacement</p>

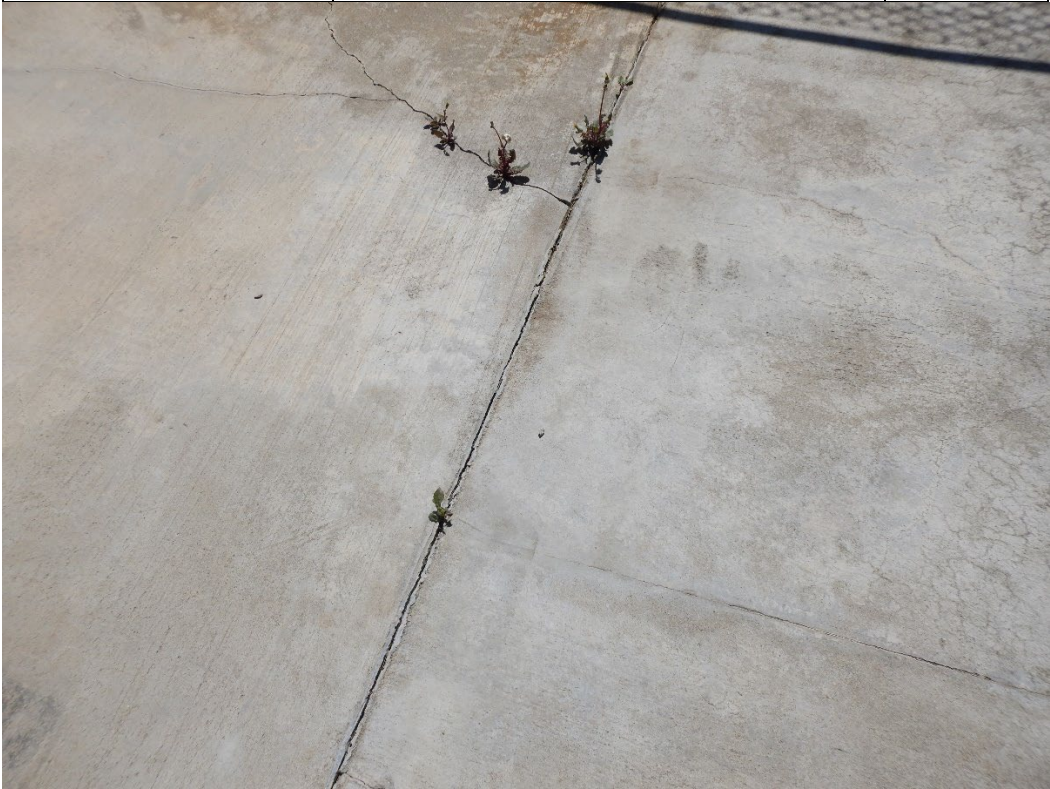
Evaluation Categories	Comments	Fiscal Impact
Deck expansion joints are well sealed and impenetrable	Expansion joints should be resealed. Lack of sealing allows water to penetrate and undermine the integrity of the slabs causing settling, ledges between slabs and unsafe gaps in the pool deck. When resealing, use foam backing rod, or "green rod" stuffed into the joint with a ½ inch to ¾ inch gap to deck level, then seal with a sealant product such as Deck-O-Seal	\$500 sealant plus man hours
