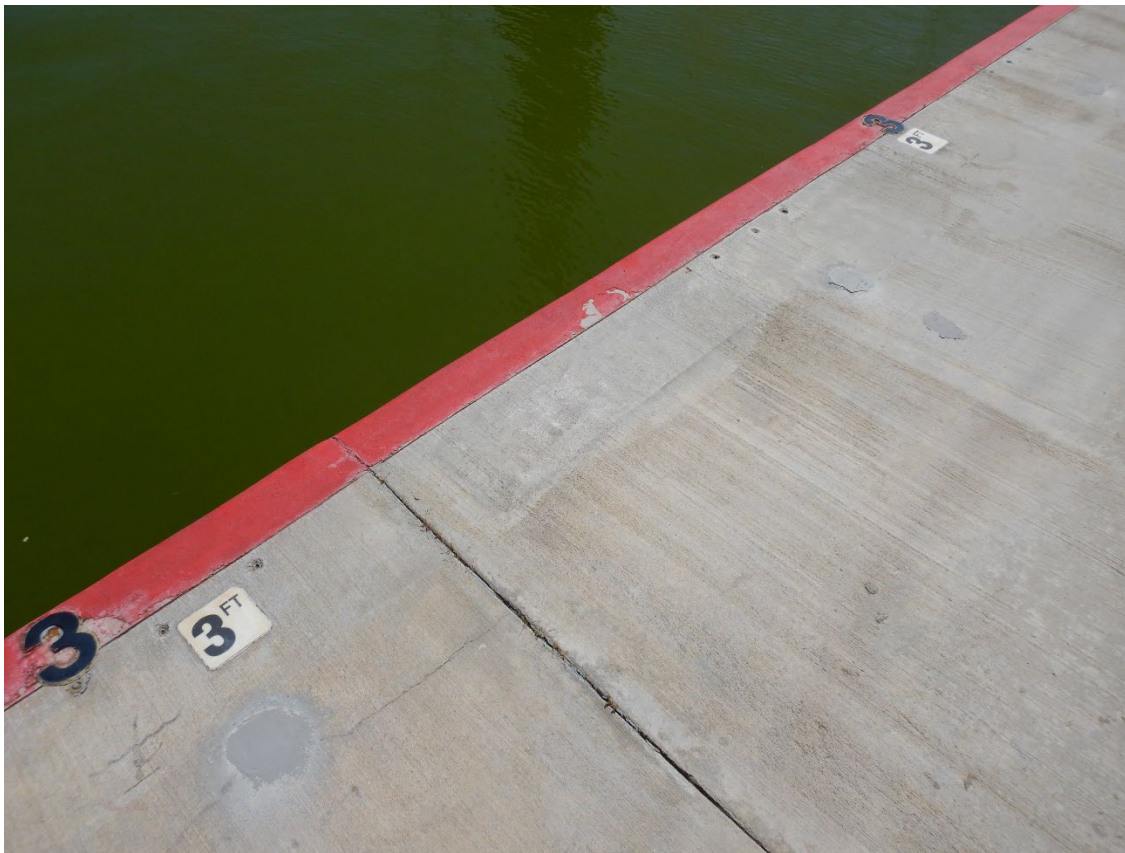
Evaluation Categories	Comments	Fiscal Impact
Deck drains are in good condition and functional.	Deck drains covers are in good condition and all are well attached and appear to be functional.	
Depth markers are of proper size are posted on deck and pool walls. They are not faded and show numerical value with foot and if applicable inches noted.	Depth markers are all at least 4" to meet code. Some are larger which is ok, they all do not have the inch or feet measurement next to numbers, this is required. Some are illegible or faded. Code requires they are spaced a minimum of 25 feet apart, the south side has an area with a longer gap between the 5 and 9 on the deck, there is a 7 on the vertical wall without a 7 above it on the deck. There should be one at the break or belt line at 4 1/2 feet depth of the pool, usually a 5-foot marker is near here to denote "deep water". Wherever there is a marker on the deck there should be one under it in the vertical pool wall. This could all be rectified with the removal of the fiberglass and replastering with new tile. Depth markers and "No Diving" markers can be set in the deck with minor grinding and replacement, this should be done by a tile or concrete or plastering company.	<p style="text-align: center;">\$2,500 to \$10,000 to replace depth markers on deck and on the vertical walls</p>

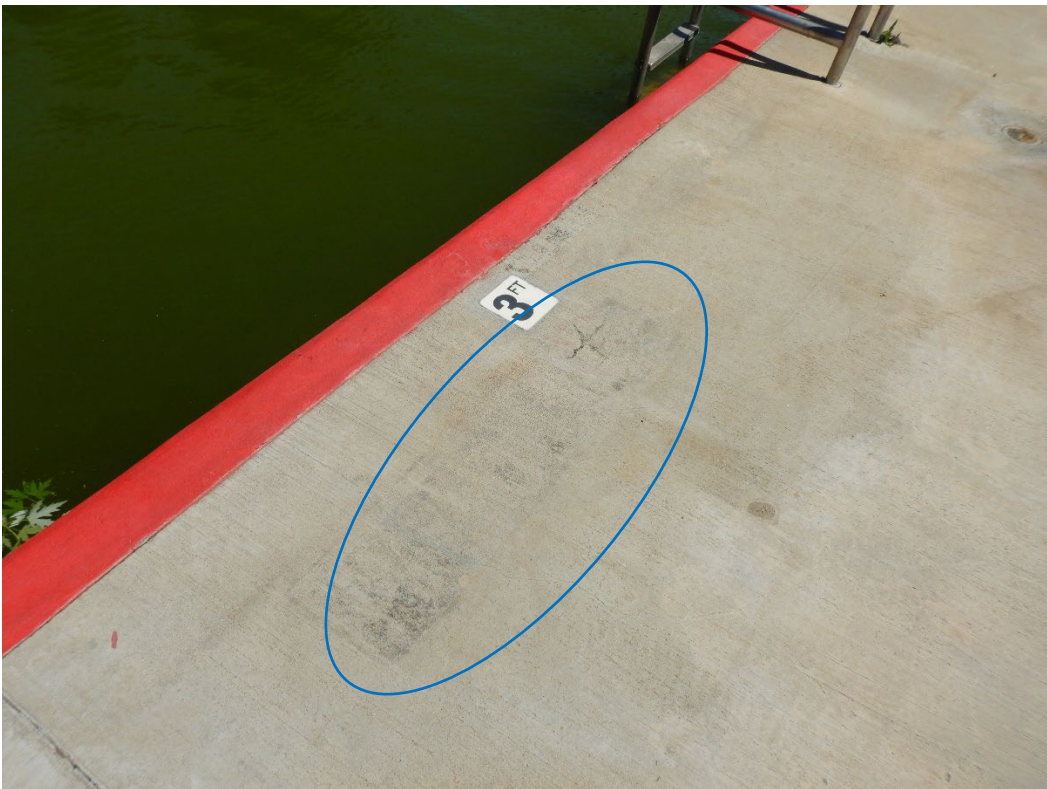
Evaluation Categories	Comments	Fiscal Impact
No diving is marked on the deck in areas of less than 5 feet of water depth.	No diving is stenciled in places around the deck. Once depth markers are re-done to be of proper size and with proper placement (every 25 feet or less with 5' near the break or belt line), no diving should be stenciled at distances that are mid-point between the markers with the international "no diving" symbol next to wording. The tot pool has no markers on the vertical walls.	\$500

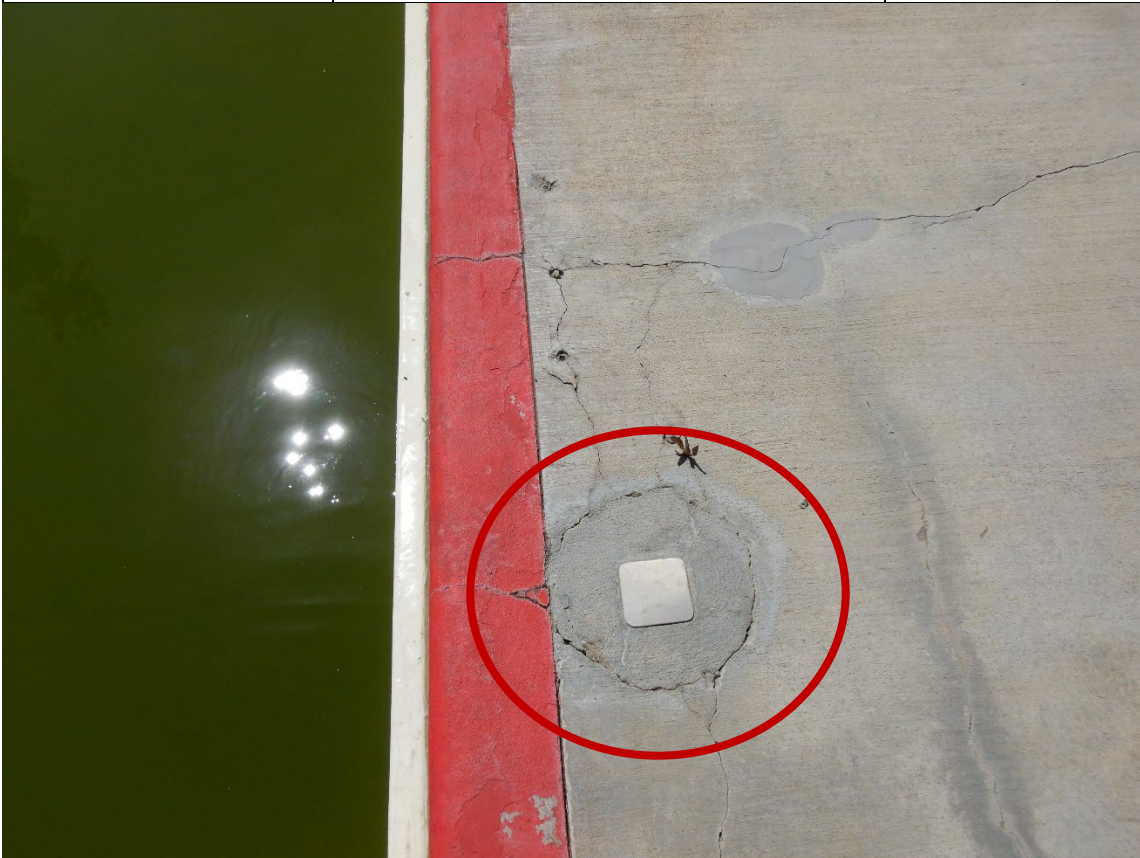
Evaluation Categories	Comments	Fiscal Impact
Starting Blocks if in place are secure and covered or signed "not for use"	I observed covers where I believe the starting block mounting holes could be. Blocks should be evaluated before using, surfaces, platforms, steps, etc. These should not be left in and if they are they should be marked "do not use" when there are no trained supervisors to monitor their use.	\$1,200 each, \$7,200 total plus installation of anchors in the deck if needed \$12,000, total \$19,200

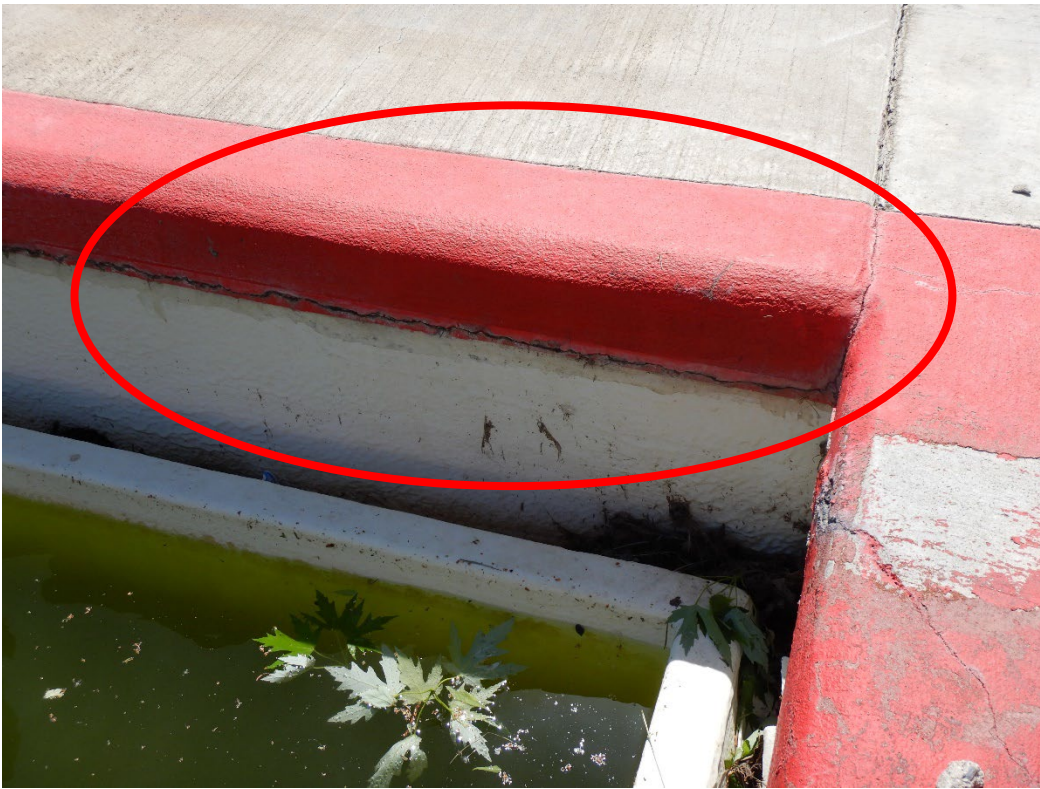
Evaluation Categories	Comments	Fiscal Impact
Condition of pool coping stones, gutter tiles, rim flow grates or skimmers.	It appears that the deck slab was laid on the pool shell at the pools edge. The union between the slab and the pool shell (gutter top) is not clean. Making it smooth would require work to smooth then fill. The design intention is such that the pool shell and deck can slide as it expands and contracts in summer and winter. Therefore, grinding the area between the deck and pool gutter wall joint and the filling might not hold. The gutter tile has been fiber glassed over as well as the vertical wall gutter tile. This has been reported in the deck section above and is of a concern to the Health Department on multiple annual reports.	This would be addressed in deck repair and replacement or resurfacing of the pool.

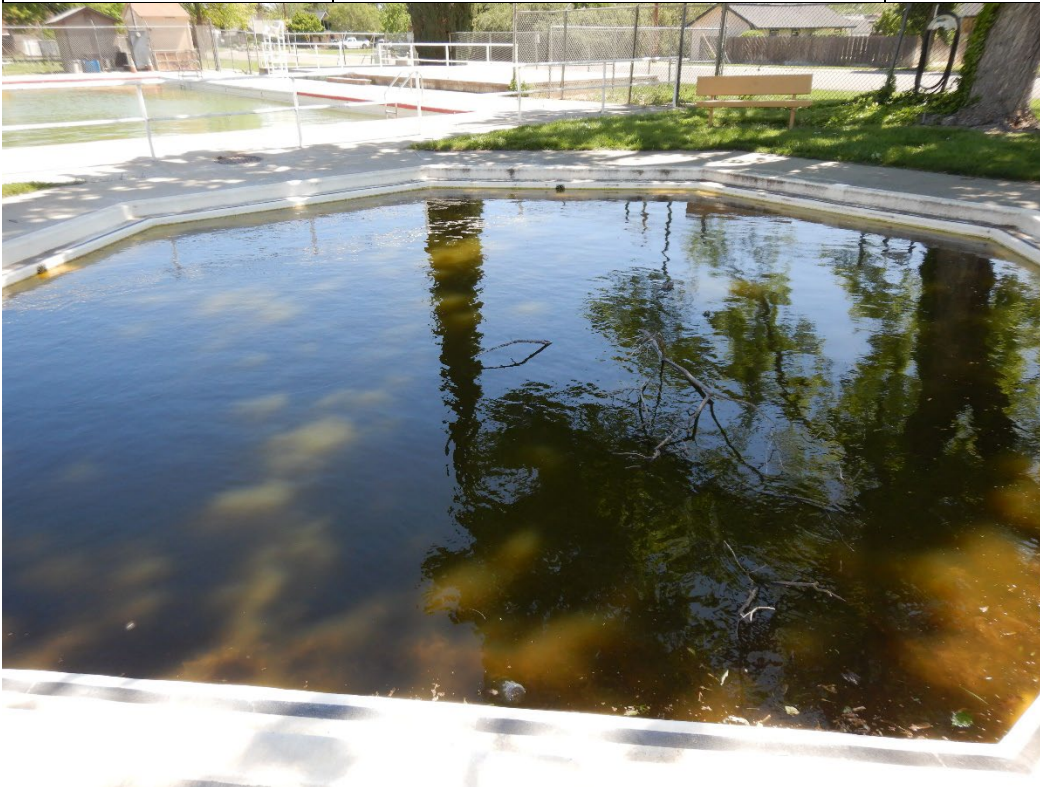
Evaluation Categories	Comments	Fiscal Impact
Built in stairs and their edges are in good condition. Handrails are tight.	The only set of stairs into a pool is the one step into tot pool, it is the perimeter of the tot pool. There is however no handrail, one should be considered for small kids and elderly parents/guardians. This pool is 2 1/2 feet deep in the center. As a side note code calls for the provision of lifeguard service in anything deeper than 18 inches.	\$3,000

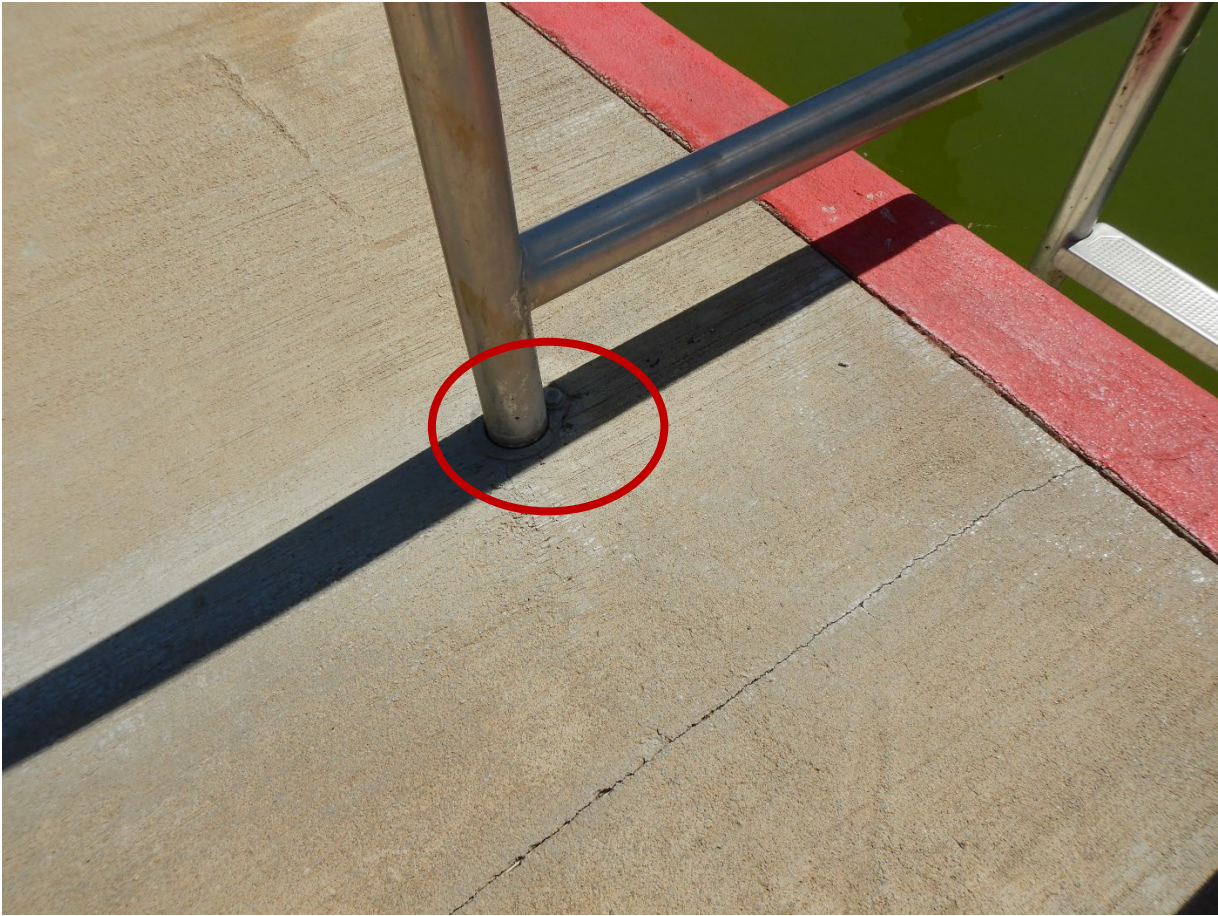
Evaluation Categories	Comments	Fiscal Impact
Ladder handrails are tight, ladder steps are in good condition	Pool ladders are the removable type, these are outdated, but still useable. However, the mounting bolts in the deck need to be tight so they do not pull up and the point of insertion at the deck needs to have covers over the tightening bolts.	\$200 for covers

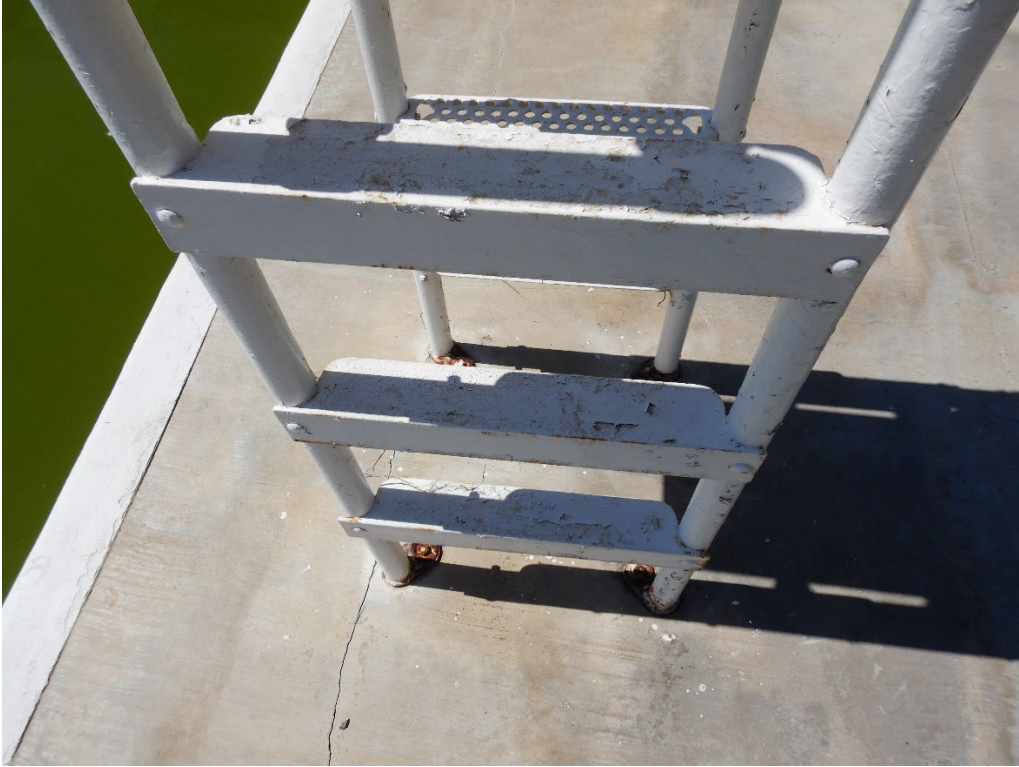
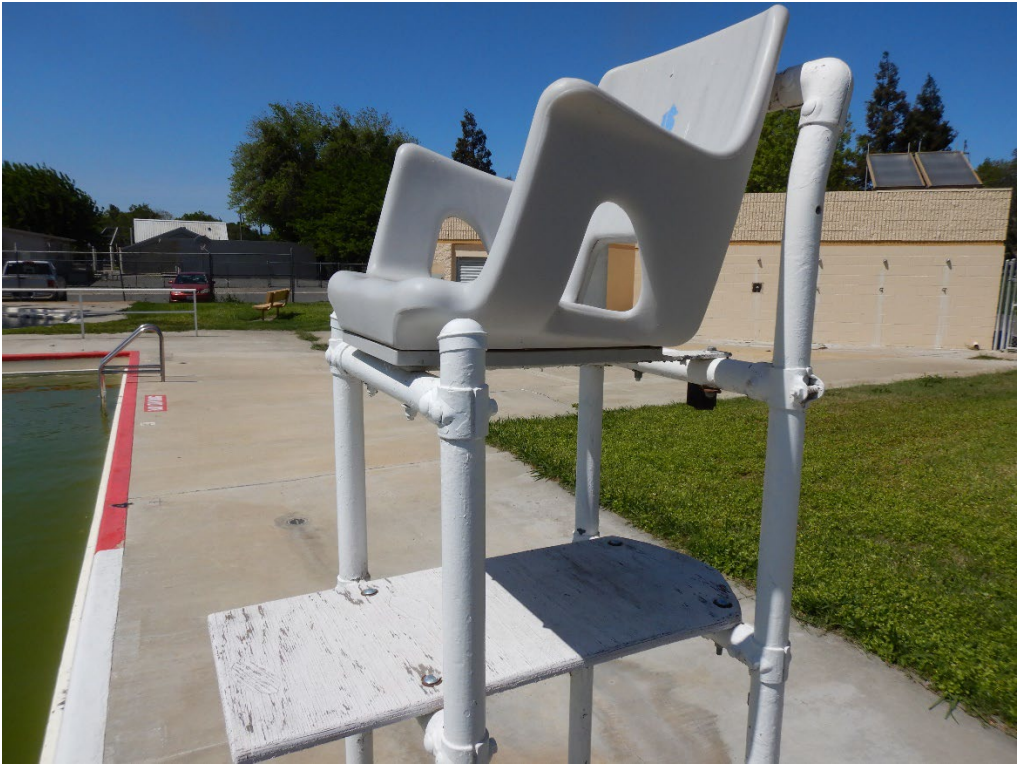
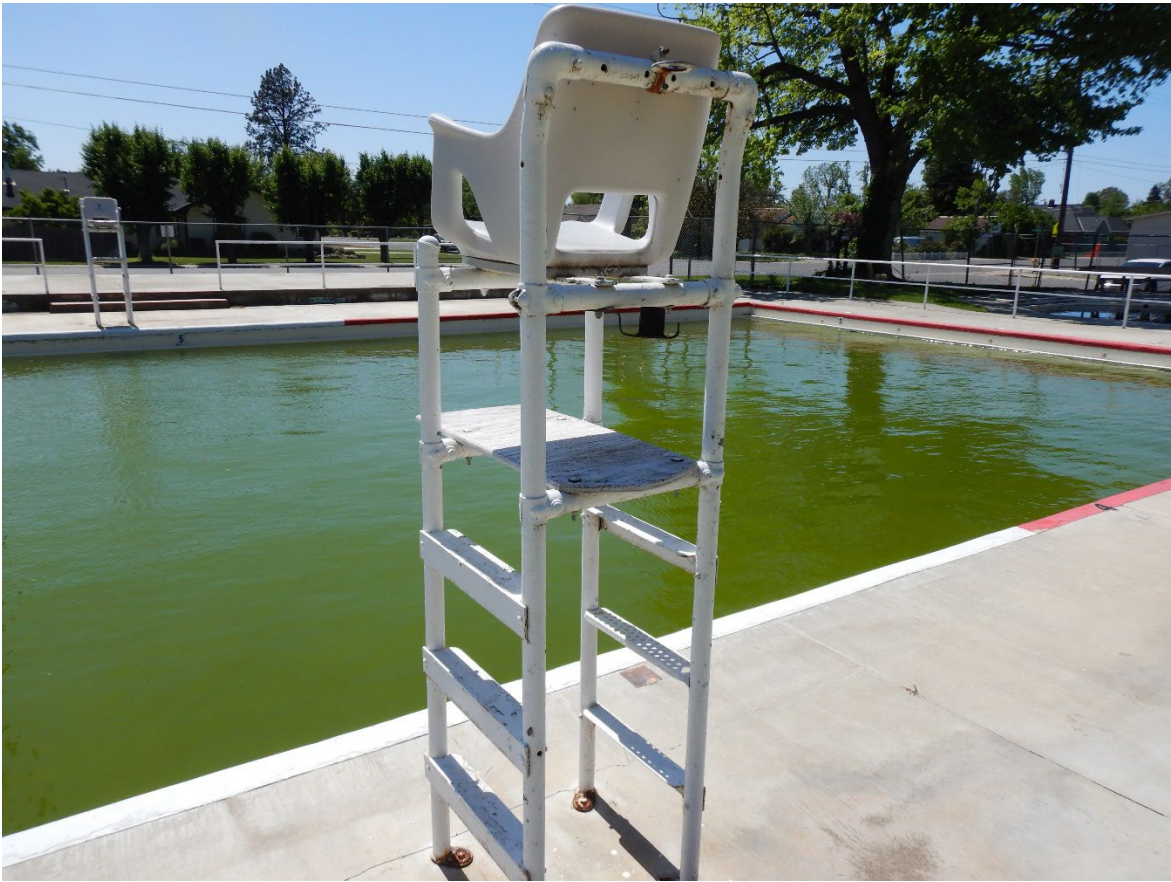
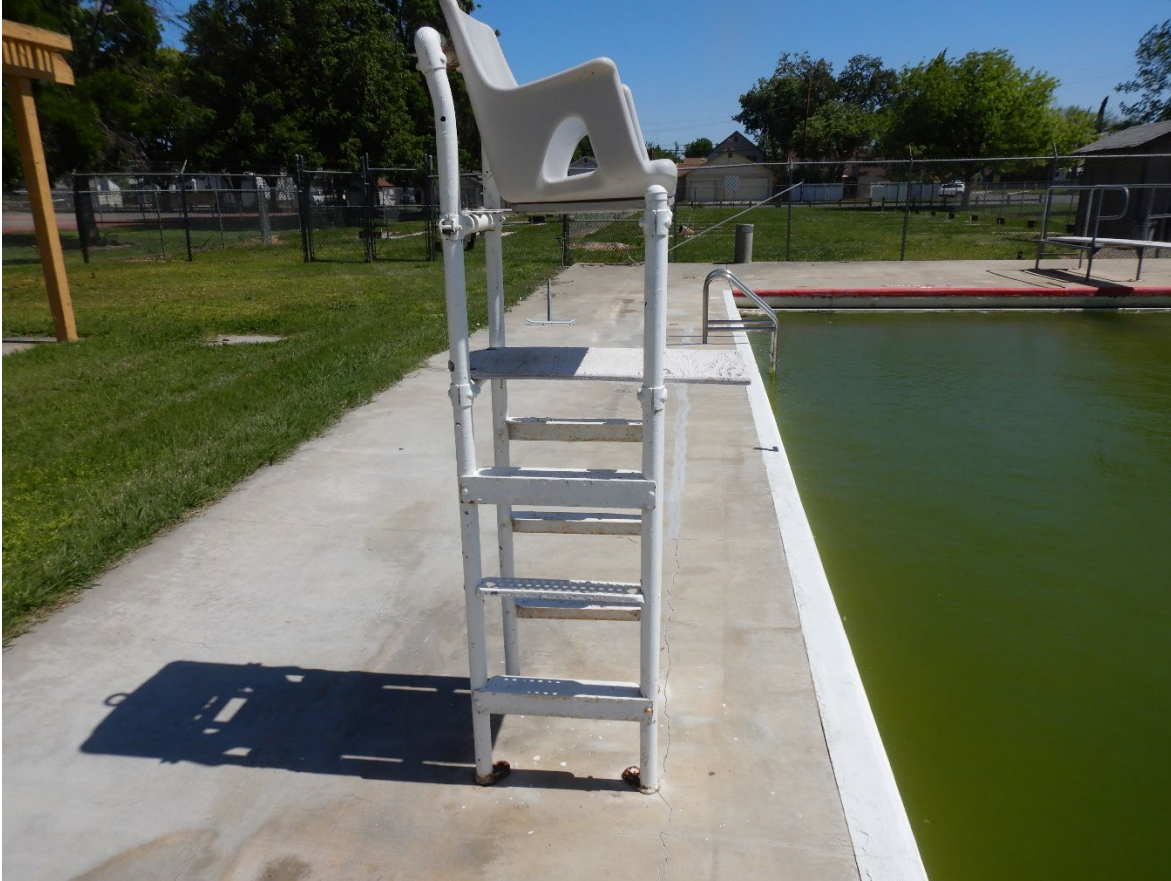
Evaluation Categories	Comments	Fiscal Impact
Functional lifeguard stands, includes; steps, rails, platforms, seat and no potential "strap hooks"	Remove these stands and make the deck flush where they were mounted, they are very old, seem slightly "home modified" and if someone was injured by one it could be the fault of the operator of the facility. Consider portable stands, 6 feet tall, two of them. They can be moved near the pool when needed and moved back when not in use. They can be locked to a fence or rail at night. Having permanent chairs is not good as if you have them you should always have Lifeguards in them whenever the pool is in use.	\$6,000 each, total \$12,000

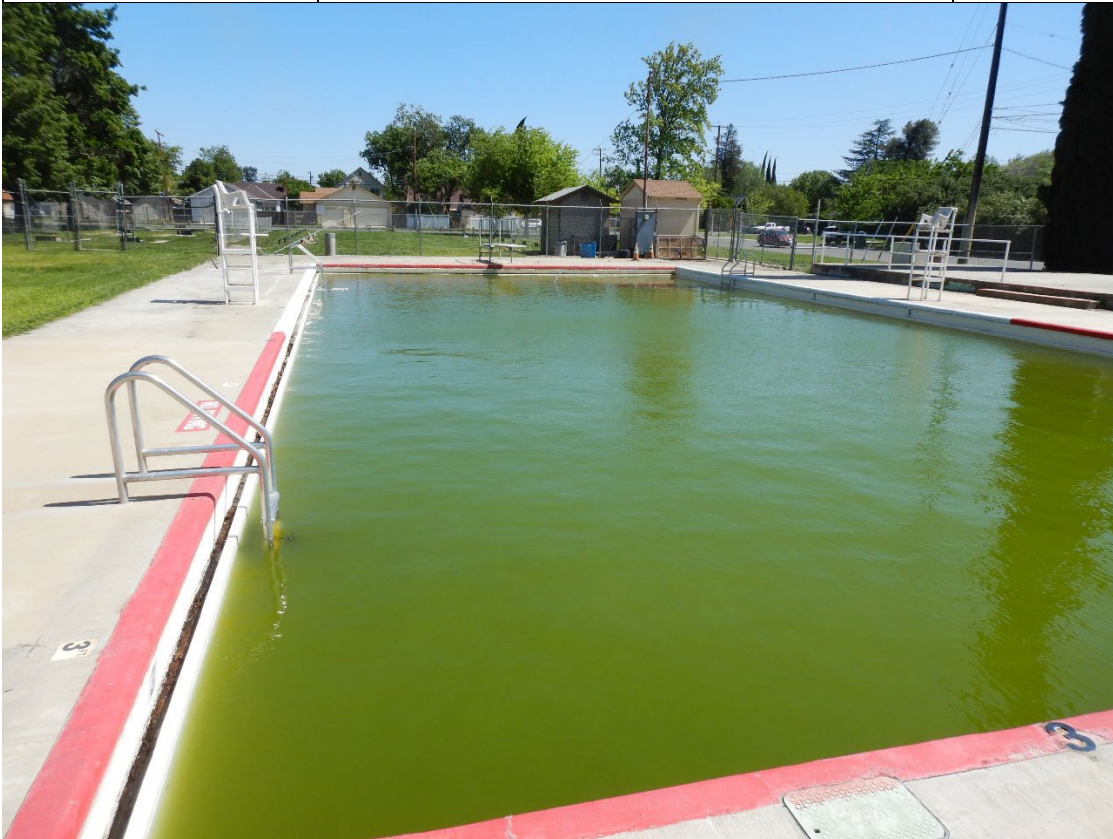
Evaluation Categories	Comments	Fiscal Impact
Water appearance is not turbid or cloudy, looks clean and pool bottom is clearly visible at main drain.	Water was green, tadpoles are loving it, could not evaluate water clarity during normal operations and more importantly peak swimmer loads.
