City of Willows

Swimming Pool Mechanical Evaluation

5/12/2022

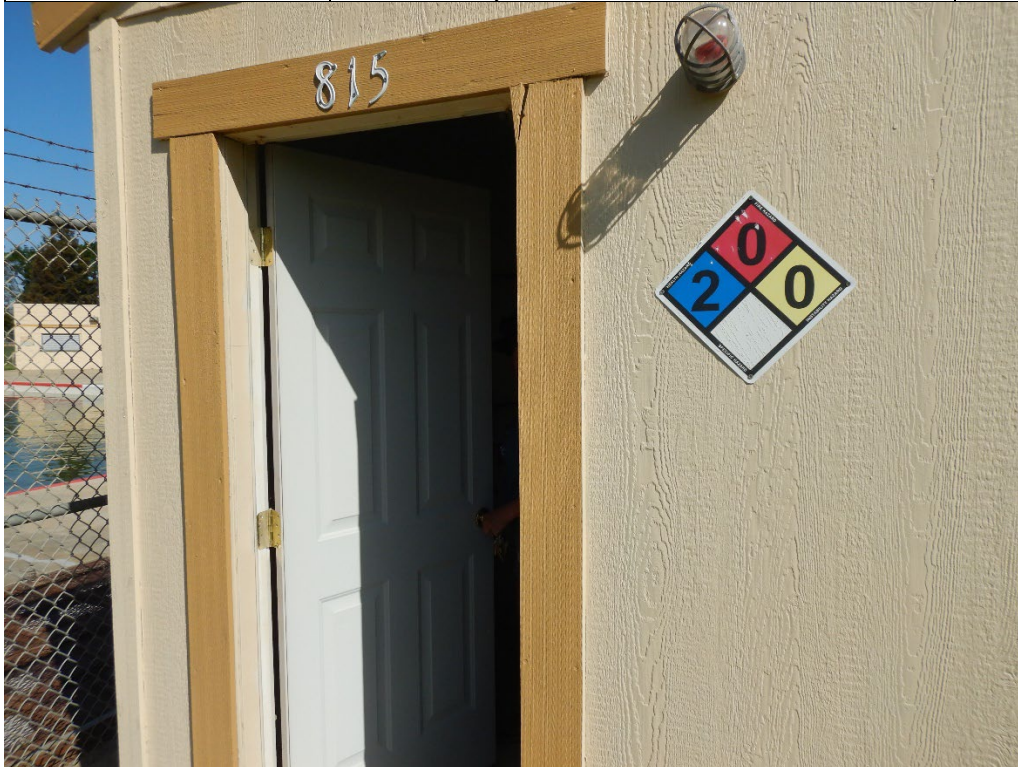
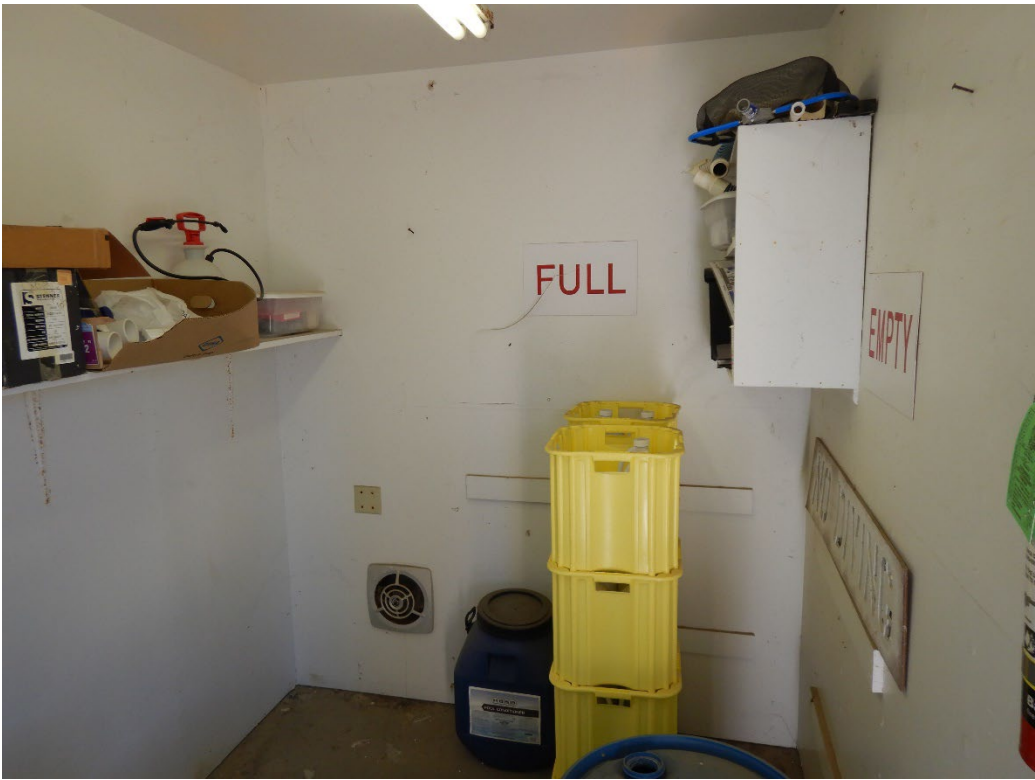
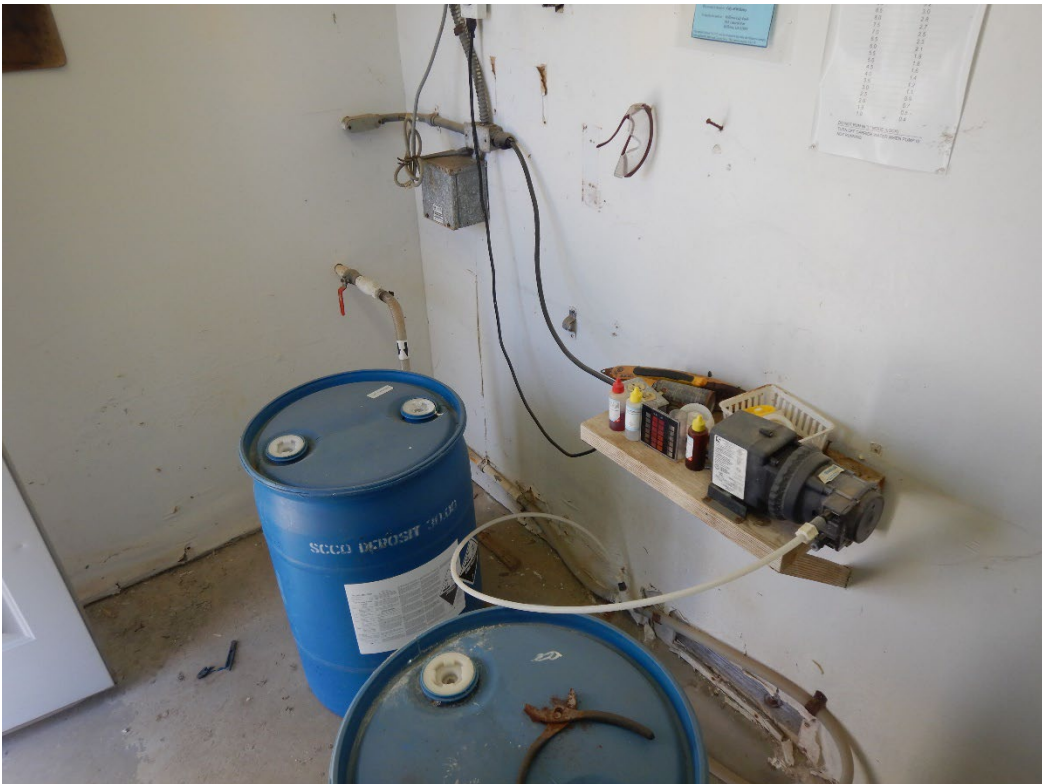
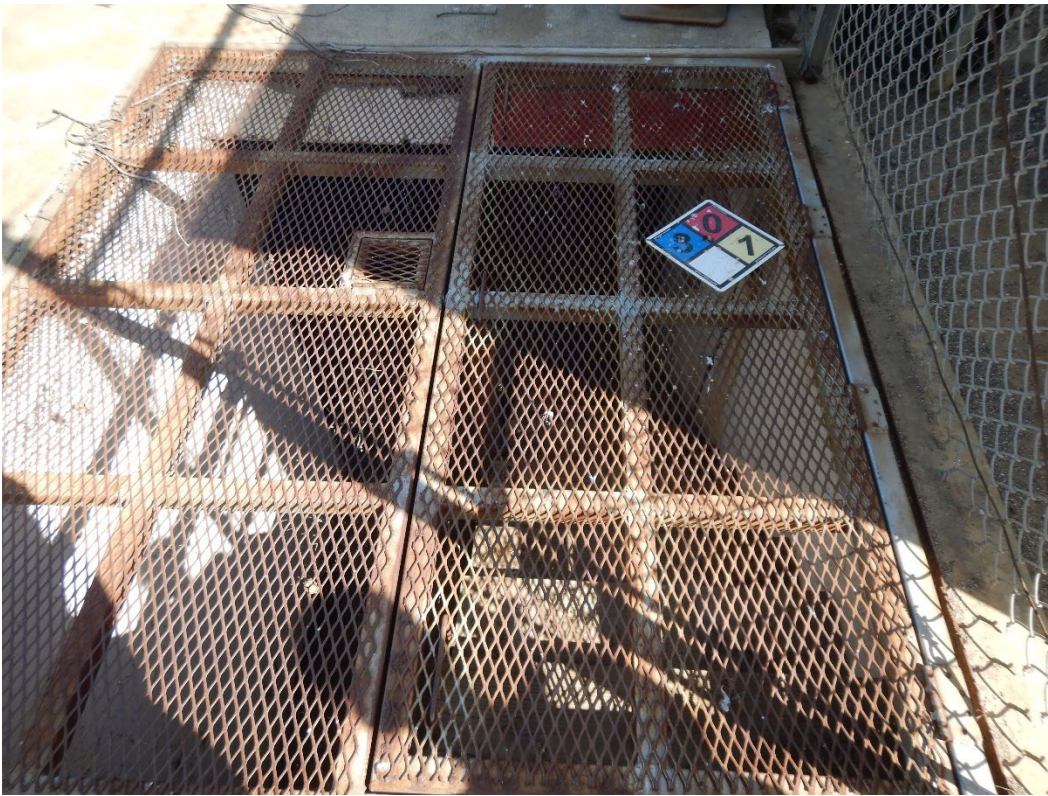
Evaluation Categories	Comments	Fiscal Impact
Pool signs meet code requirements, including Capacity, 911, RB/CPR, Active Diarrhea, Pool Rules. No Diving; No LG on Duty,	Required signs are (listed here). They should be in plain sight and "unavoidable" when patrons enter and use the facility.	\$500
Additional signs depending on facility amenities and type of use; No Swimming After Dark, No Running, Shower Before Entering, and others	Due to the 6-foot fence in some areas of the pool and the ease of after-hours entry, no swimming after dark should be posted next to a no lifeguard on duty sign for liability against midnight swimmers and the liability, they bring in event of a catastrophic incident. Health Department report calls for gender identification signs on the restroom entrances	\$300

Evaluation Categories	Comments	Fiscal Impact
Entrance to mechanical areas and chemical storage areas are well marked, hazardous material signs and precautions are appropriate,	Chemical storage is in shed outside the pool area, it has Haz Mat warning signs on the door, consider a sign on door "employees only" or something similar. Dry chemicals are stored in the mechanical room. Without some sort of slurry system to introduce the chemicals to the pool water are the bags carried to the pool? The bags and crates are large, heavy and the staircase is not conducive to carry these out of that room.	\$25 for sign

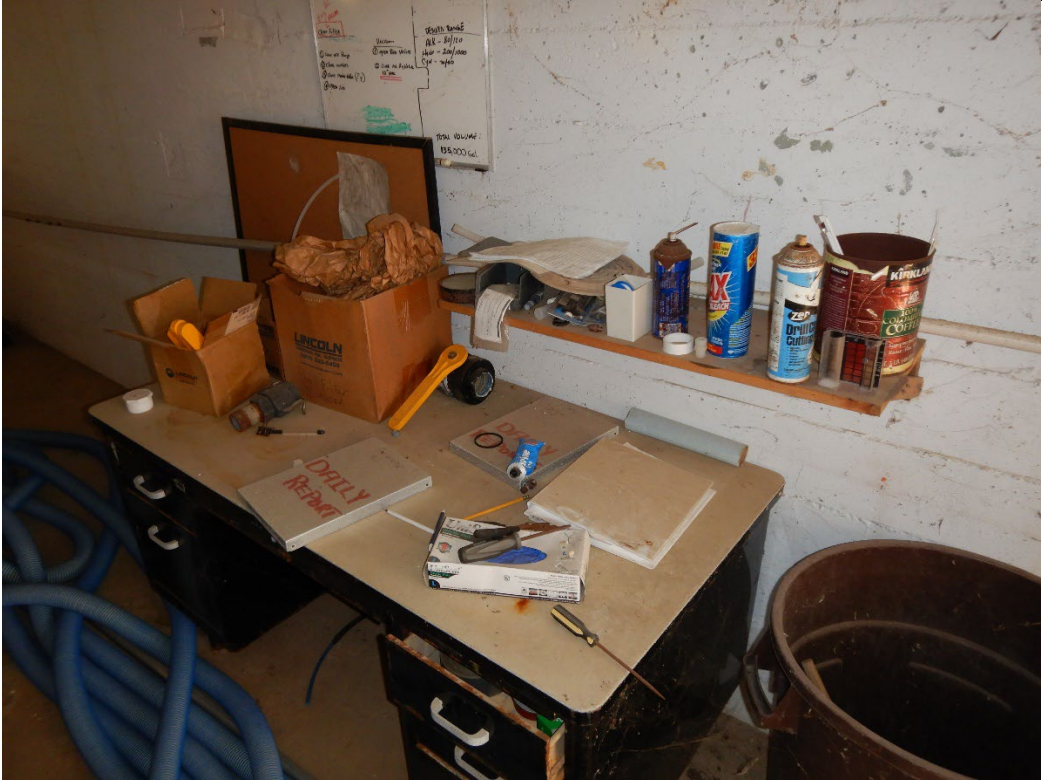
Evaluation Categories	Comments	Fiscal Impact
Safety Data Sheets are on file or in a binder and readily available. A facility map with an evacuation plan is posted and visible.	There were no readily available Safety Data Sheets. These sheets provide data on the dangers of chemicals and other materials and how to treat exposure. SDS should be kept in a binder in the mechanical room. There should also be a posted evacuation plan in the mechanical room	\$50

Evaluation Categories	Comments	Fiscal Impact
Portable tools and equipment are stored correctly, and other equipment is stored correctly and in a proper location.	As indicated above, the pool has not been operating for some time. It is hard to judge as there are items throughout the mechanical room.	\$0

Evaluation Categories	Comments	Fiscal Impact
Extra pool mechanical equipment is stored correctly and in a proper location.	Most pools have an area where spare or "to be repaired" equipment is stored. It is good to have these items well organized and out of the way of normal operations.	\$0

Evaluation Categories	Comments	Fiscal Impact
Area is clean and not cluttered. Working surfaces are well maintained and ready for use.	The pool has not been operational in two years, it is hard to judge this area. There will be some cleaning required to restart the facility.	\$0

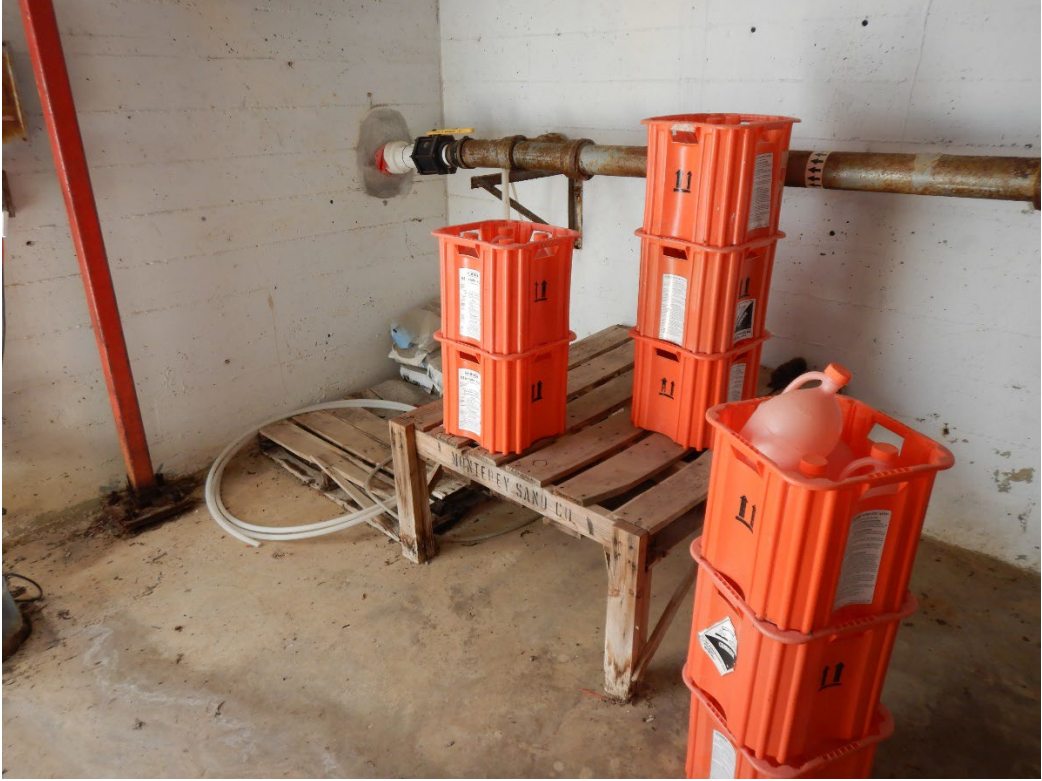
Evaluation Categories	Comments	Fiscal Impact
Extra pool mechanical equipment is stored correctly and in a proper location.	Most pools have an area where spare or "to be repaired" equipment is stored. It is good to have these items well organized and out of the way of normal operations.	\$0

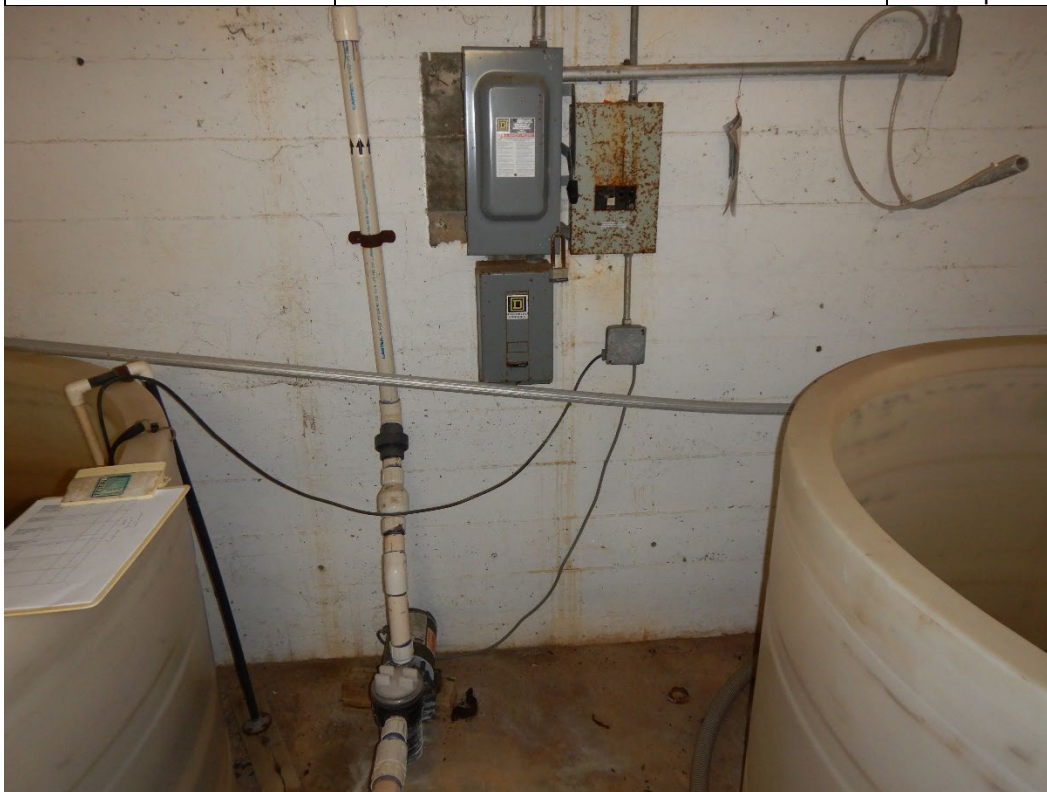
Evaluation Categories	Comments	Fiscal Impact
There is at least three feet of clearance in front of all electrical panels.	Code requires three feet of clearance in front of all electrical panels. When renovating the mechanical room this needs consideration when laying out the spaces.	\$0 to \$5,000 depending on plans

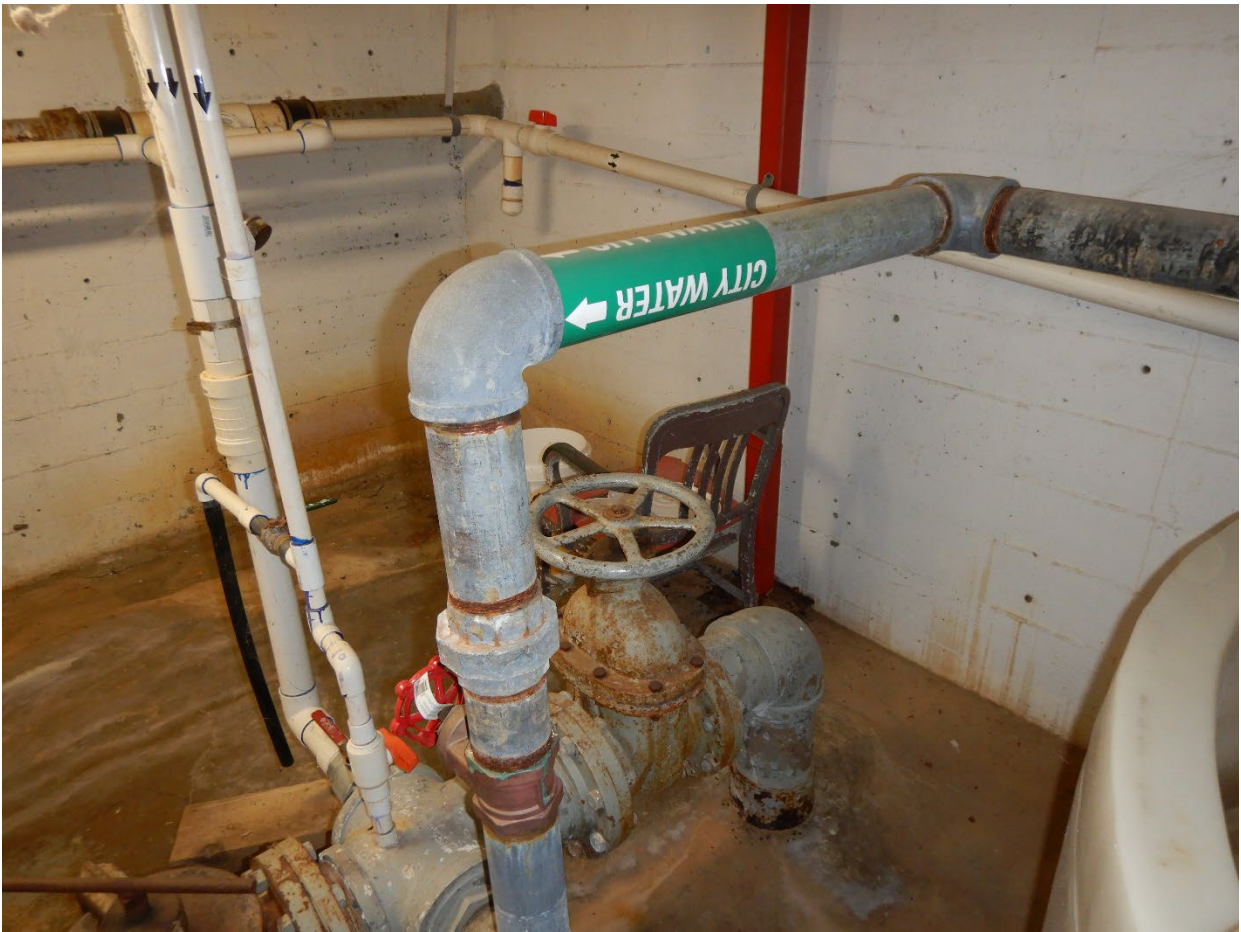
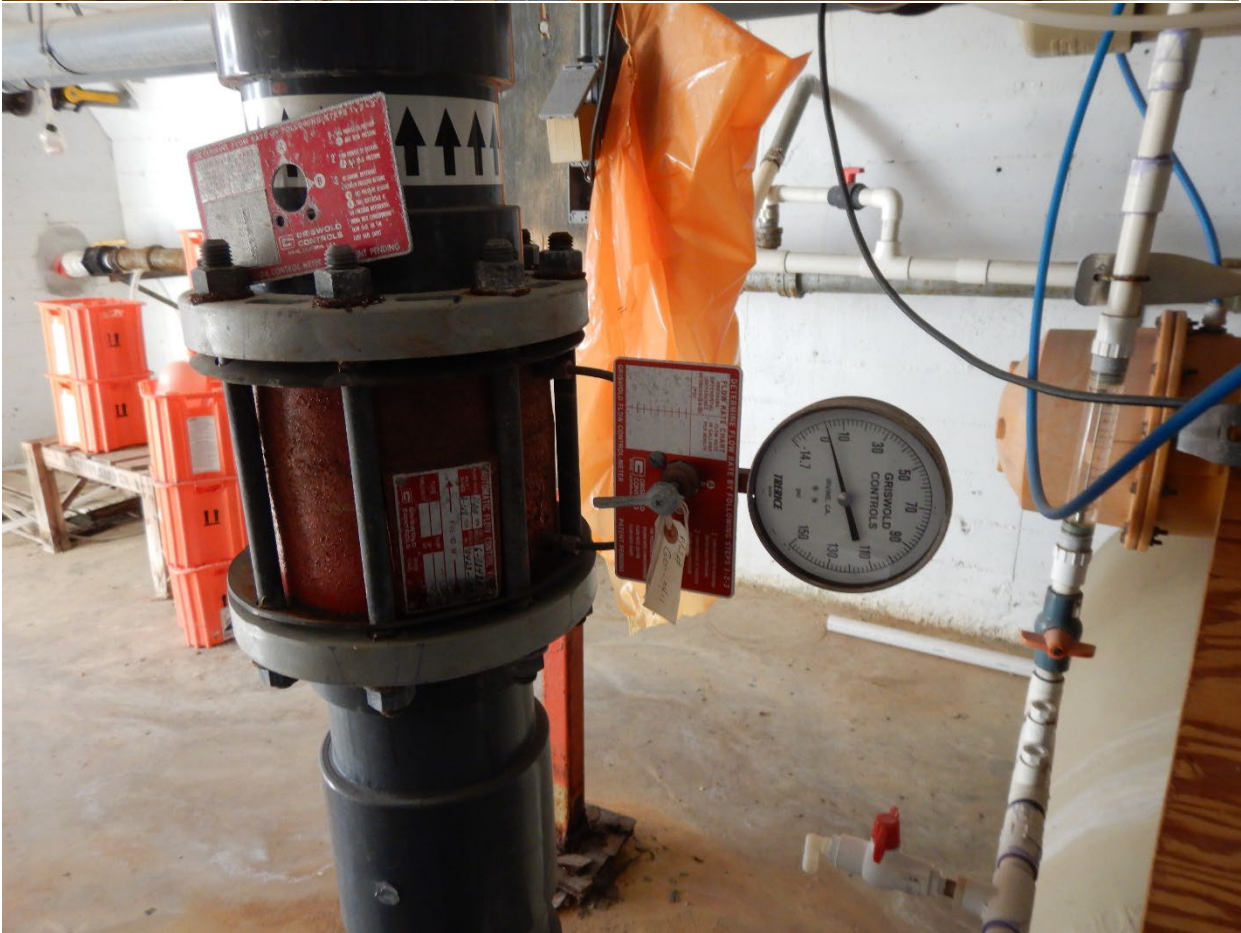
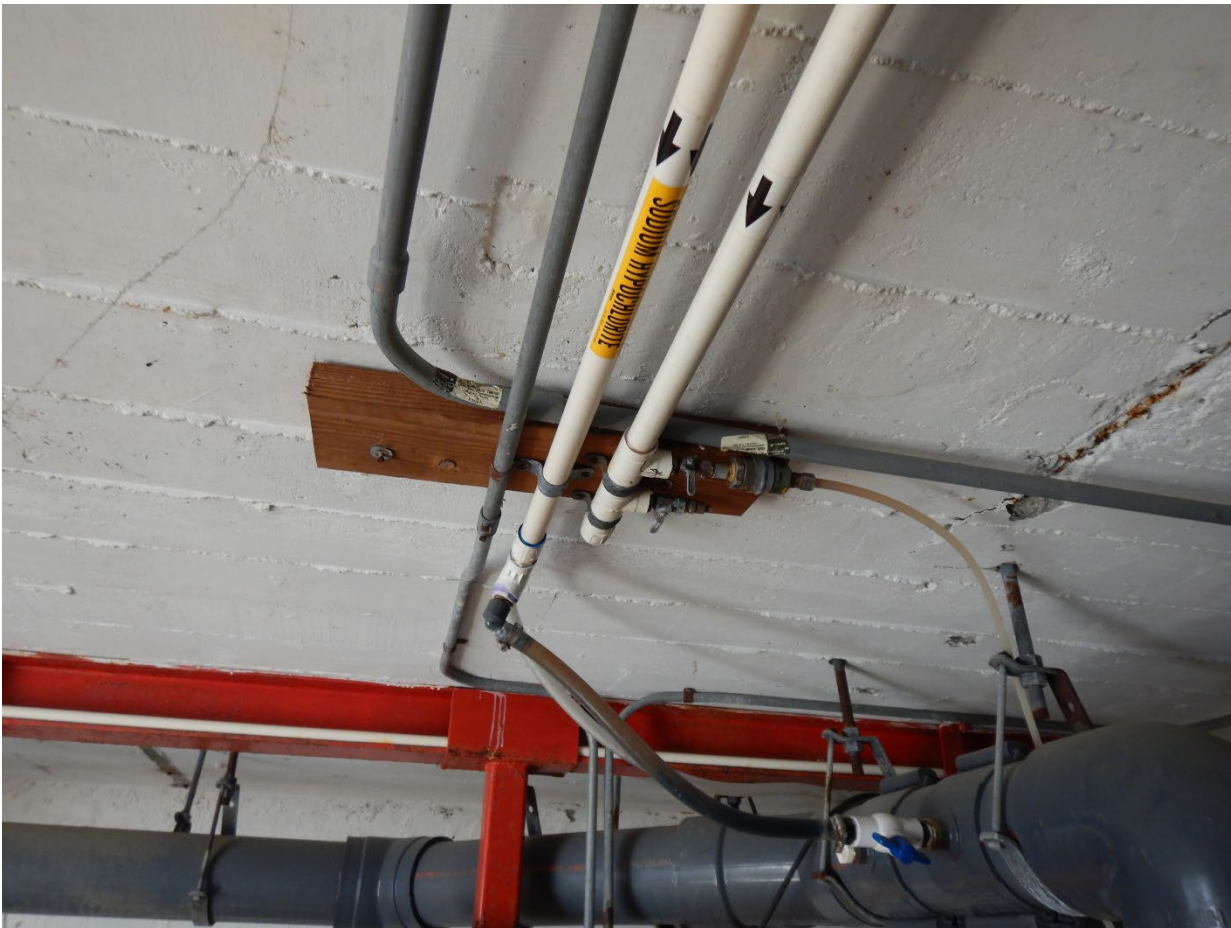
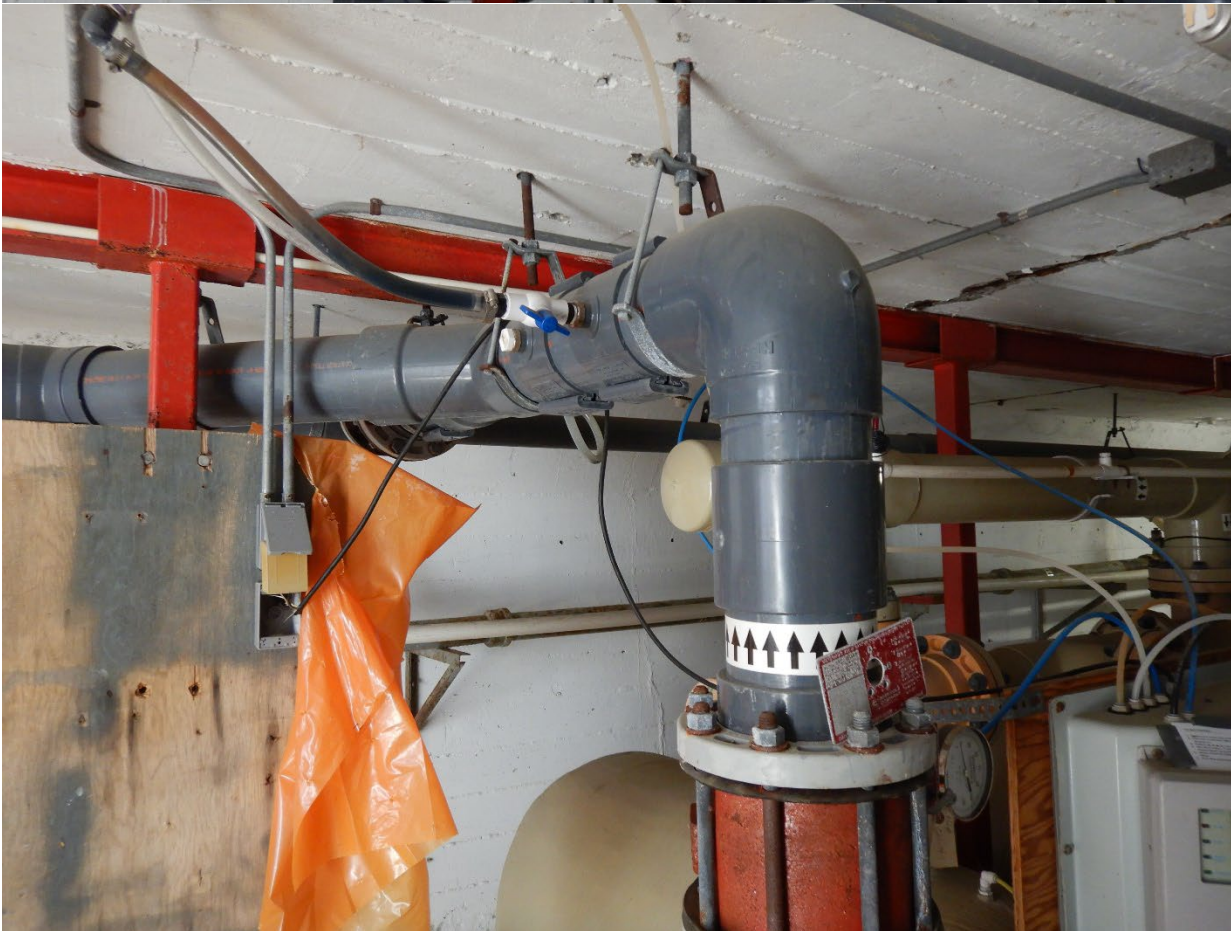
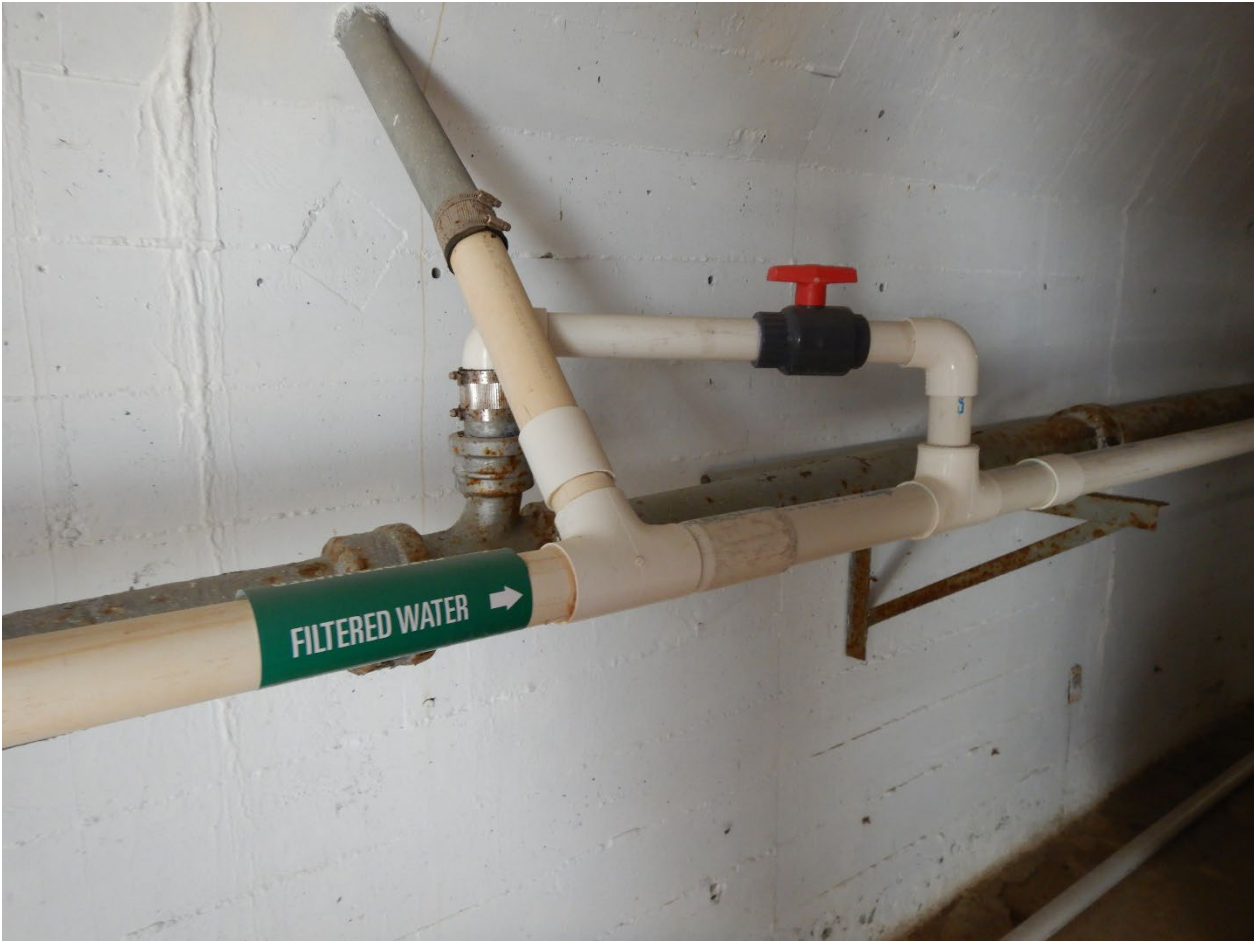
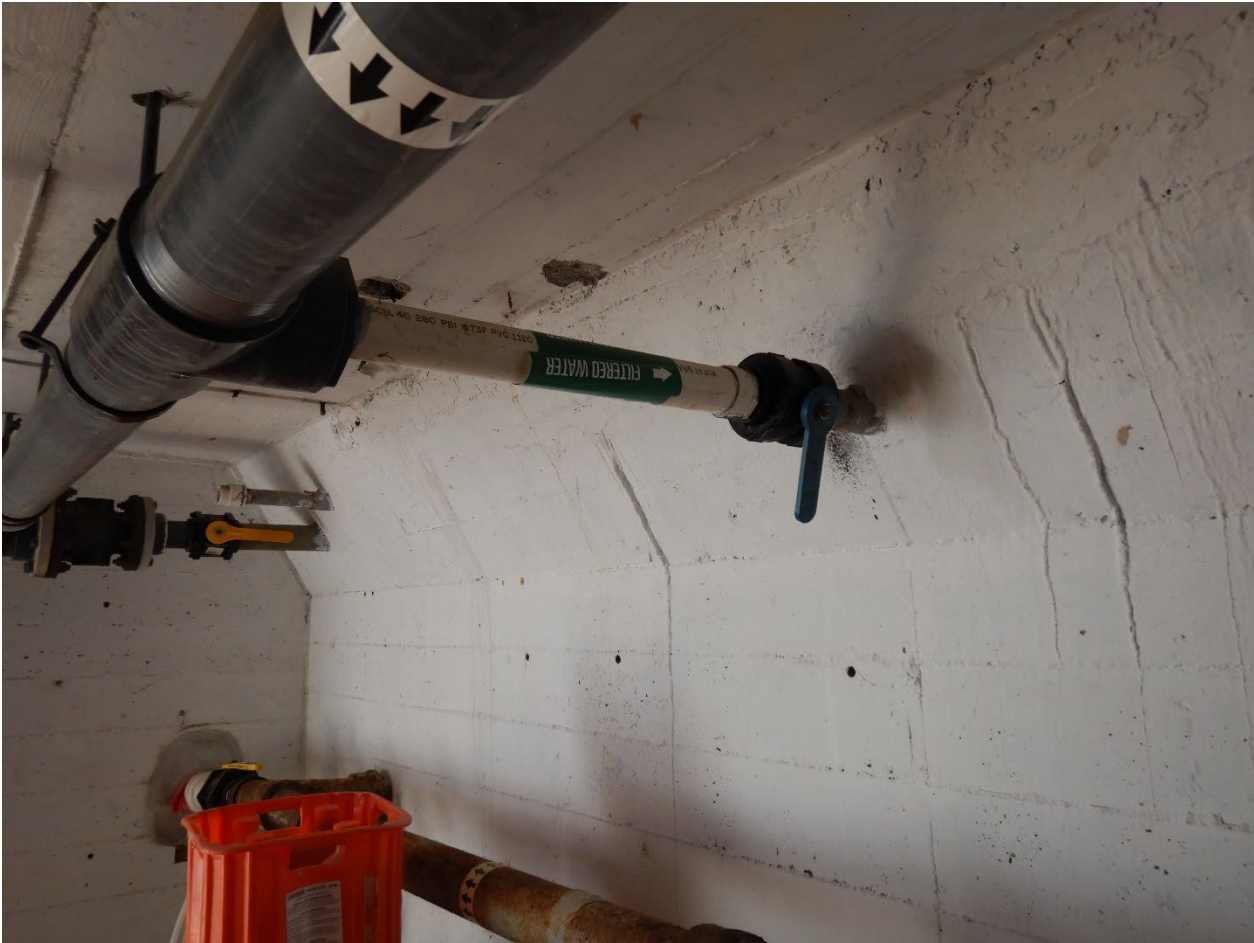
Evaluation Categories	Comments	Fiscal Impact
Daily pool log is kept and up to date, test times, routine maintenance, and regular inspections, are noted.	We found a blank pool log that is acceptable but could definitely be improved to capture much more operational information. We can supply one upon request.	\$0
Additional chemicals if added are noted in pool log (anything not from automated chemical controllers)	There is a space for these additions on the current log.	\$0
Special projects and equipment replacements are recorded and tracked for long range maintenance planning	Any daily repairs or projects should be noted on the operational log sheet. Code also calls for having an operating procedures manual and brochures/manuals for each piece of equipment in the mechanical room.	\$0

Evaluation Categories	Comments	Fiscal Impact
Pipe contents and flow direction are well marked on the appropriate plumbing.	Pipes that are part of the pool circulatory system should be labeled with contents and flow direction. Some of the main plumbing is marked and some is not, there have been repairs and replumbing over time that make it difficult to follow the flow of the system.	\$200
Pipe valves, pressure and flow gauges, and water shut-off points are well marked, visible and easily accessible to ensure operational readiness in the event of an emergency	The mechanical room has many gauges and shut-off points, valves, and flow reducers/controllers. Some are accessible, others are harder to access. A plumbing diagram with critical shutoff points should be posted in plain sight so anyone can perform basic system shutdown. The flowmeter is old and needs to be replaced and positioned properly in an unobstructed ten-foot run of pipe.	\$1,000

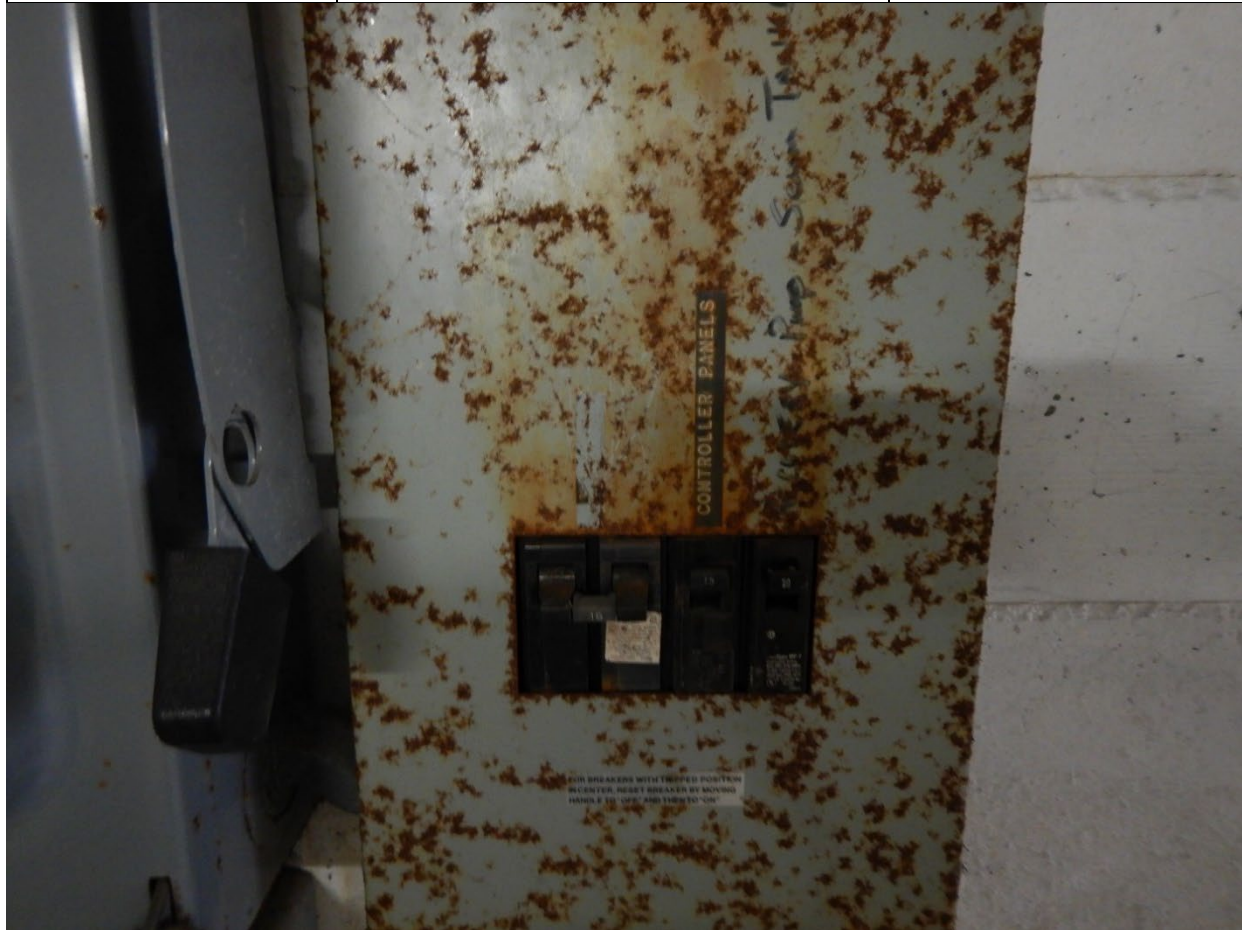
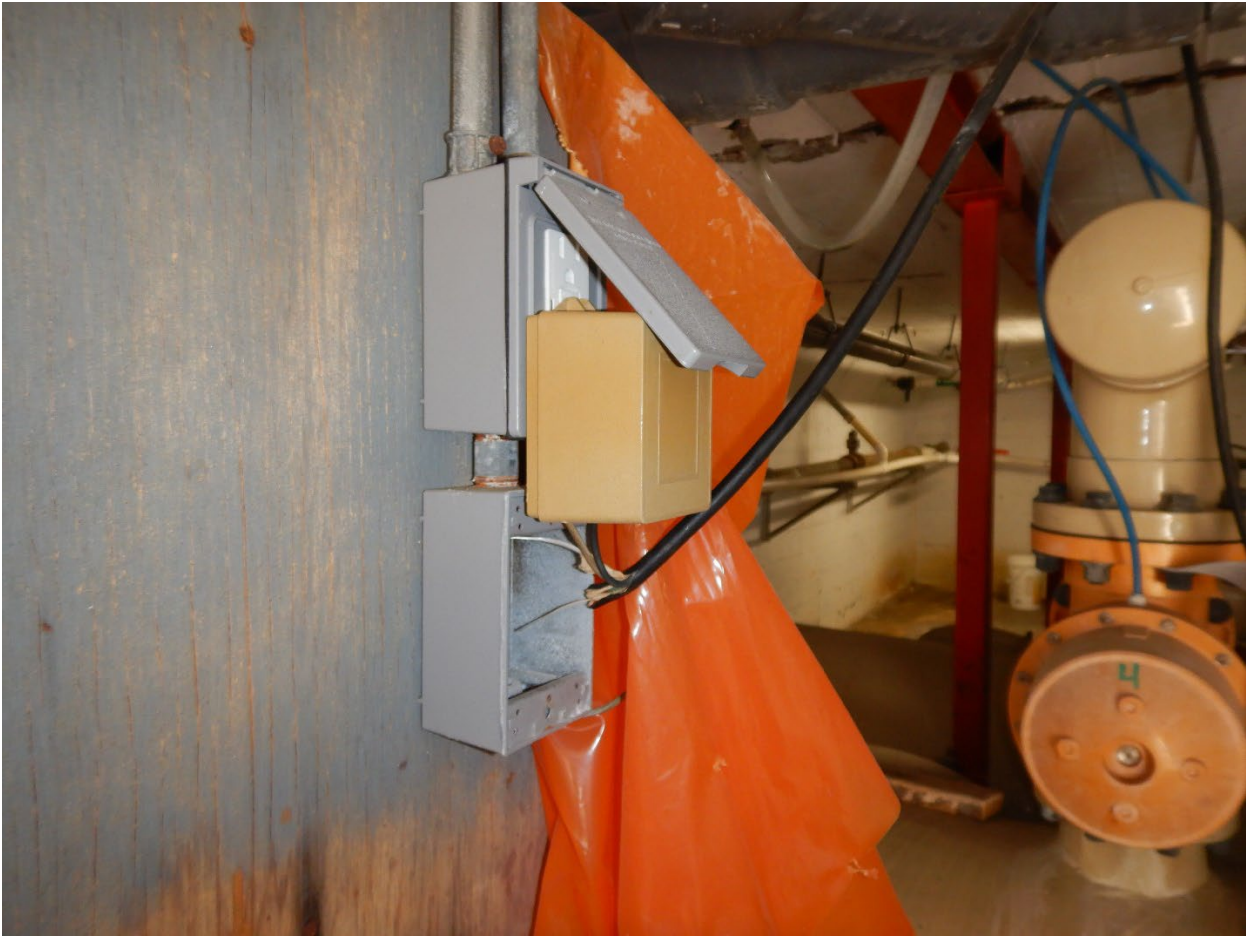
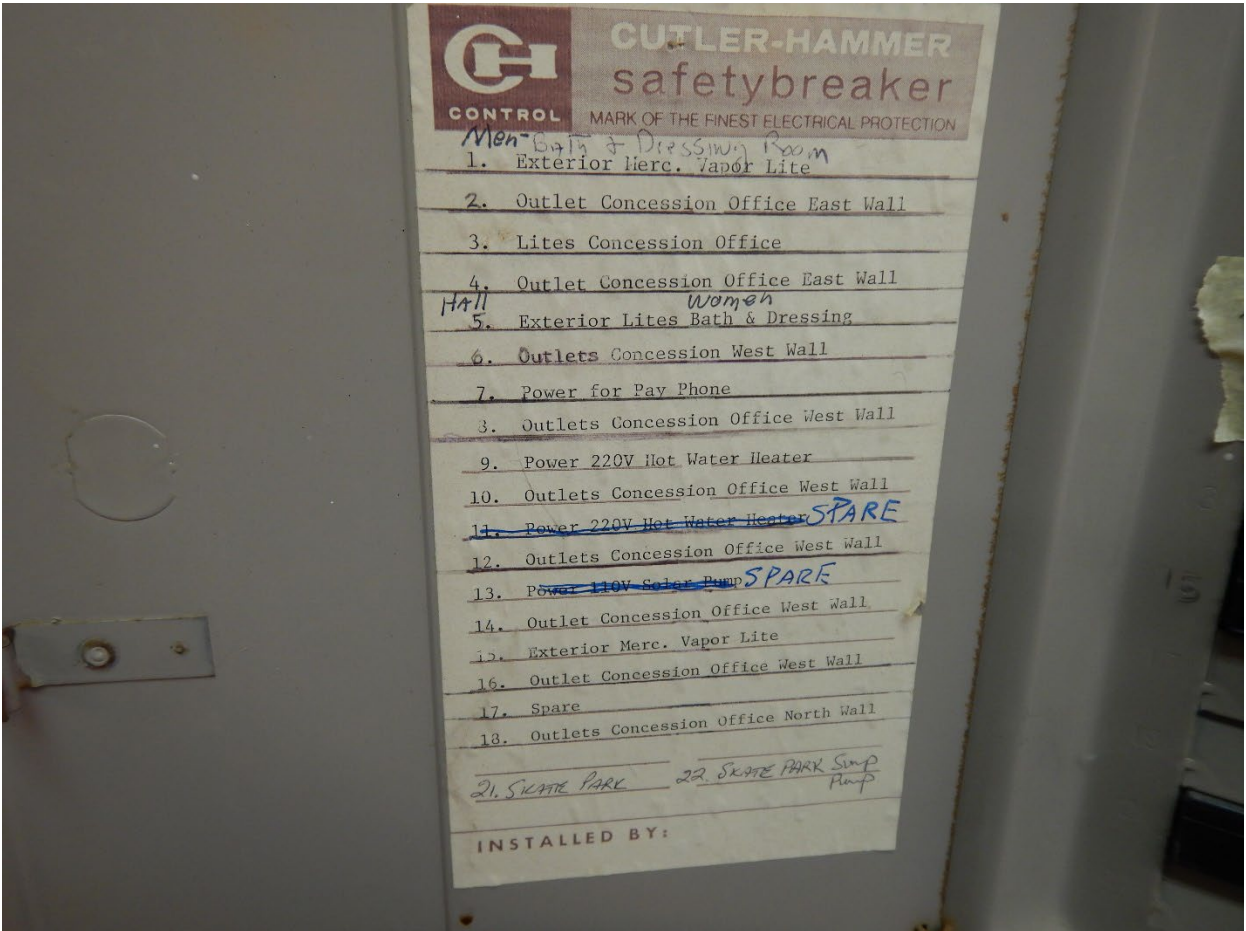
Evaluation Categories	Comments	Fiscal Impact
Lights - Pool, Overhead, Buildings	There are no overhead lights at the facility and no pool lights. All building lights, the lights on the building and lights in the mechanical should be changed out to LED lights for better lighting and cost savings.	\$2,500

Evaluation Categories	Comments	Fiscal Impact
Circuit Breakers, Outlets	There are multiple outlets and some electrical hook-ups that need to be evaluated and reconfigured. The circuit breaker panel is very old and should be updated if the mechanical room is renovated.	Part of larger renovation bid from AquaSource attached as Exhibit A

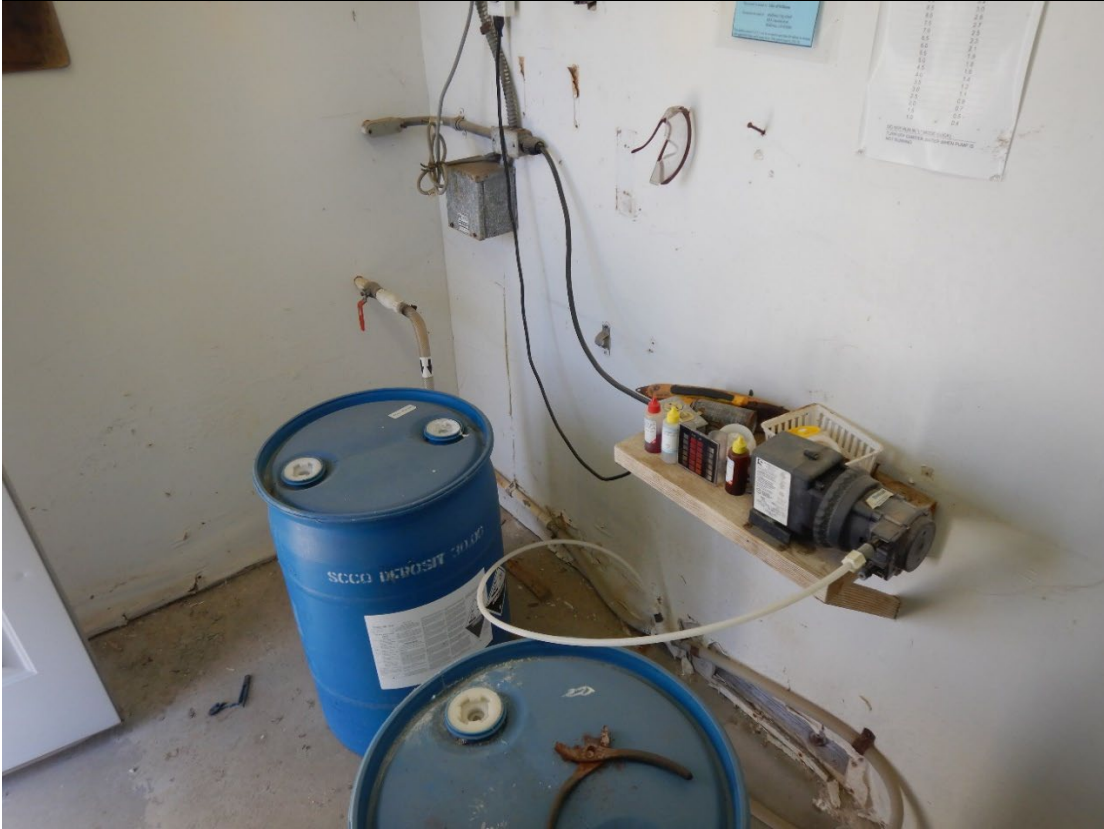
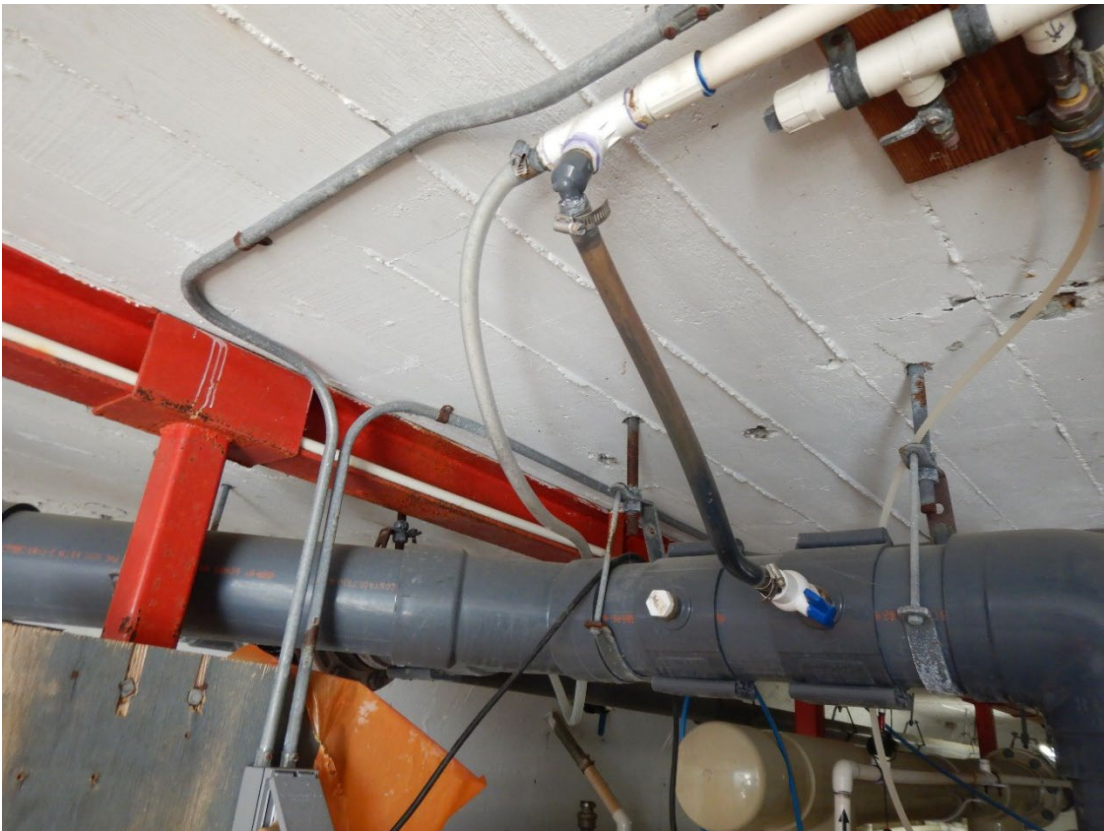
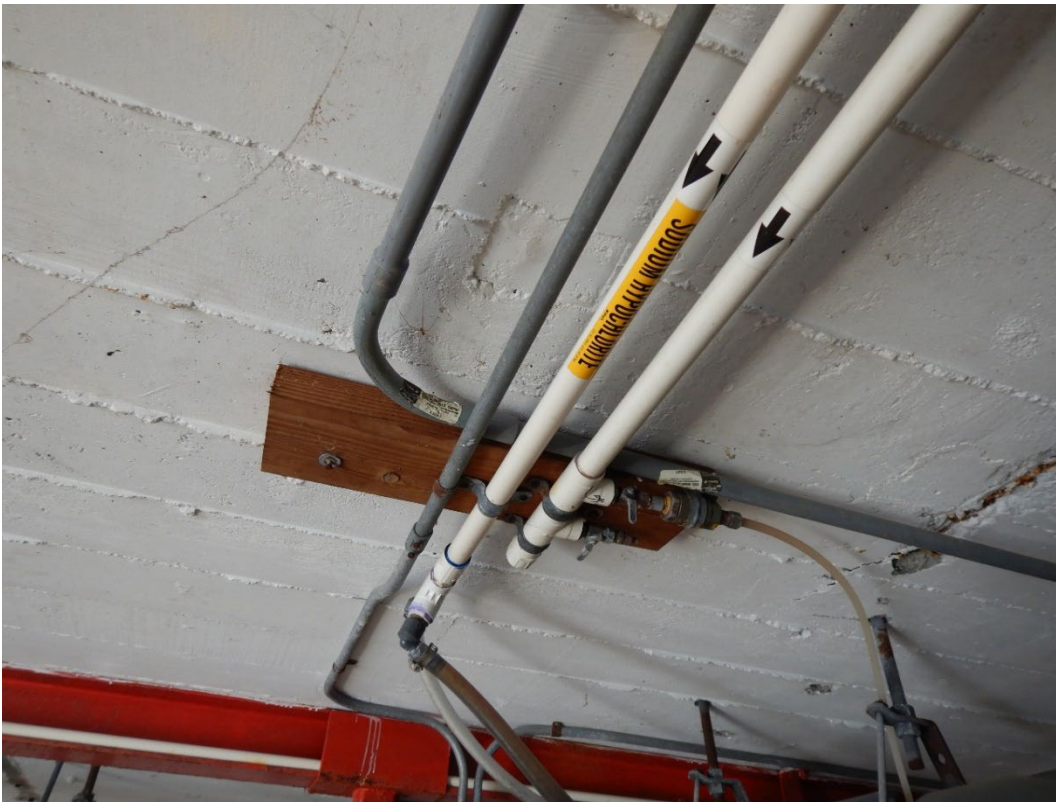
Evaluation Categories	Comments	Fiscal Impact
Chemical Feeding System	The facility appears to have had a chemical feeding system with a chemical controller. It appears to have been removed therefore the system would require manual feeding of chemicals. This is ineffective and cumbersome. An automated chemical feeding system should be installed.	Part of larger renovation bid from AquaSource attached as Exhibit A

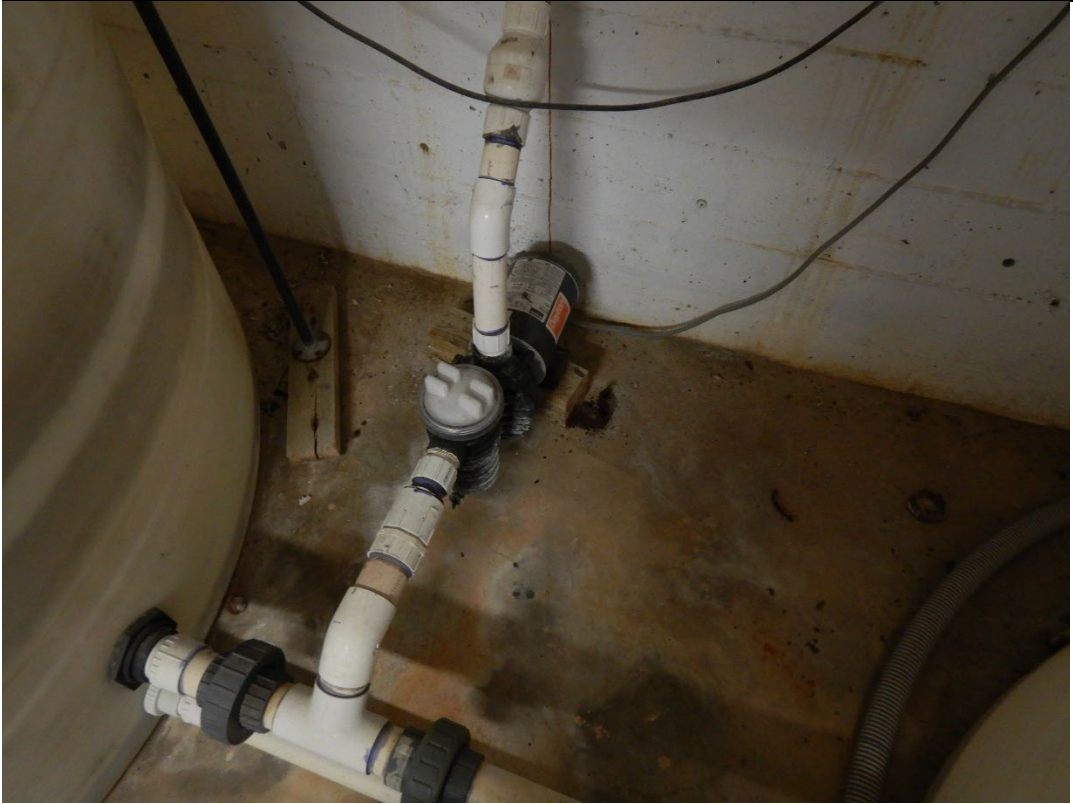
Evaluation Categories	Comments	Fiscal Impact
Surge Tank/Pit	The gutter water return system is plumbed into two large holding tanks; these act as surge tanks for retaining water when swimmers are in the pool. The water is pumped back into the pool when the ball float gets elevated, and the return pump goes back on. It is unclear how plumbing returns to put the water back in the circulatory system.	Part of larger renovation bid from AquaSource attached as Exhibit A
