City of Willows

Swimming Pool Mechanical Evaluation

5/12/2022

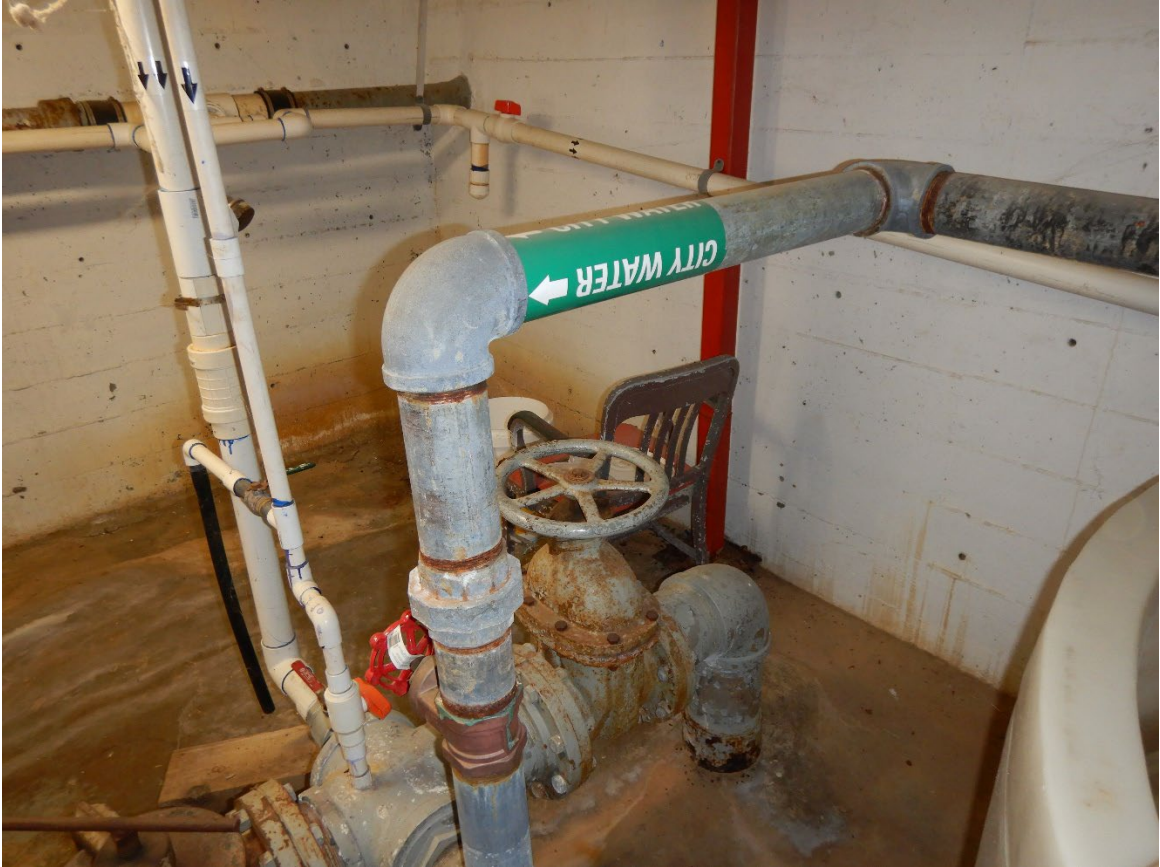
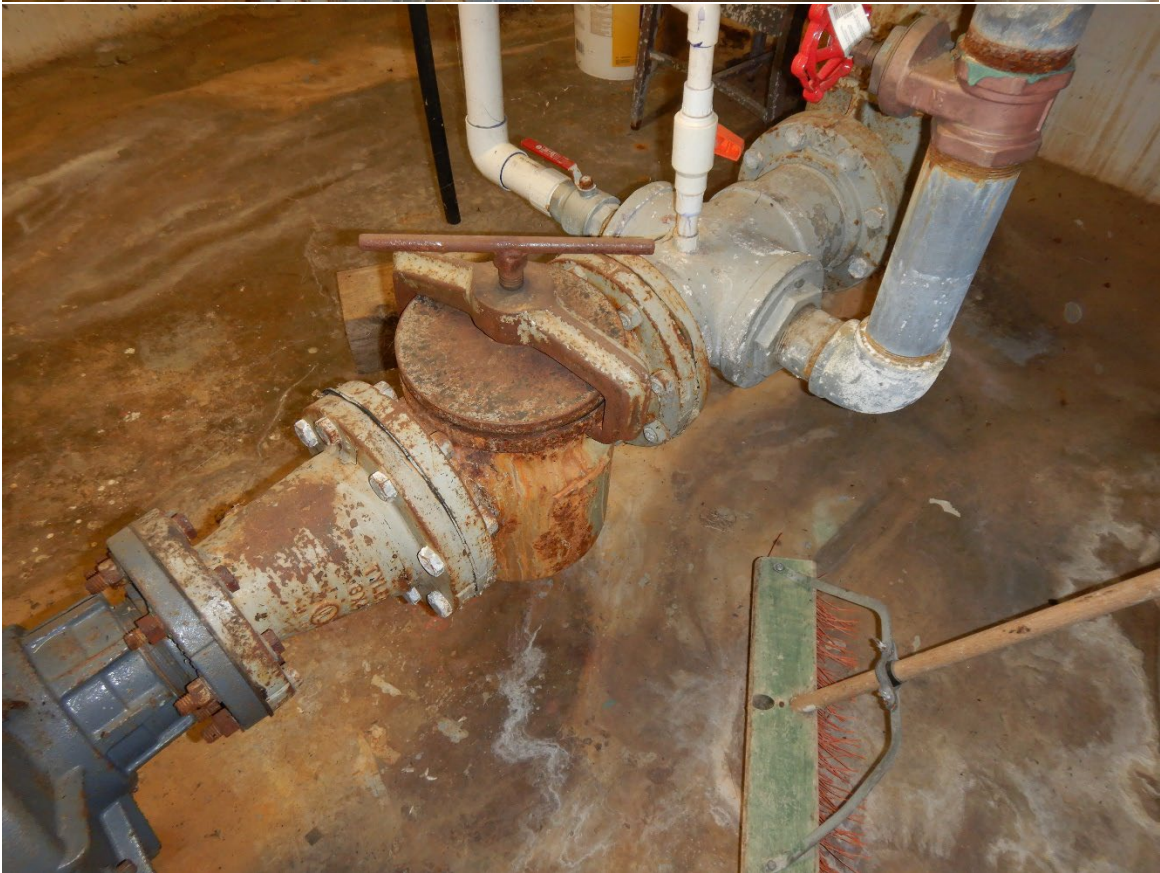
Evaluation Categories	Comments	Fiscal Impact
Pool Water Make-up	Pool water make-up source that keeps the proper amount of water in the circulatory system is plumbed into the suction side of the main pump. This needs to be remedied through the renovation process.	Part of larger renovation bid from AquaSource attached as Exhibit A

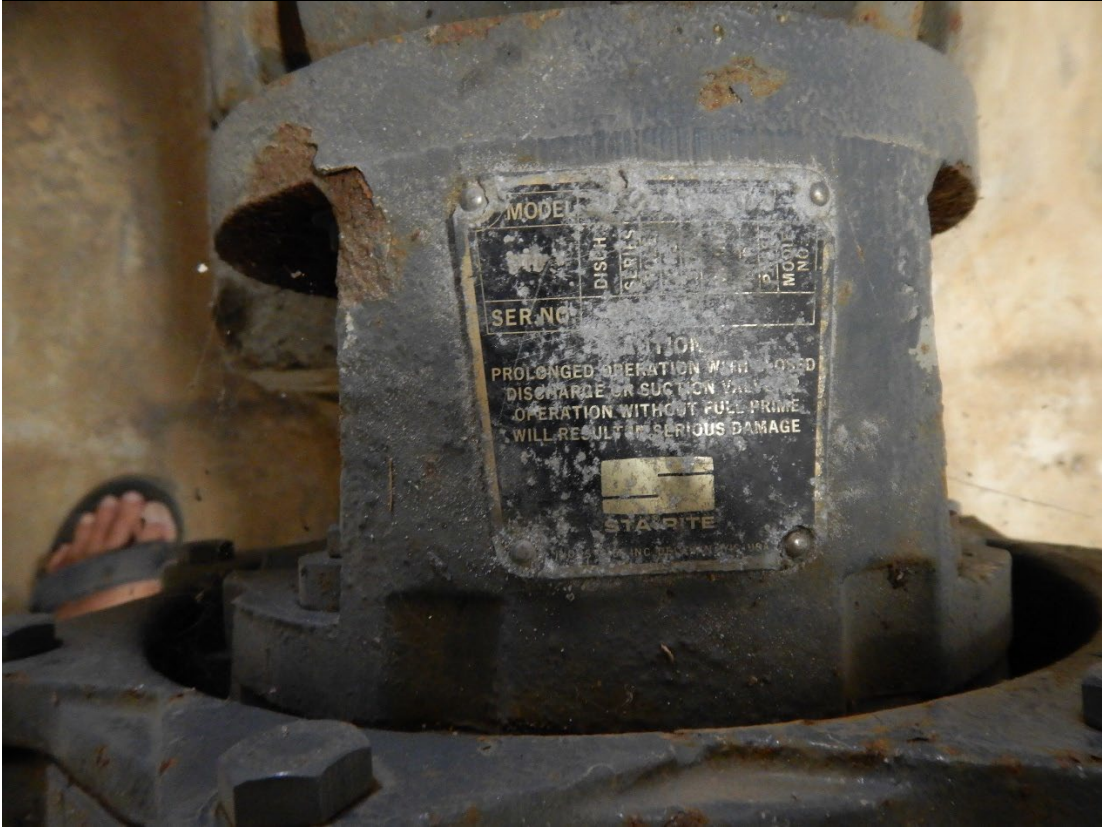
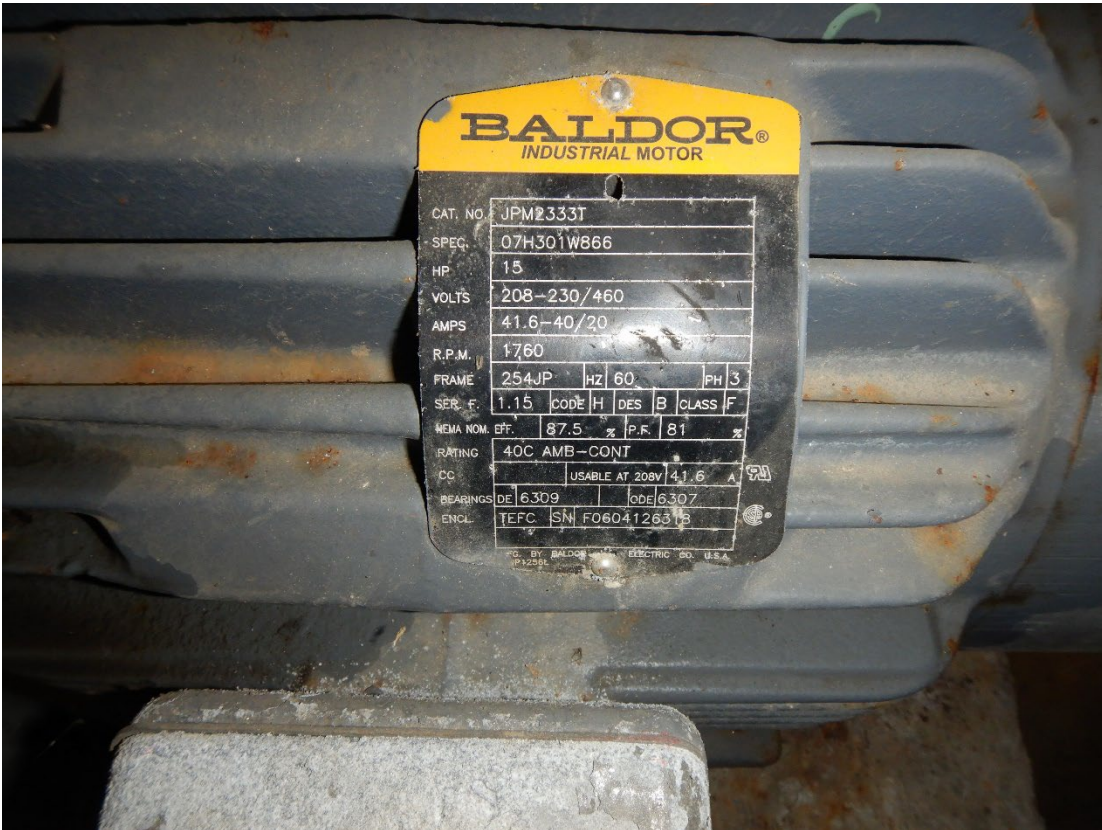
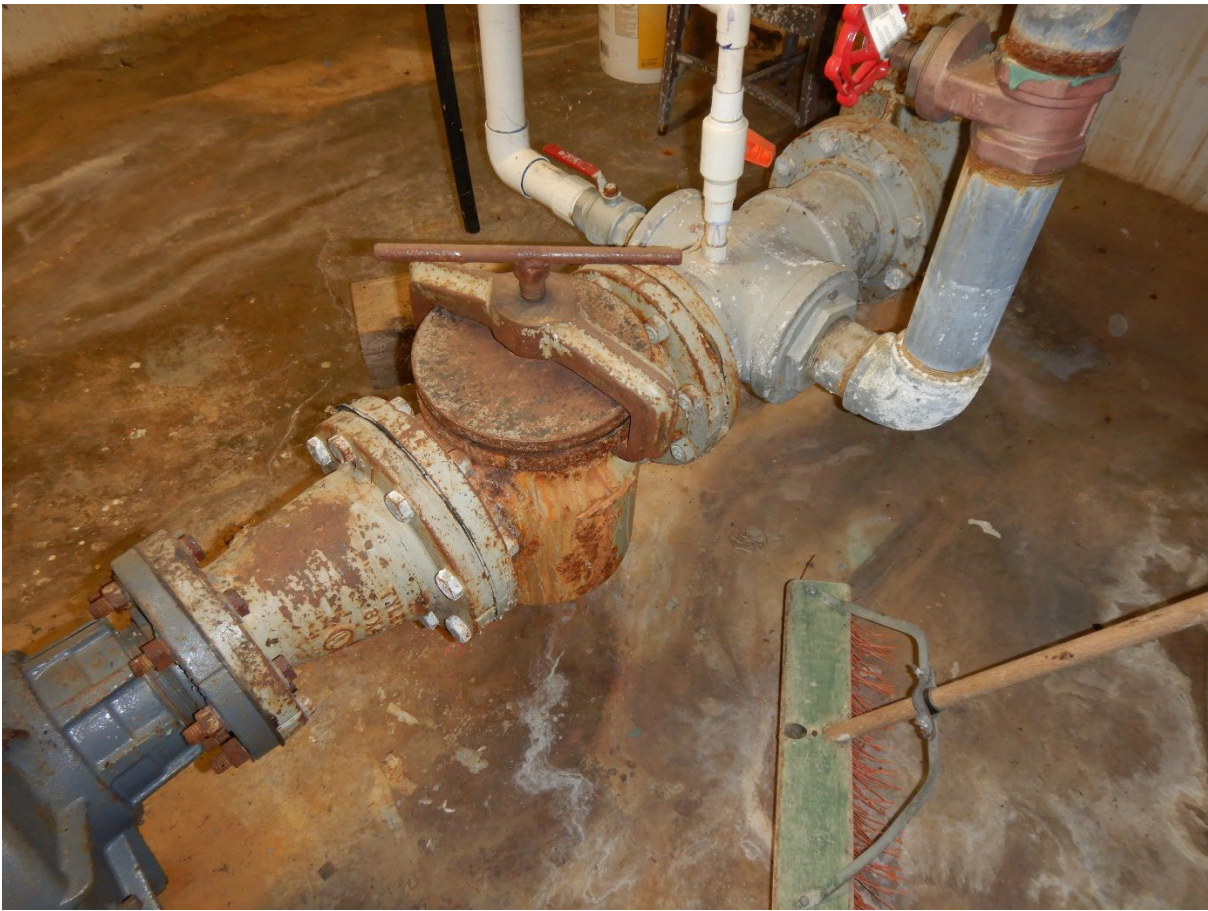
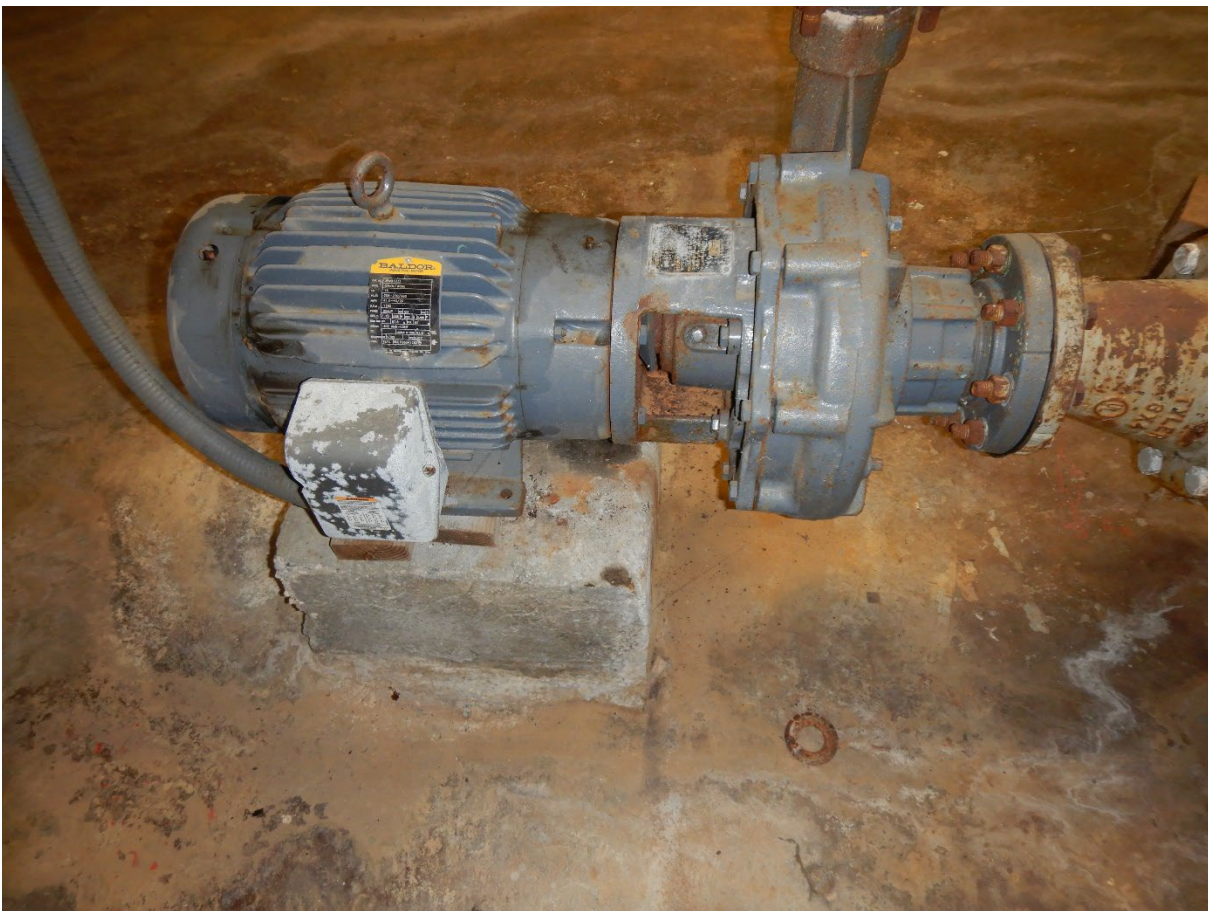
Evaluation Categories	Comments	Fiscal Impact
Main Pump (motor, impeller and strainer)	The main motor and the impeller are old and should be replaced with a newer more energy efficient pump system.	Part of larger renovation bid from AquaSource Attached as Exhibit A

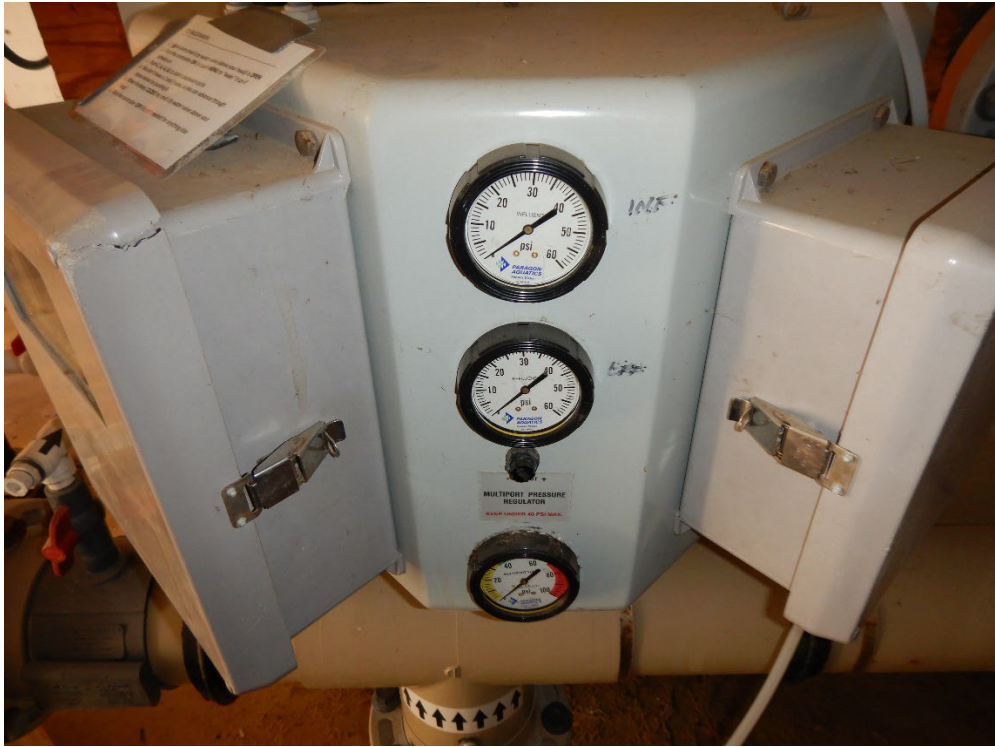
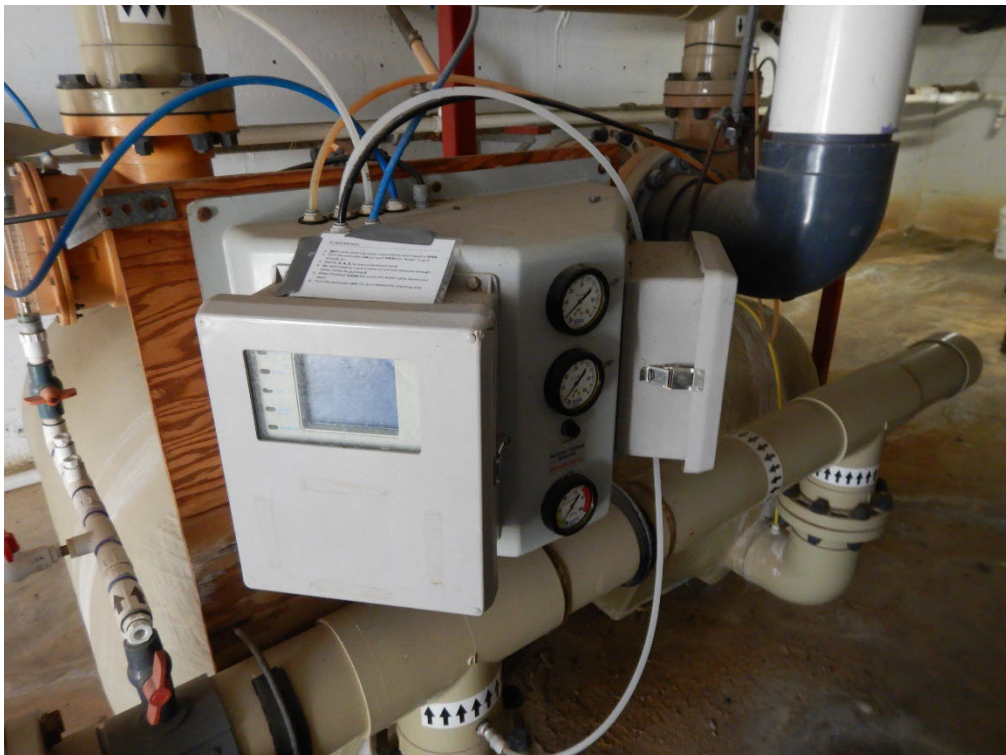
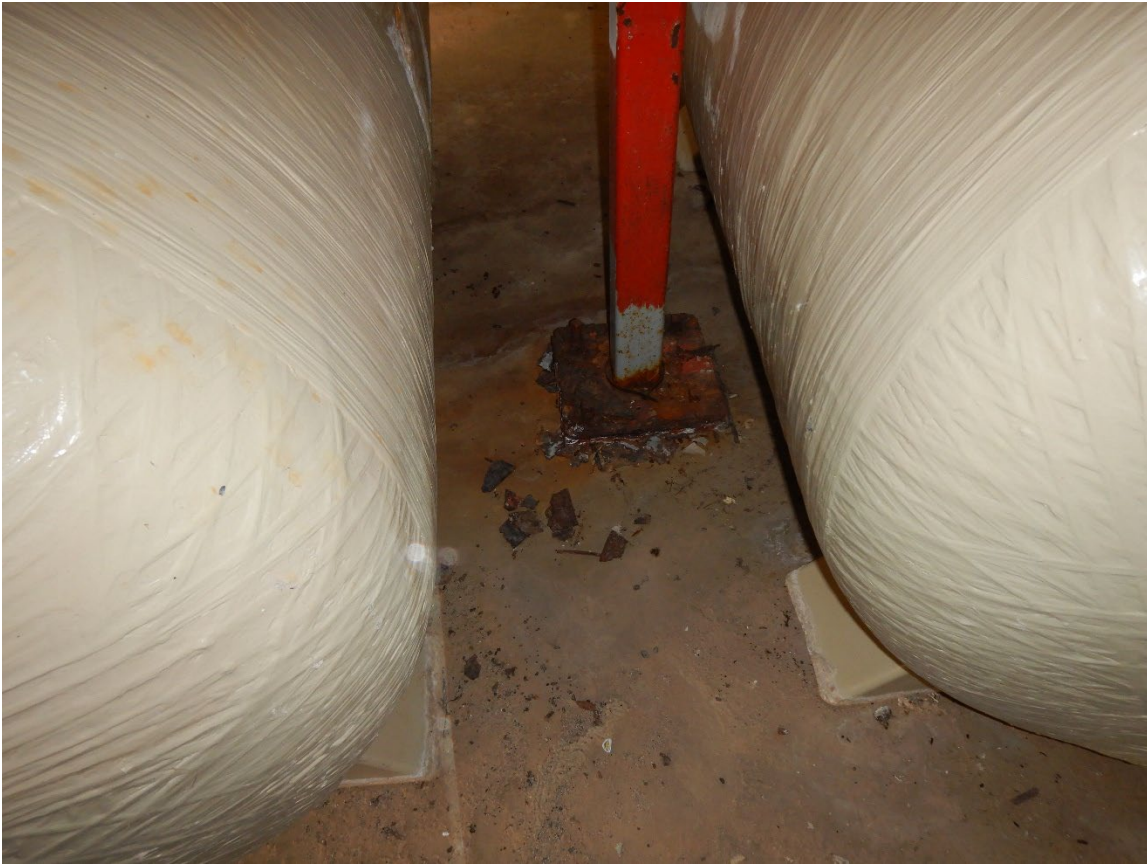
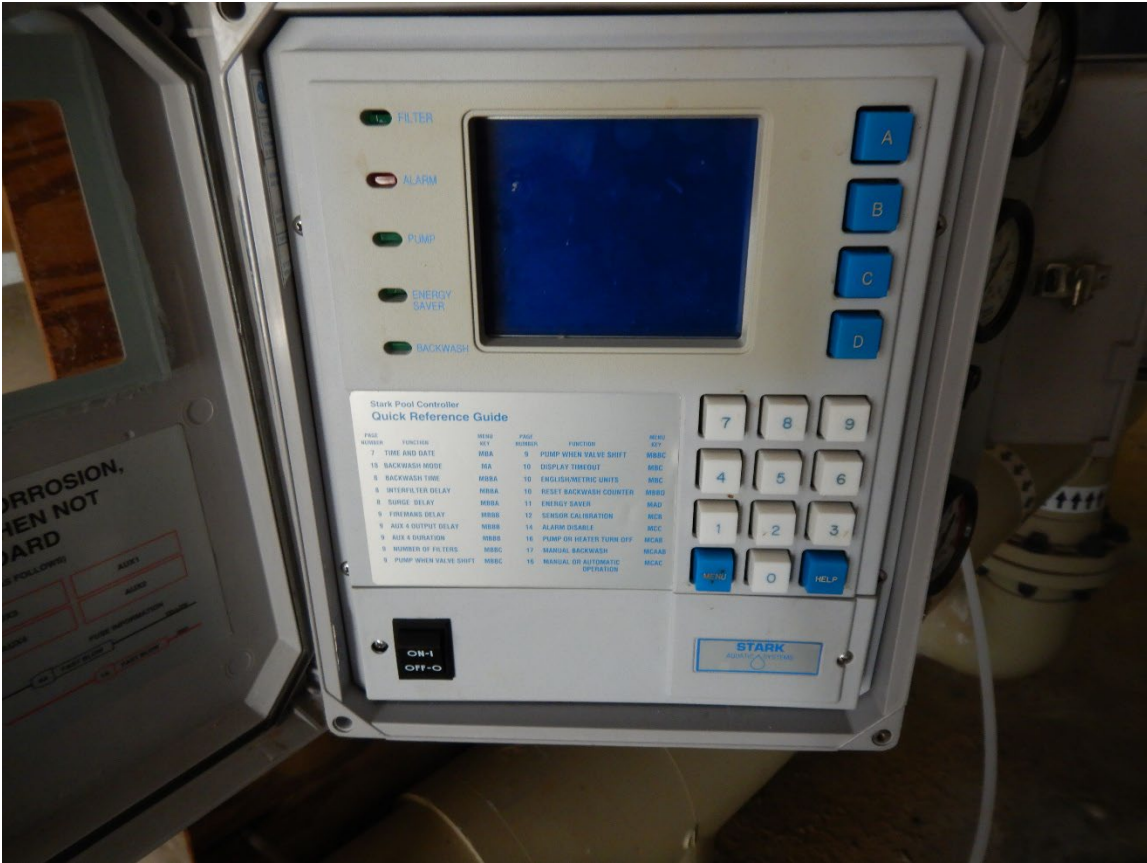
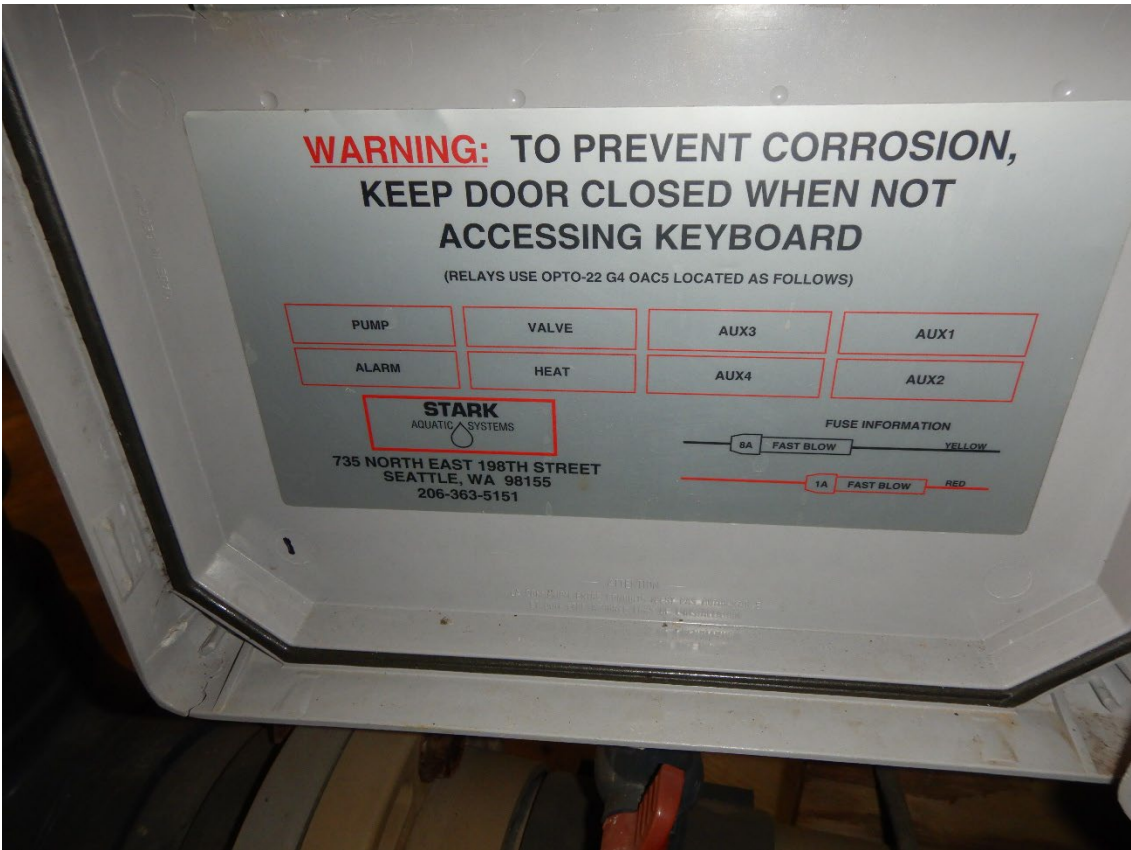
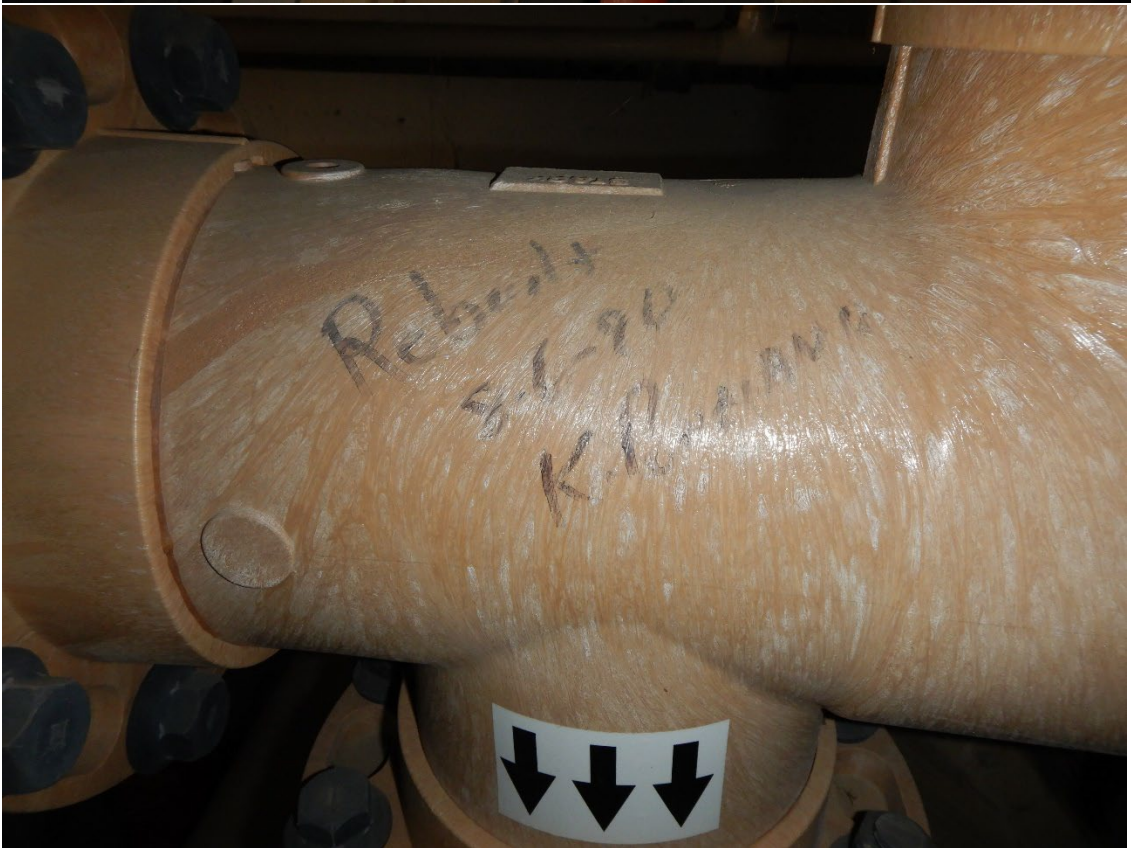
Evaluation Categories	Comments	Fiscal Impact
Filtration	The system has two spun fiberglass Stark brand filters. These were visually evaluated by both TAM and AquaSource. It is believed that they can continue to be used. However, the filtration media (generally sand) should be replaced before any future use and the tanks visually inspected and the two backwash valves should be rebuilt. AquaSource quote includes valve rebuild, but not new filter media.	\$10,000 for filter media replacement, valve rebuild is included as part of larger renovation bid from AquaSource Attached as Exhibit A
