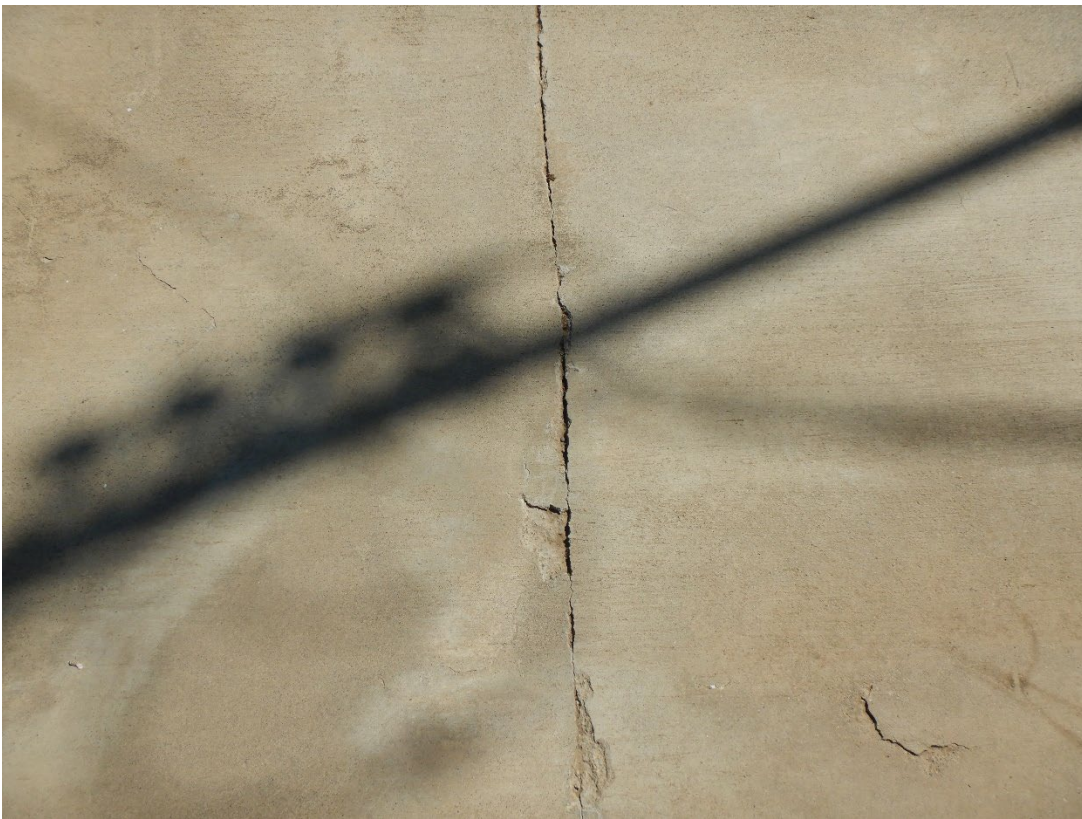
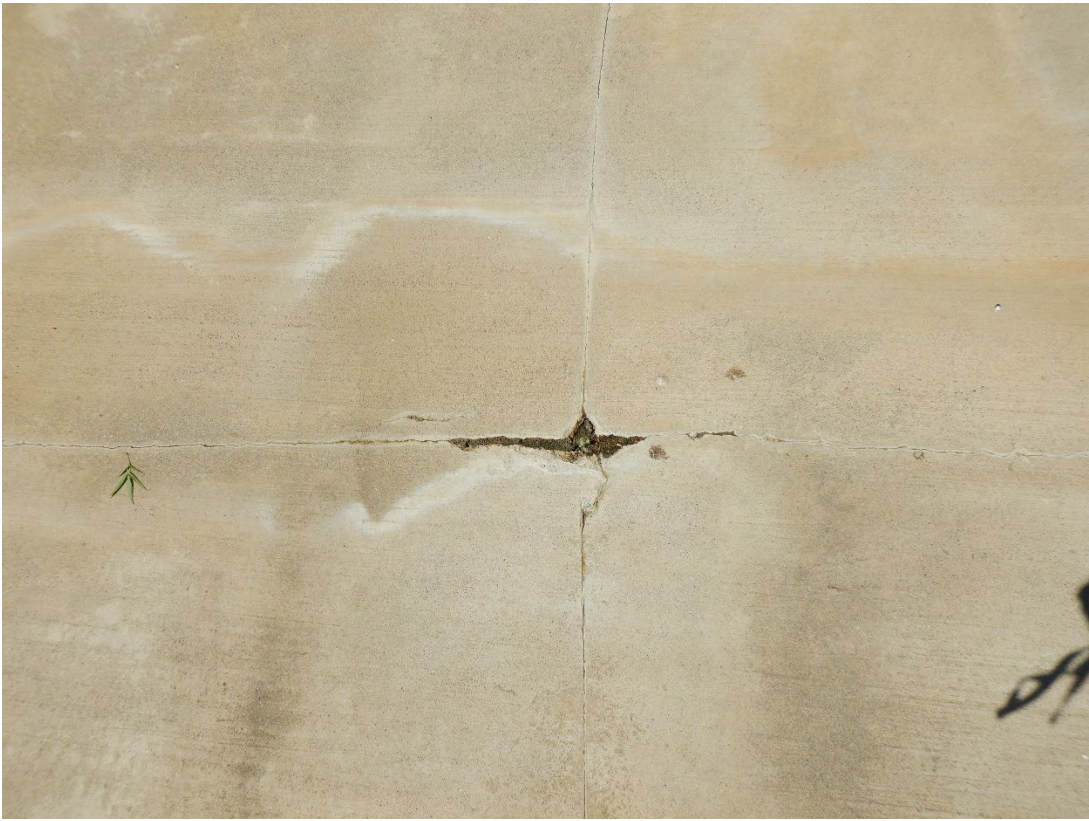
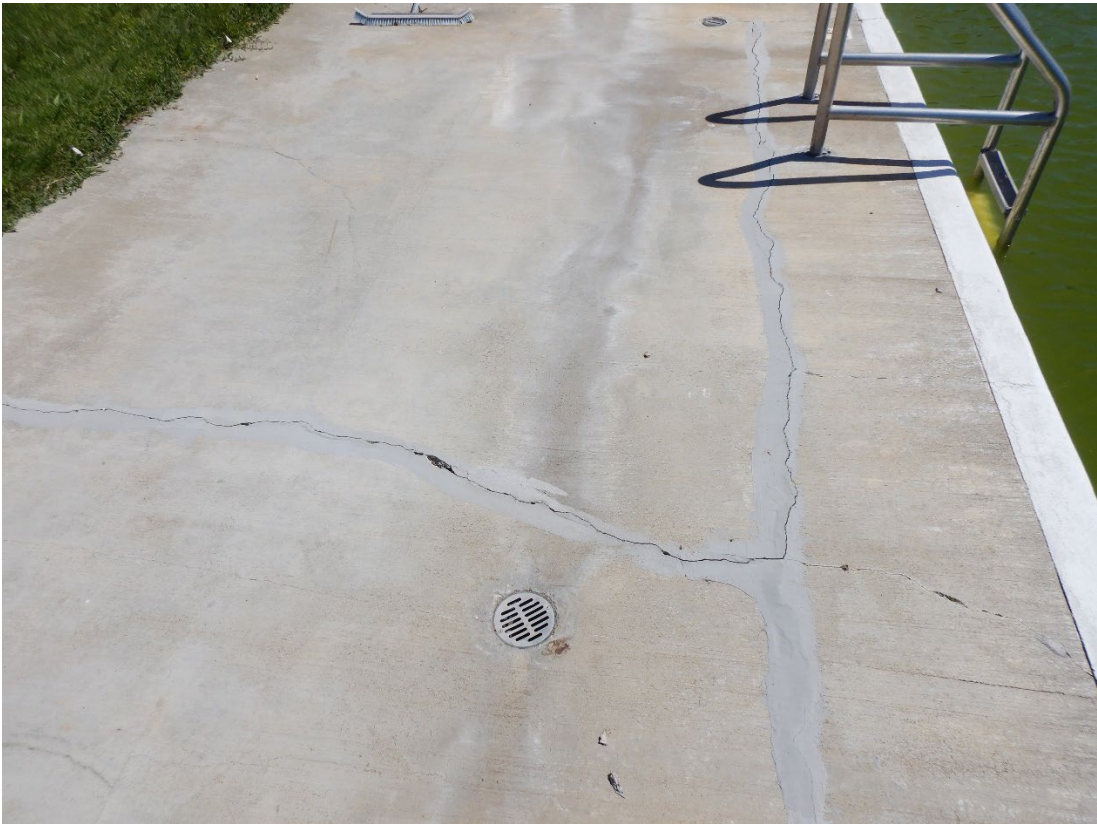
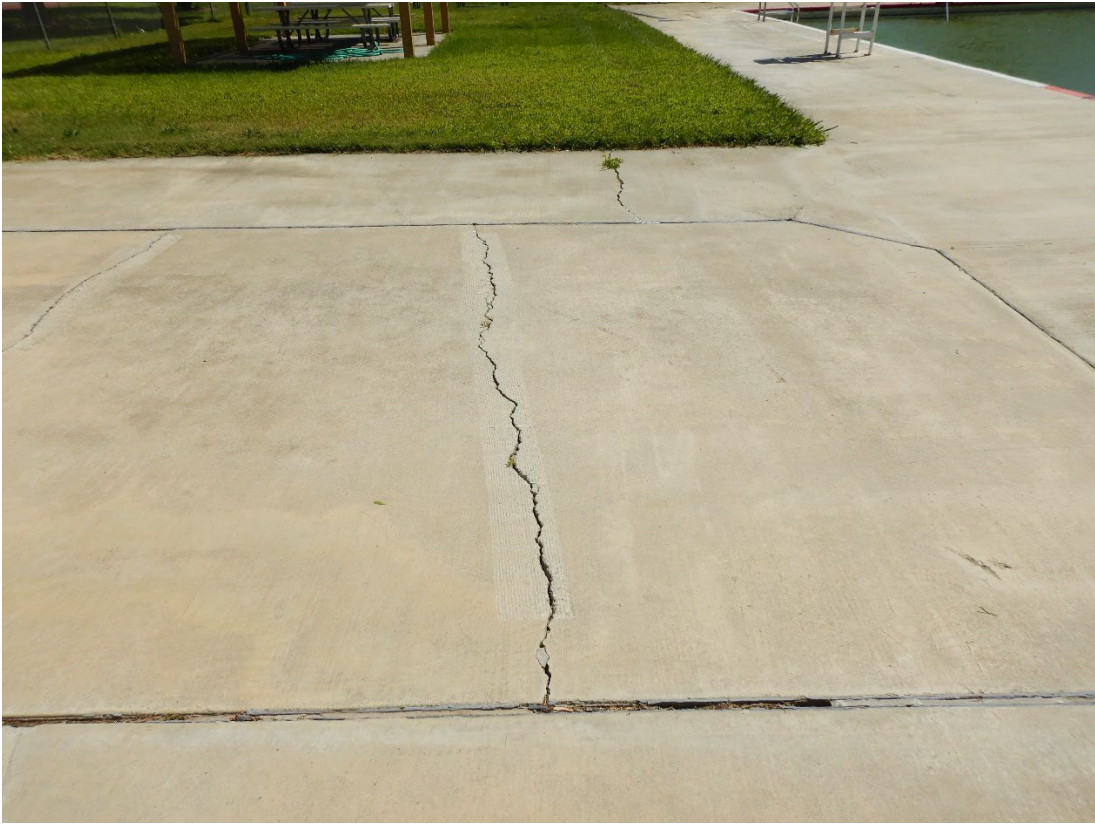
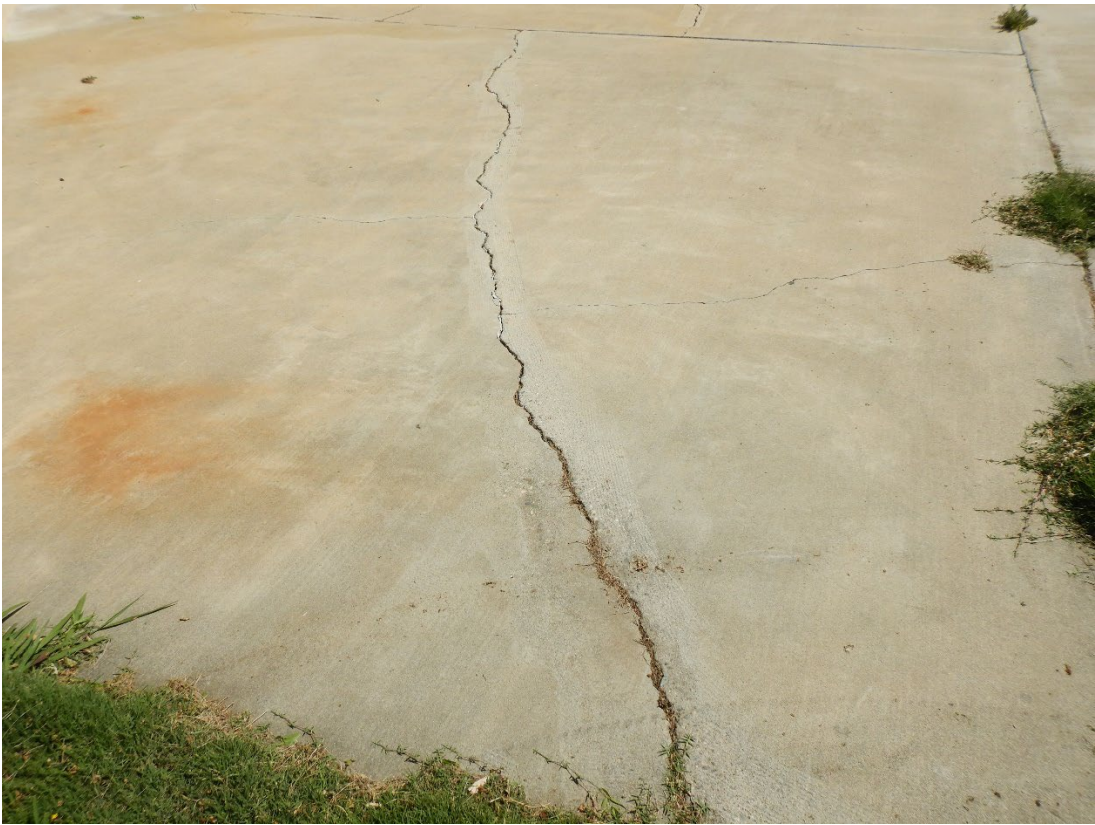
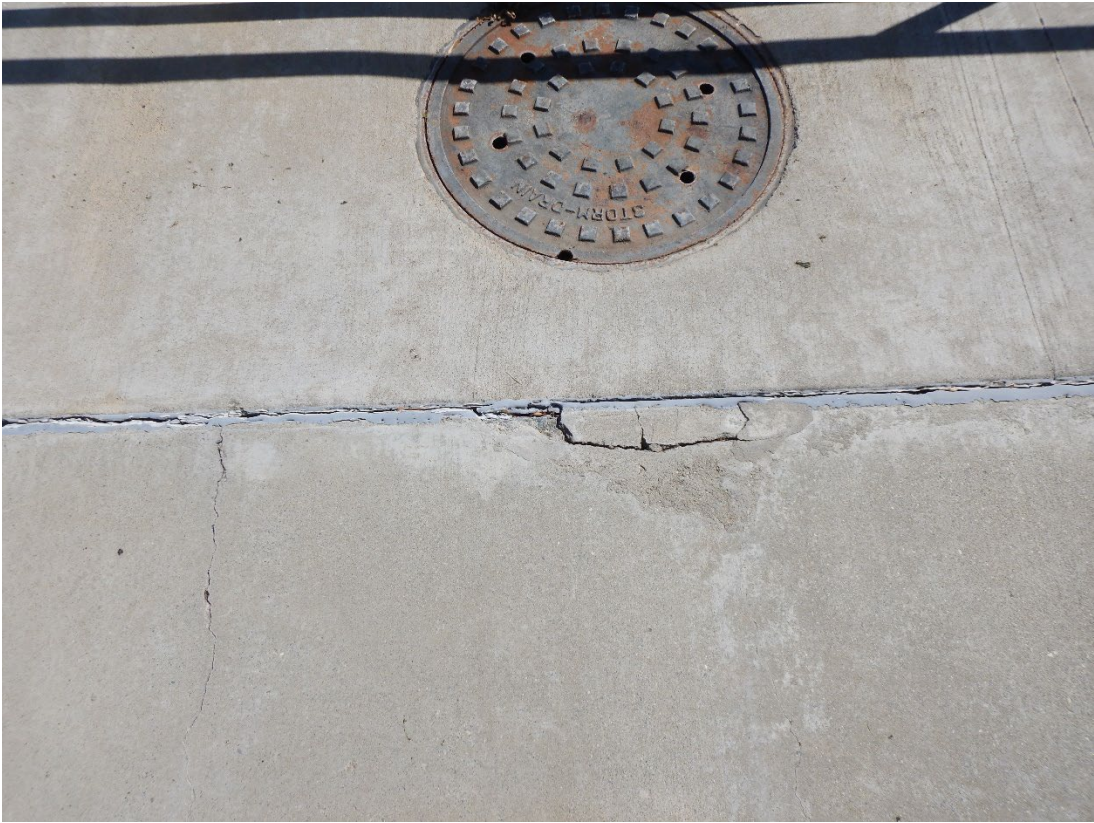
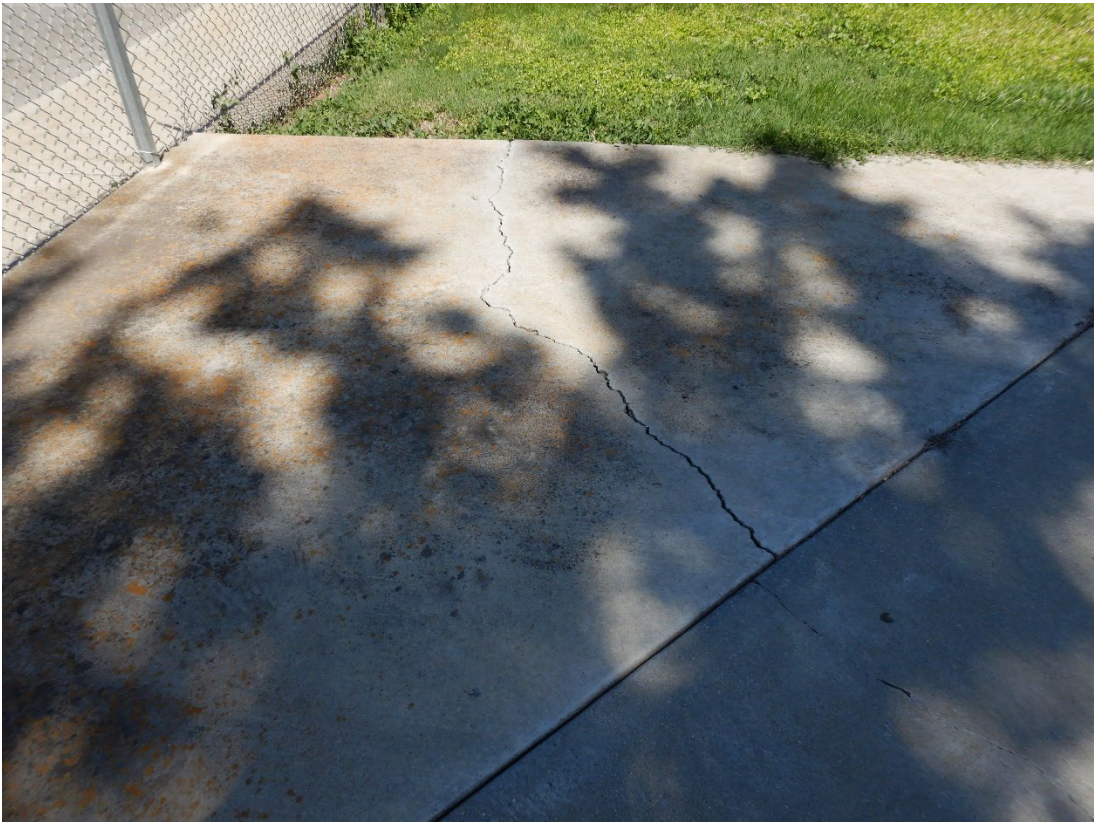
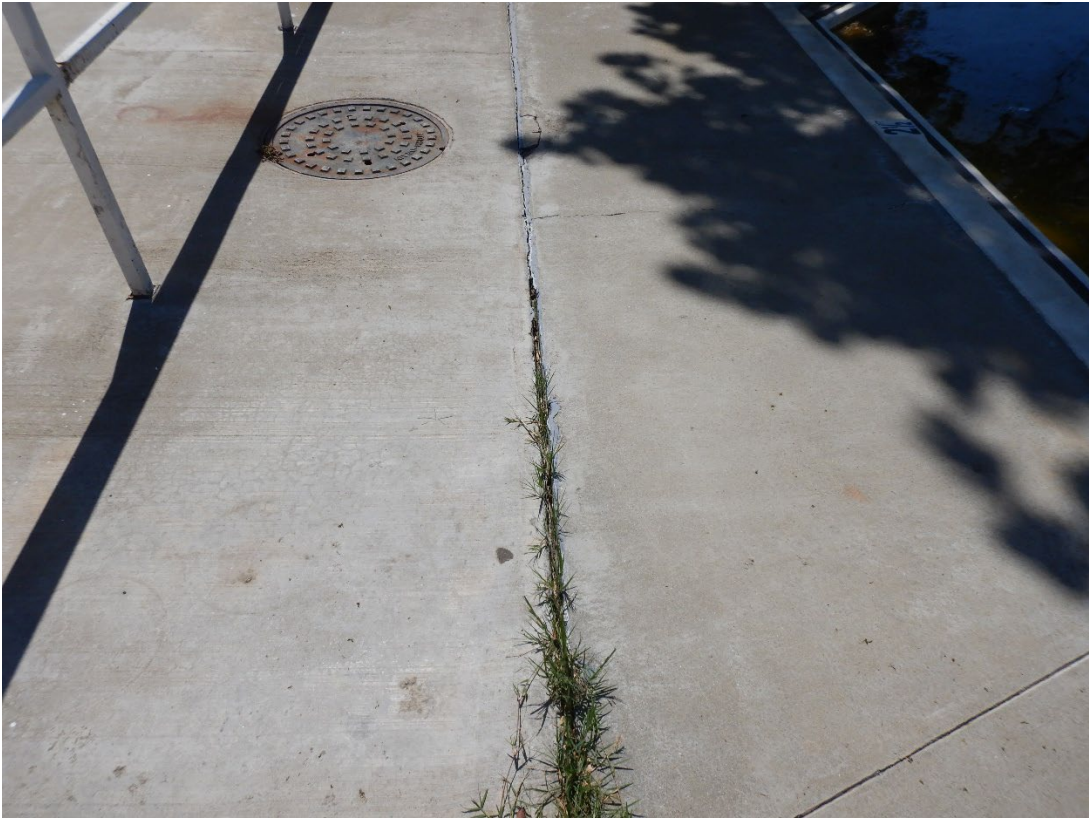
Evaluation Categories	Comments	Fiscal Impact
Deck expansion joints are well sealed and impenetrable	Expansion joints should be resealed. Lack of sealing allows water to penetrate and undermine the integrity of the slabs causing settling, ledges between slabs and unsafe gaps in the pool deck. When resealing, use foam backing rod, or "green rod" stuffed into the joint with a ½ inch to ¾ inch gap to deck level, then seal with a sealant product such as Deck-O-Seal	\$500 sealant plus man hours

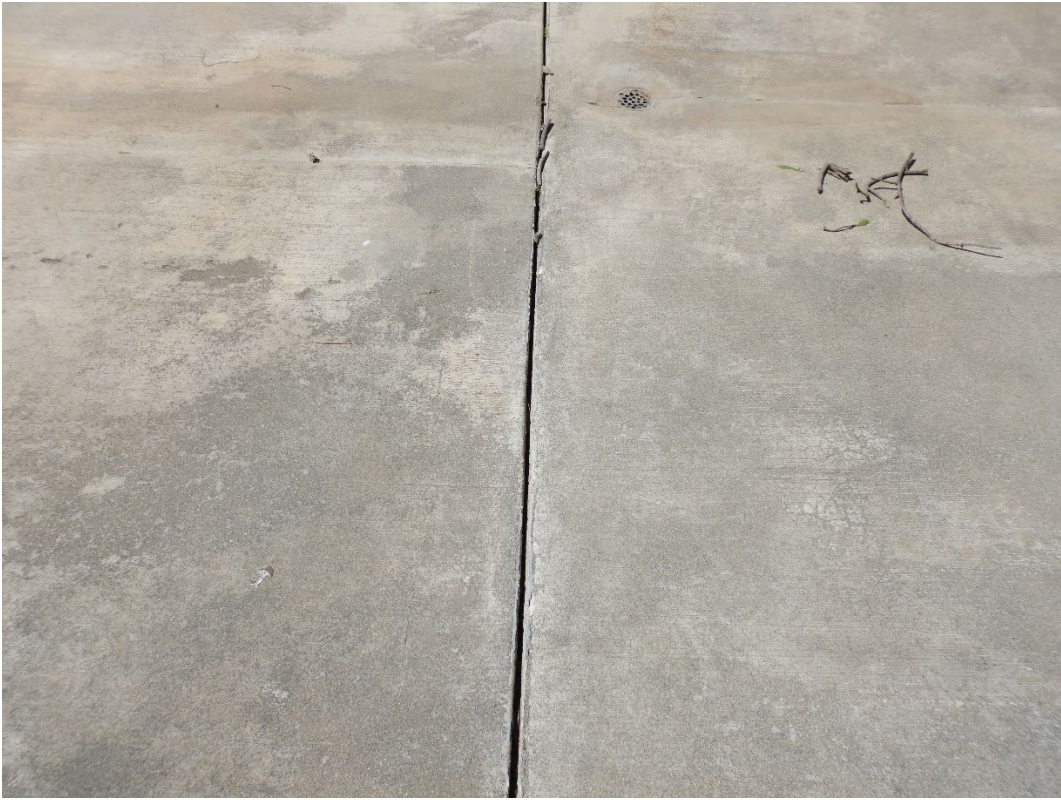
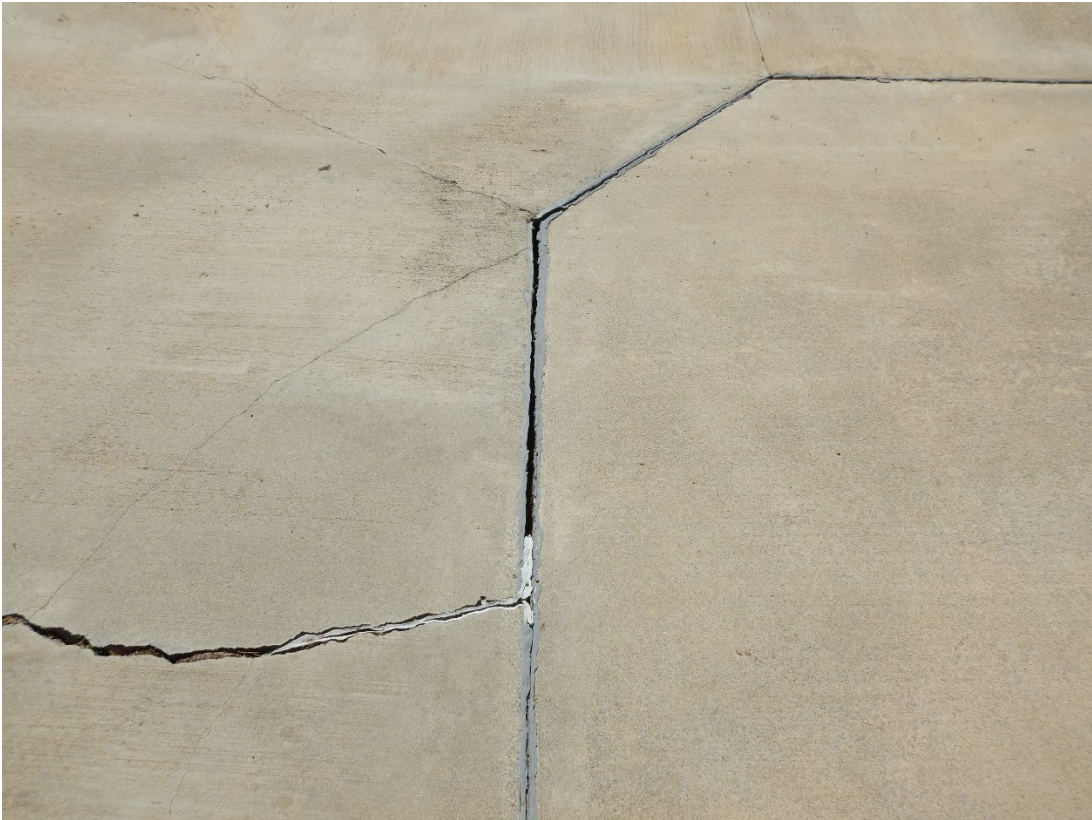
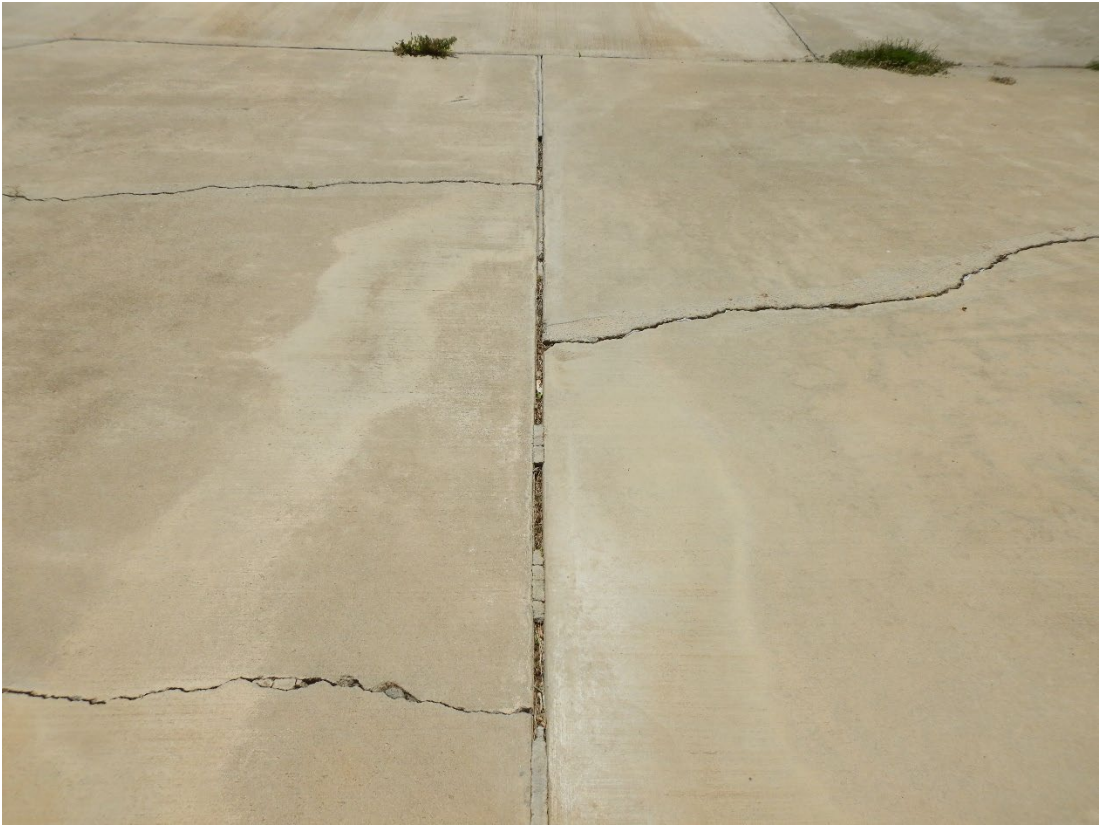
Evaluation Categories	Comments	Fiscal Impact
Deck drains are in good condition and functional.	Deck drains covers are in good condition and all are well attached and appear to be functional.	
Depth markers are of proper size are posted on deck and pool walls. They are not faded and show numerical value with foot and if applicable inches noted.	Depth markers are all at least 4" to meet code. Some are larger which is ok, they all do not have the inch or feet measurement next to numbers, this is required. Some are illegible or faded. Code requires they are spaced a minimum of 25 feet apart, the south side has an area with a longer gap between the 5 and 9 on the deck, there is a 7 on the vertical wall without a 7 above it on the deck. There should be one at the break or belt line at 4 1/2 feet depth of the pool, usually a 5-foot marker is near here to denote "deep water". Wherever there is a marker on the deck there should be one under it in the vertical pool wall. This could all be rectified with the removal of the fiberglass and replastering with new tile. Depth markers and "No Diving" markers can be set in the deck with minor grinding and replacement, this should be done by a tile or concrete or plastering company.	<p style="text-align: center;">\$2,500 to \$10,000 to replace depth markers on deck and on the vertical walls</p>

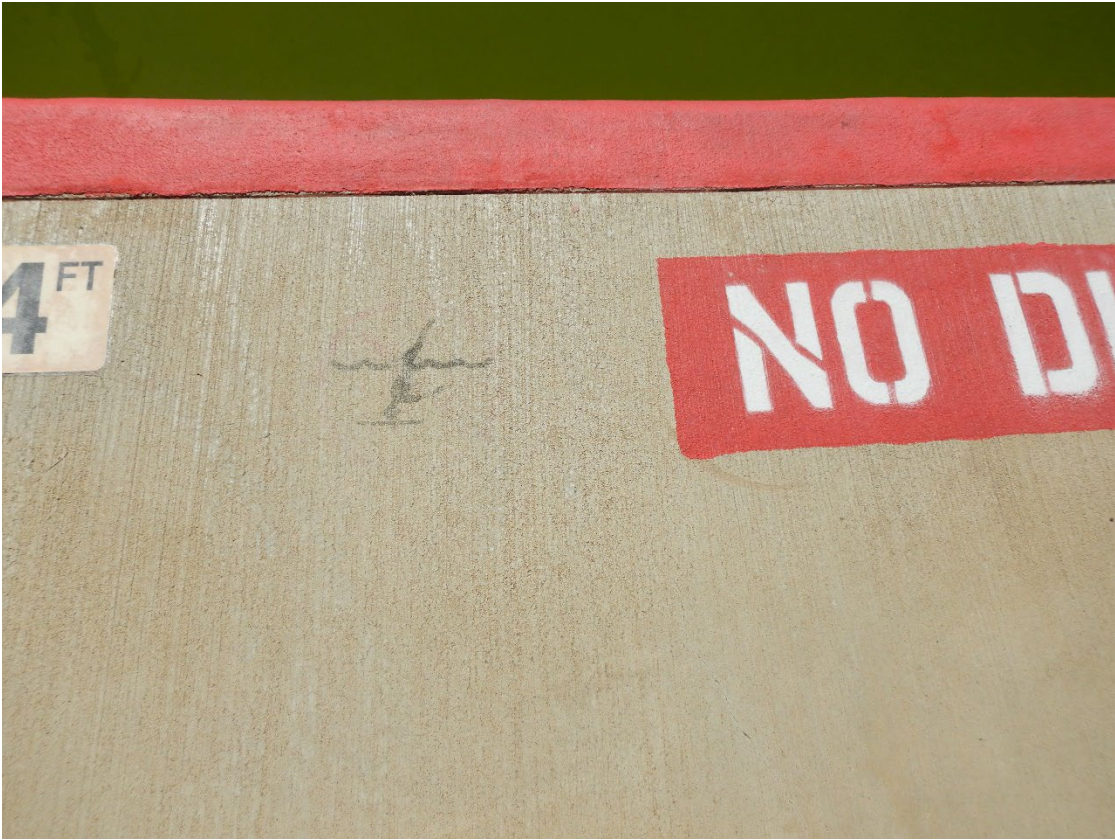
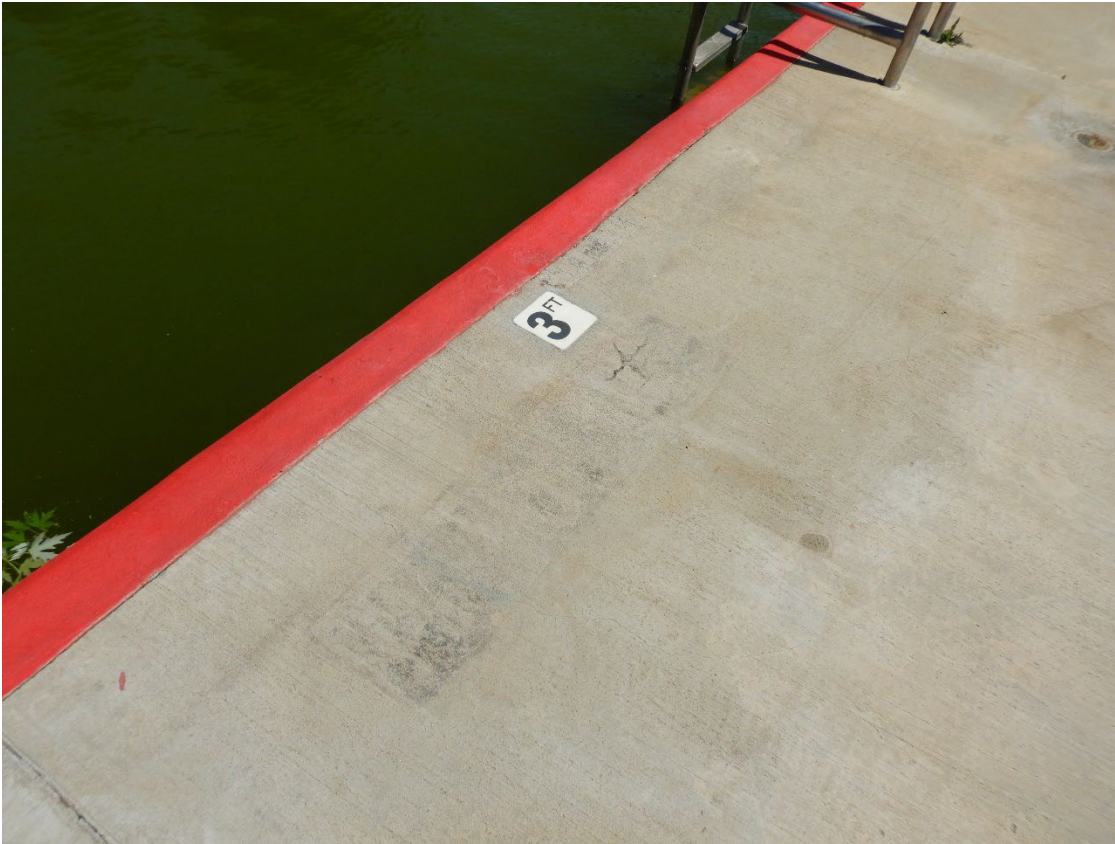
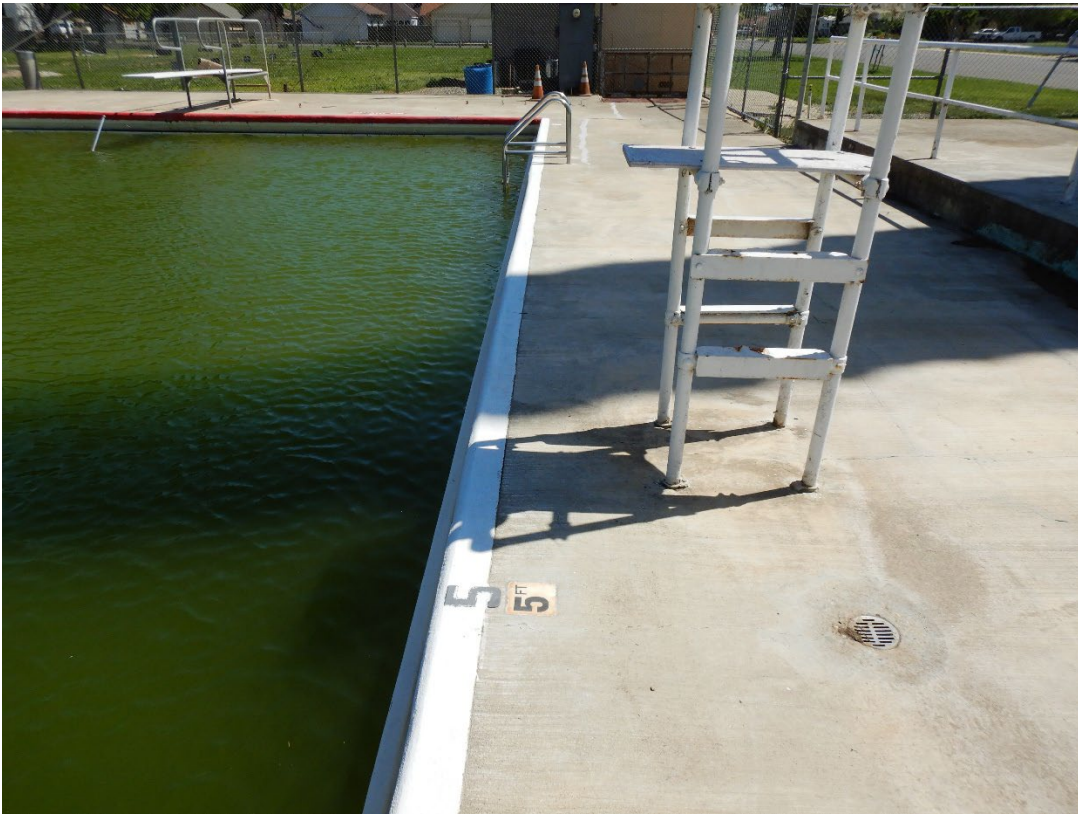
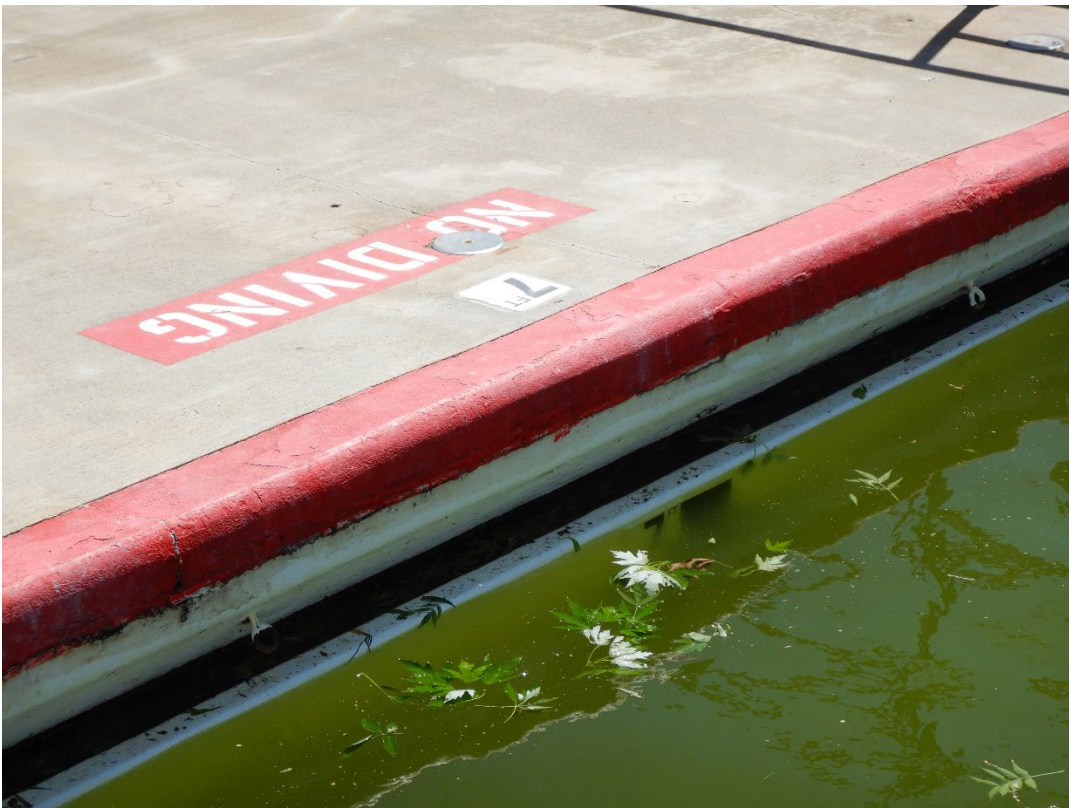
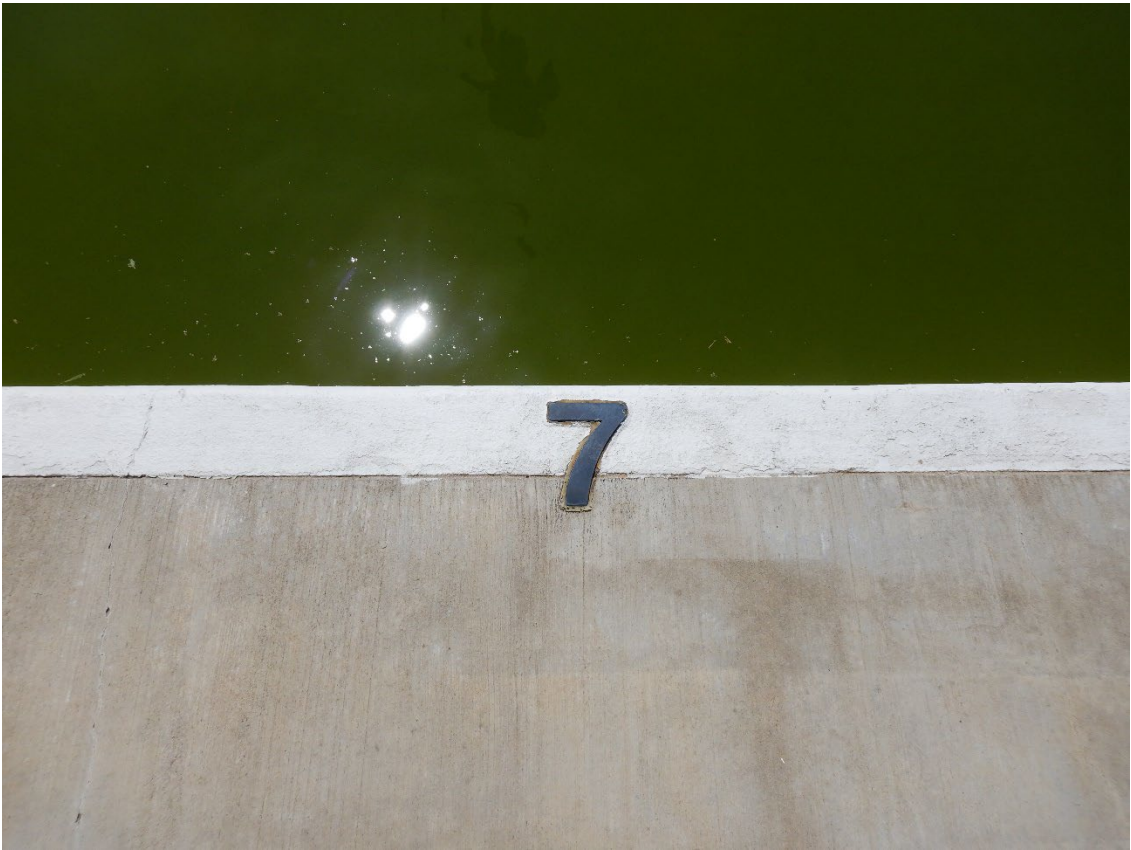
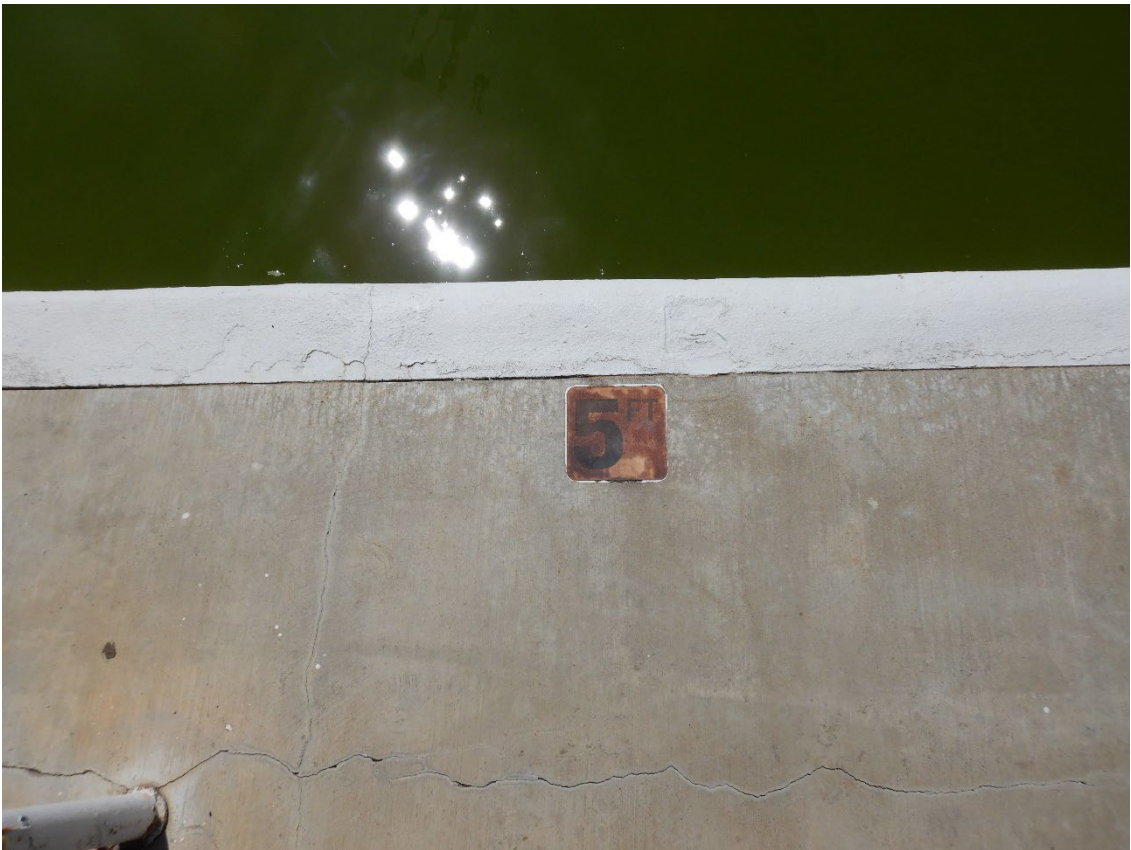
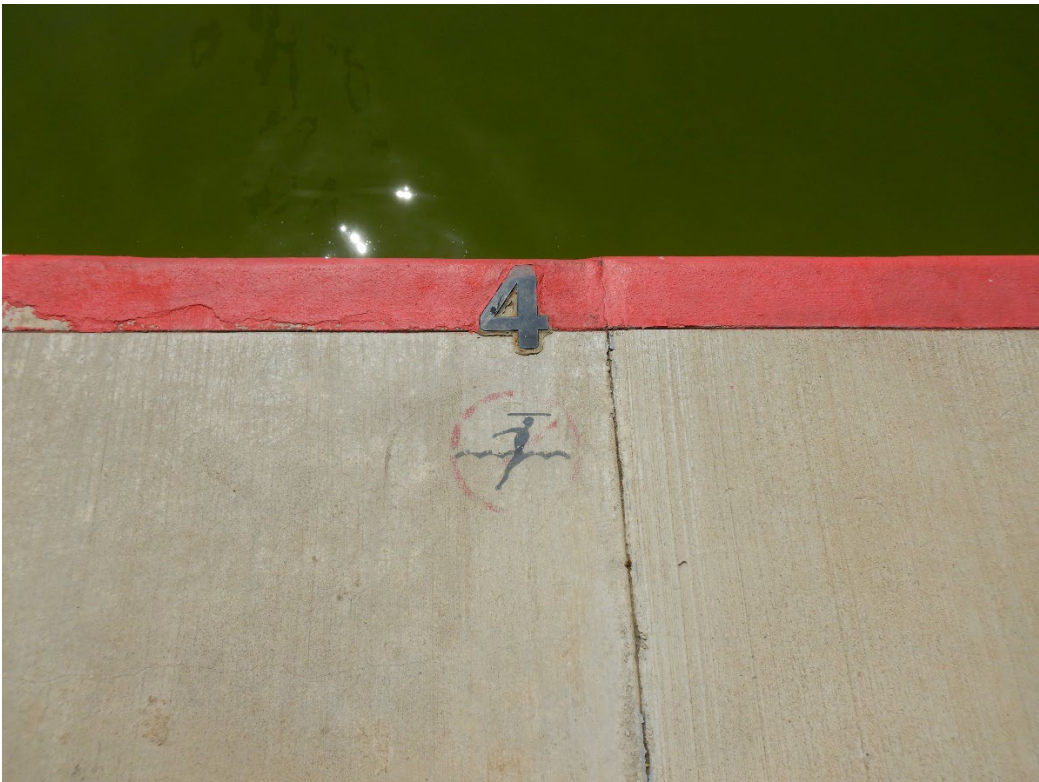
Evaluation Categories	Comments	Fiscal Impact
No diving is marked on the deck in areas of less than 5 feet of water depth.	No diving is stenciled in places around the deck. Once depth markers are re-done to be of proper size and with proper placement (every 25 feet or less with 5' near the break or belt line), no diving should be stenciled at distances that are mid-point between the markers with the international "no diving" symbol next to wording. The tot pool has no markers on the vertical walls.	\$500

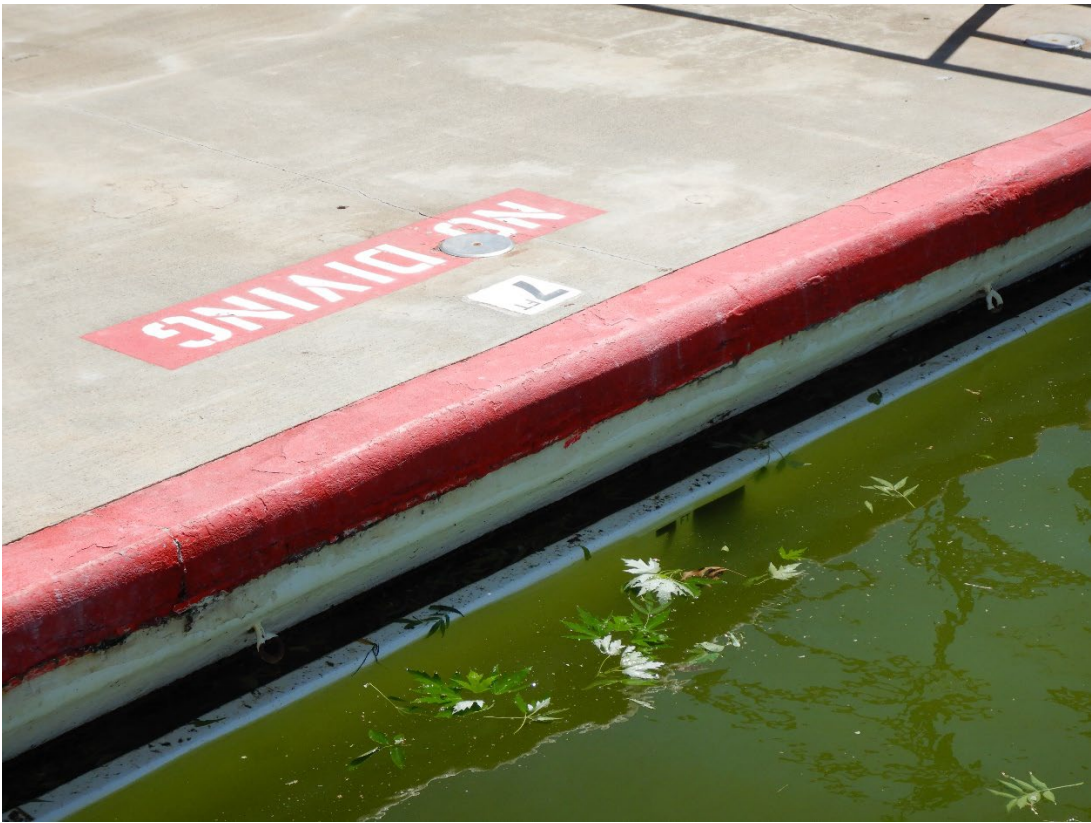
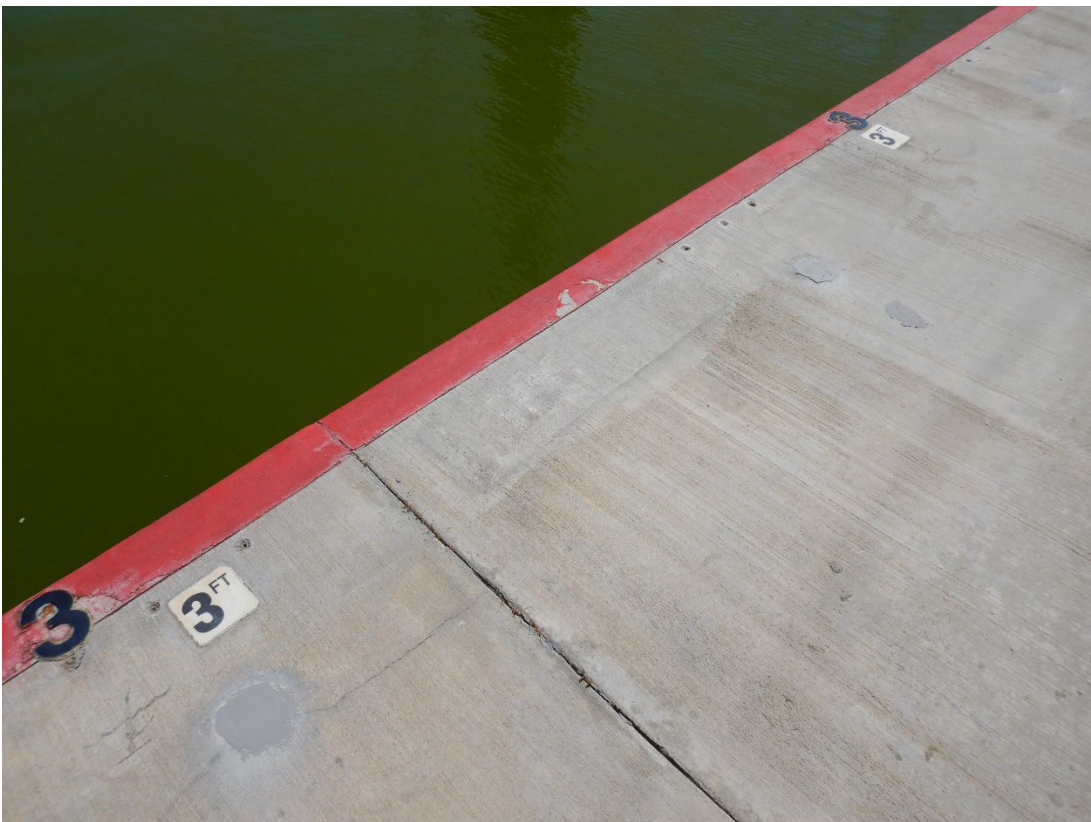
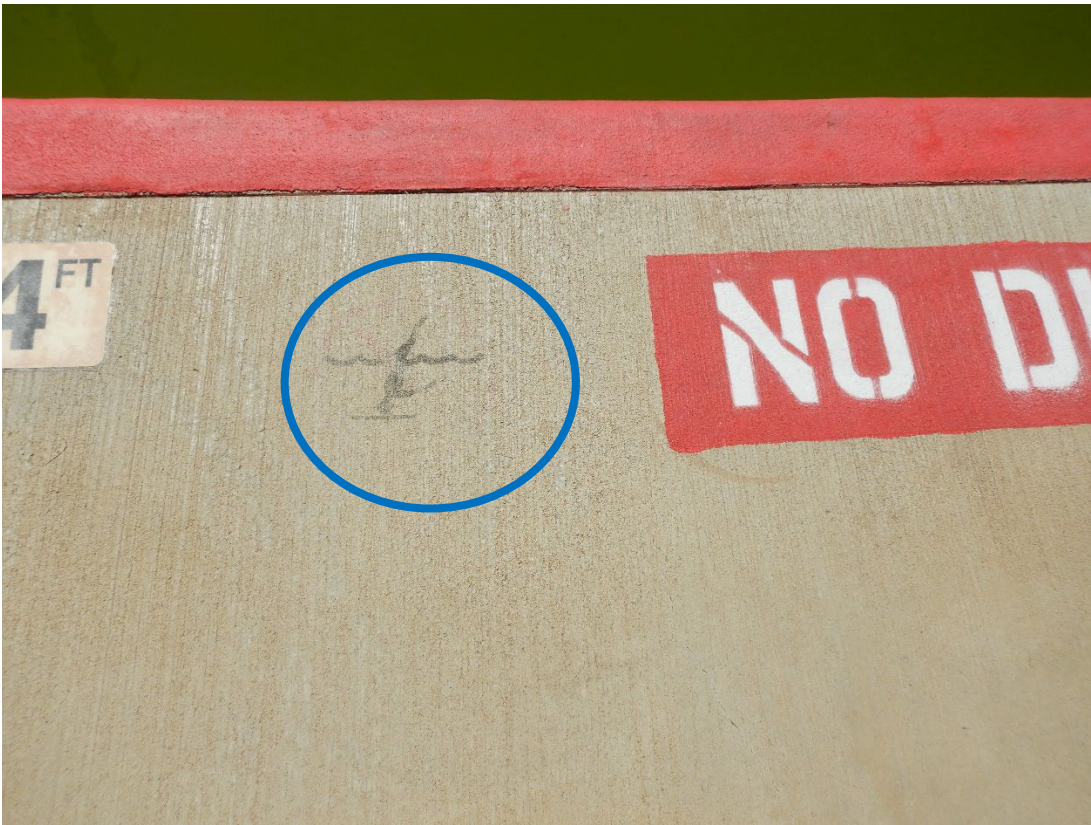
Evaluation Categories	Comments	Fiscal Impact
Starting Blocks if in place are secure and covered or signed "not for use"	I observed covers where I believe the starting block mounting holes could be. Blocks should be evaluated before using, surfaces, platforms, steps, etc. These should not be left in and if they are they should be marked "do not use" when there are no trained supervisors to monitor their use.	\$1,200 each, \$7,200 total plus installation of anchors in the deck if needed \$12,000, total \$19,200

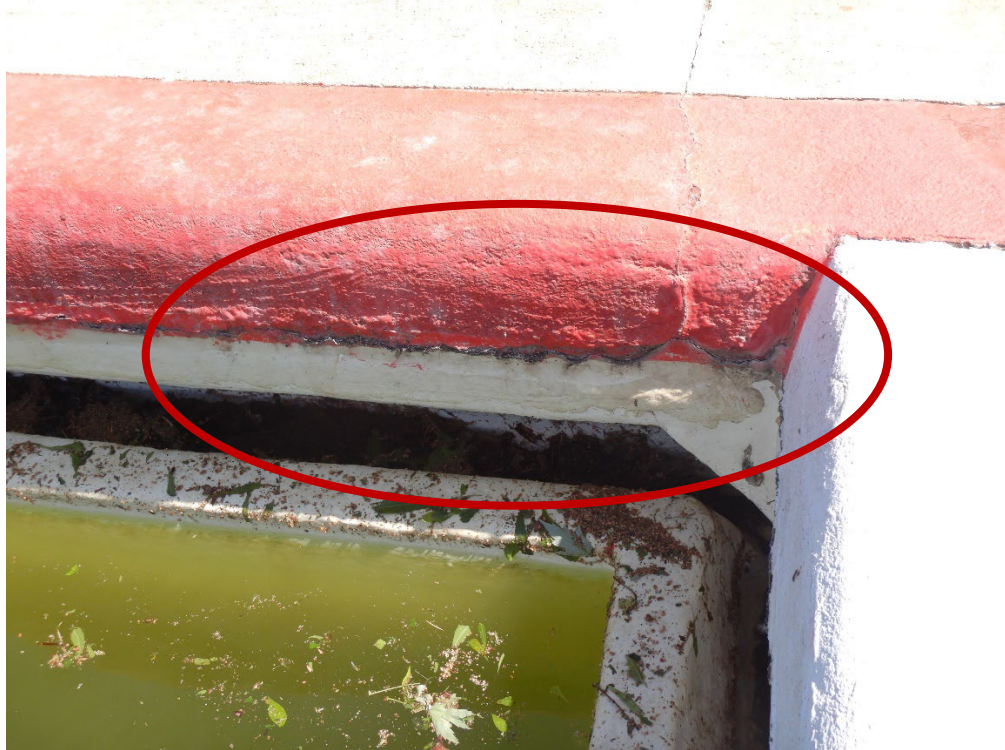
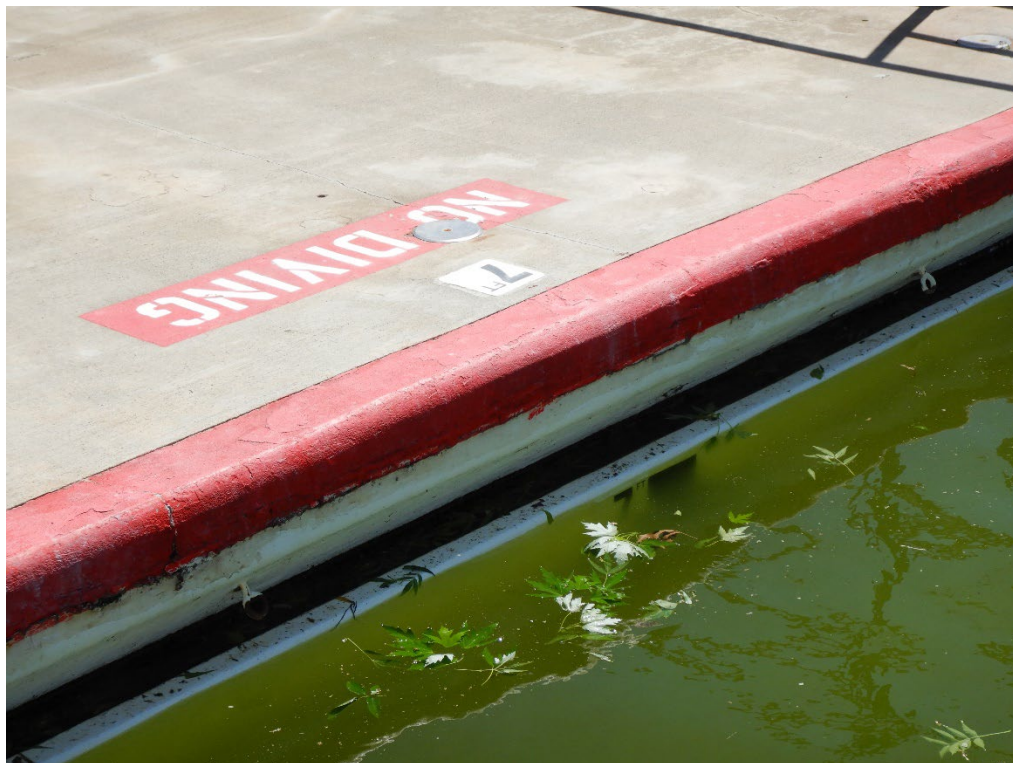
Evaluation Categories	Comments	Fiscal Impact
Condition of pool coping stones, gutter tiles, rim flow grates or skimmers.	It appears that the deck slab was laid on the pool shell at the pools edge. The union between the slab and the pool shell (gutter top) is not clean. Making it smooth would require work to smooth then fill. The design intention is such that the pool shell and deck can slide as it expands and contracts in summer and winter. Therefore, grinding the area between the deck and pool gutter wall joint and the filling might not hold. The gutter tile has been fiber glassed over as well as the vertical wall gutter tile. This has been reported in the deck section above and is of a concern to the Health Department on multiple annual reports.	This would be addressed in deck repair and replacement or resurfacing of the pool.

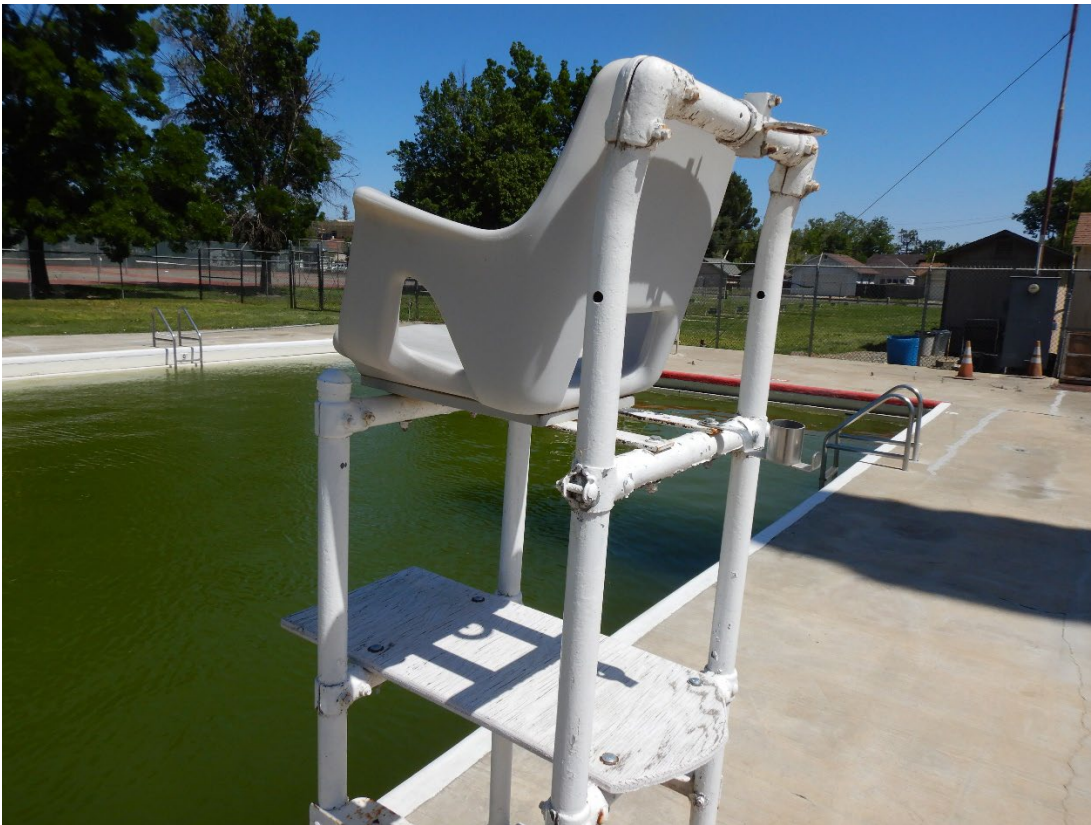
Evaluation Categories	Comments	Fiscal Impact
Water appearance is not turbid or cloudy, looks clean and pool bottom is clearly visible at main drain.	Water was green, tadpoles are loving it, could not evaluate water clarity during normal operations and more importantly peak swimmer loads.
