City of Willows

Swimming Pool Mechanical Evaluation

5/12/2022

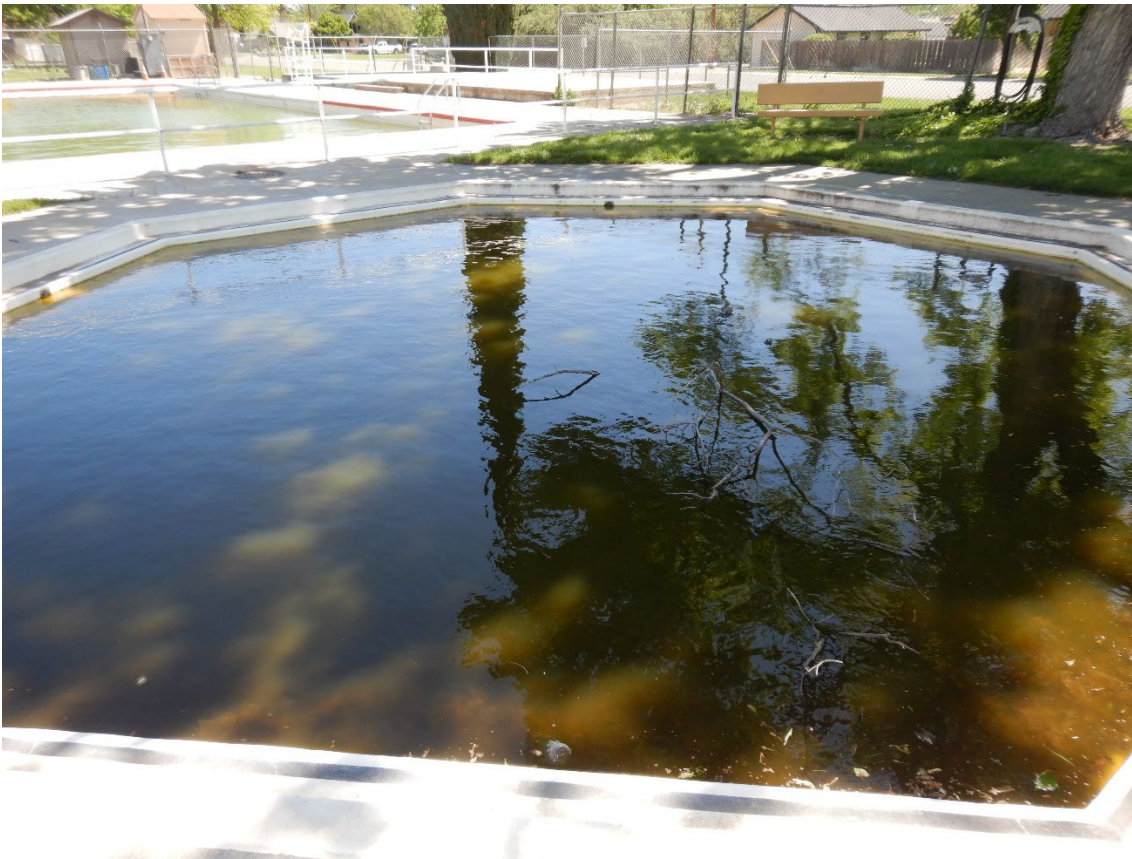
Evaluation Categories	Comments	Fiscal Impact
Pool drain covers are VGB Compliant, Inlets and other covers are in good condition.	I was unable to observe the bottom drains in the main and tot pool. These drain covers need to be of the anti-entrapment type and need to be replaced, re-inspected and recertified every 5, 7 or 10 years according to the manufacturer specifications. This can be done by a licensed contractor or engineer. I was also unable to inspect the covers for return water lines due to water clarity.	\$5,000 for replacement drain covers and recertification
